Historic Environment Feature Management Report:

Waun Wen Ruined Farmstead

UID: 311125

PRN 7146 Name WAEN-WEN

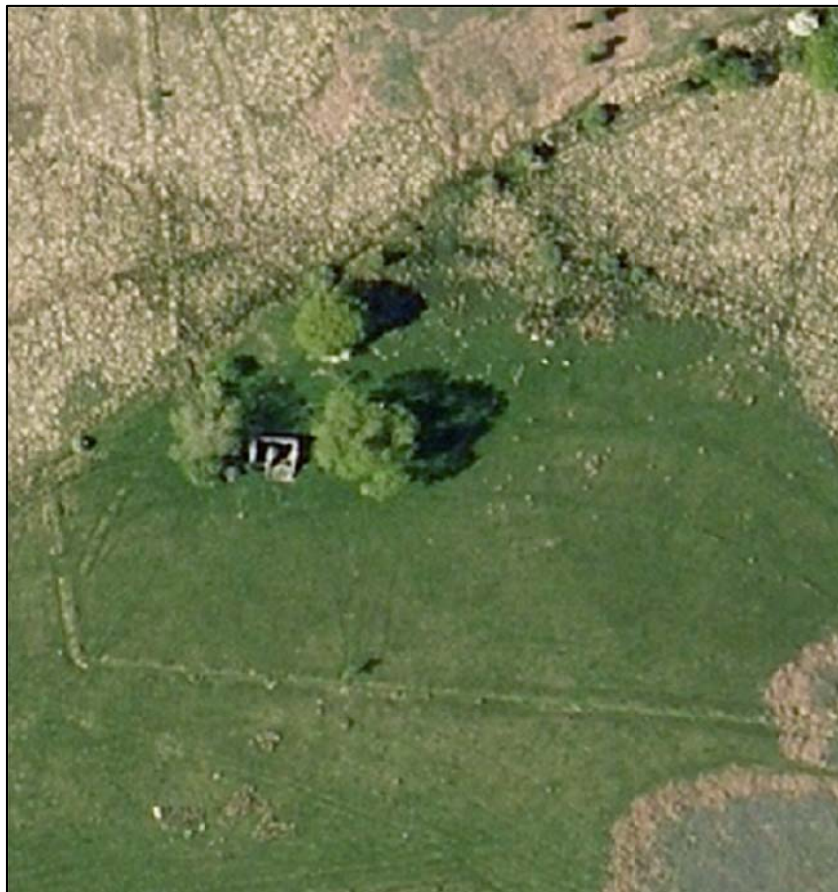
© Next Perspectives. Welsh Assembly Government 2009

A minor farmstead named as Waen Wen on the Ordnance Survey 1st edition map (1889). It is depicted on the most recent Ordnance Survey mapping (Mastermap 2011). Recent aerial photographs (Ordnance Survey Next Perspectives 2009) show the remains of a roofless structure with walls standing to full height. The area around the remains is rough grass enclosed by mature trees.

The main management issue for this site is the control of vegetation which has the potential to damage both buried archaeological remains and the built structure through the disruptive activity of root development. Trees can pose a threat through wind throw or falling limbs.

The management outcome is to maintain the built structural remains in a stable and visible condition.

- Remove mature trees which are at risk of wind throw and could threaten upstanding remains of the cottage and cottage enclosure through uprooting (root plate damage) or falling limbs
- Remove any young trees or vegetation growing out of the wall tops but cutting by hand. Do not pull-up by the roots as this is potentially destabilising to masonry bonds.
- Cut any scrub back by hand in order to retain the visibility of the building ruins.
- Maintain a canopy of mature trees over the site. This will prevent light entering the ground, inhibiting scrubby vegetation growth.

It may be desirable to carry out a programme of masonry consolidation and re-pointing in order to make the structure safe. Contact Dyfed Archaeological Trust for further advice.
