Historic Environment Feature Management Report:

Tricock House, Ruined Cottage

PRN 8318 Name TRICOCK HOUSE
Period Post-medieval **Site Type** COTTAGE
NGR SN5928047100

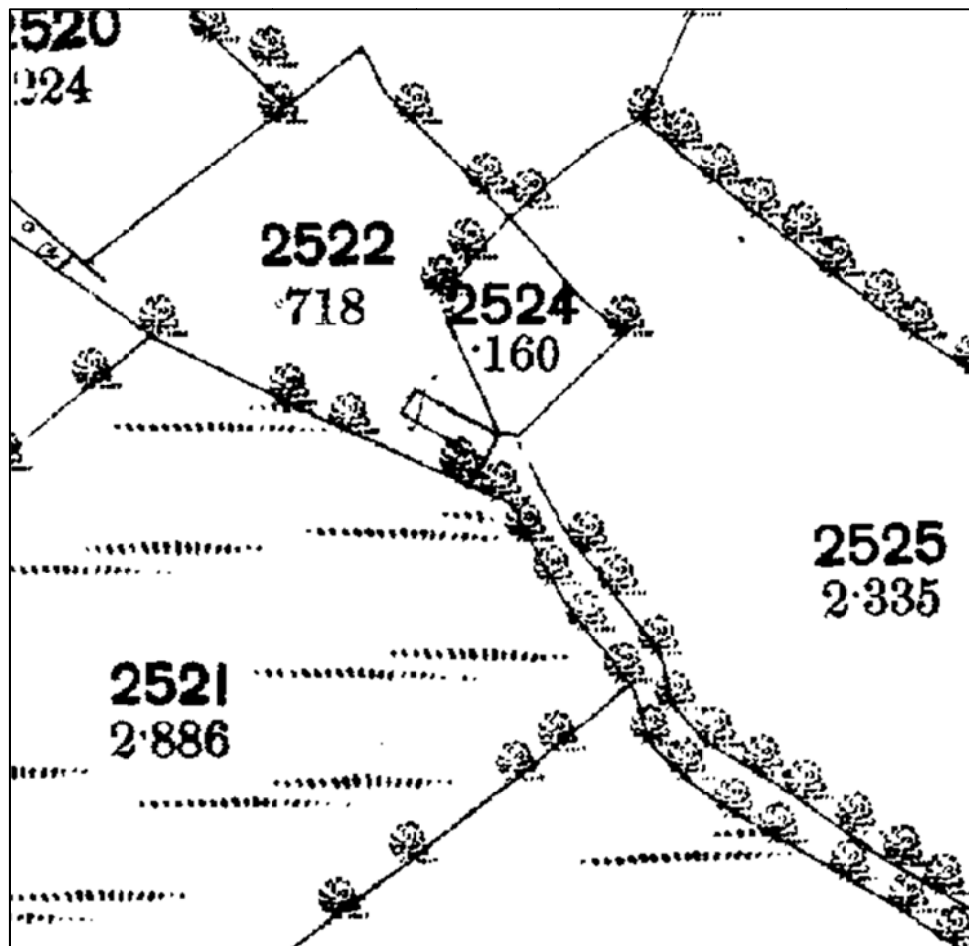
Detail from the Ordnance Survey 1st edition map (1889) © and database right Crown copyright and
Landmark Information Group Ltd (All rights reserved 08/05/2012)

A ruined cottage and associated enclosure walls marked on the Pencarreg Tithe Map of 1839. It is shown on Ordnance Survey 1st edition map (1889) as a rectangular structure. By the 2nd edition Ordnance Survey map it covers the same footprint but with the SE end being open sided; presumably representing a barn or cart house or some such agricultural building. This configuration is continued up to the most recent Ordnance Survey mapping (Mastermap 2011), indicating survival in a ruined form. A field visit in 1984 declared that only an "earthen banked enclosure" survived but it is unclear whether this refers to the buildings wall bases or an associated paddock or garden plot. Recent aerial photographs (Ordnance Survey Next Perspectives 2009) show the area surrounded by trees under a thick canopy.

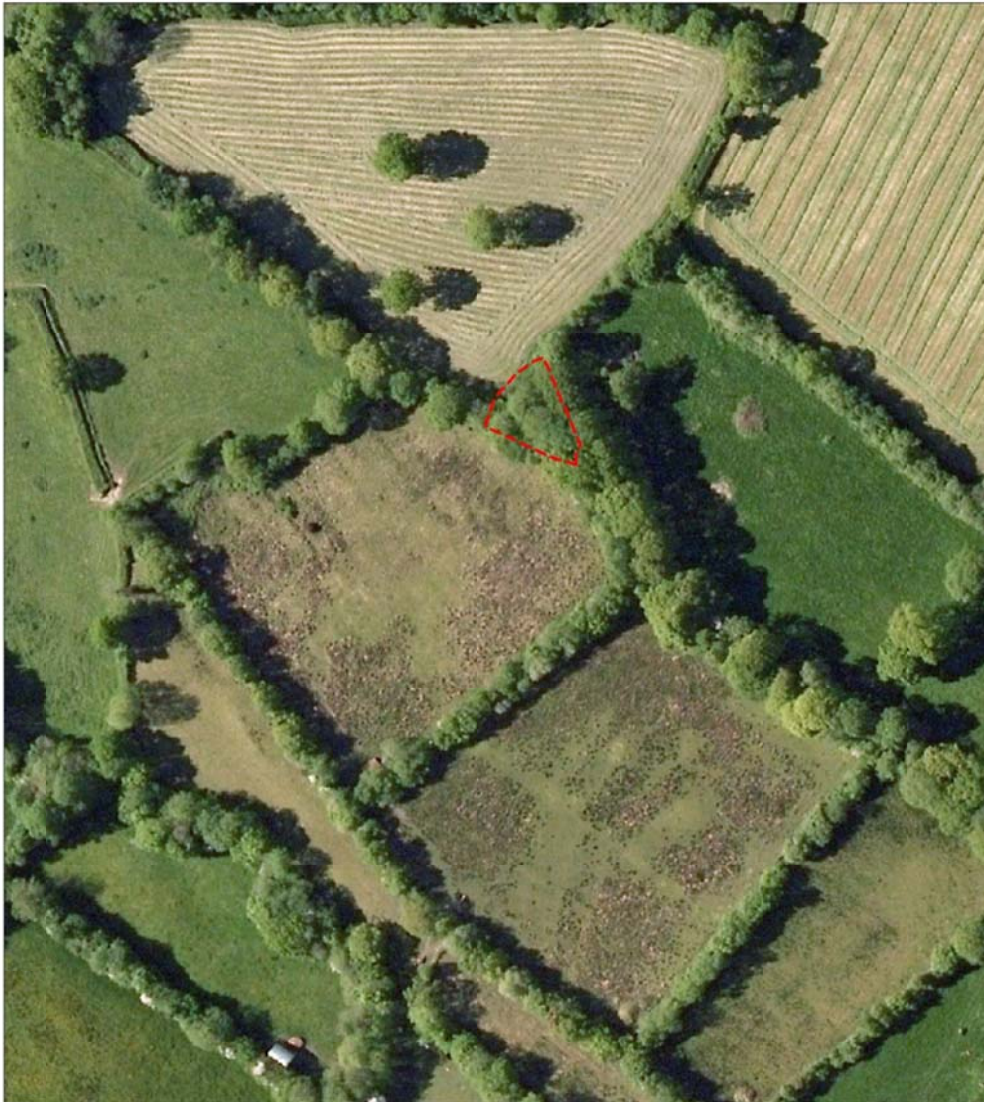
Aerial Photograph

Historic Environment Feature UID 309 645
