Historic Environment Feature Management Report:

Pen Allt Rhys Groes longhouse and enclosure

Customer Reference Number: A0022055

UID: 314178

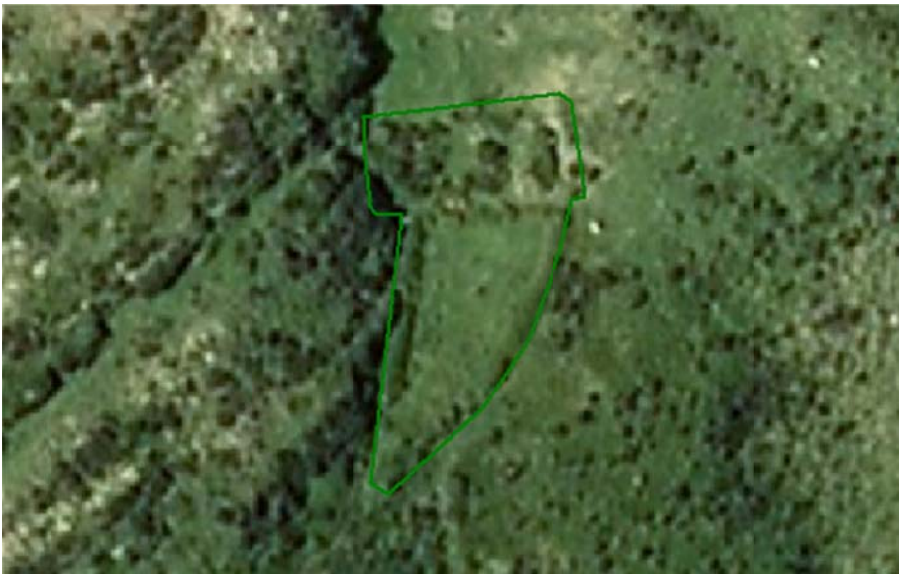
© Next Perspectives. Welsh Assembly Government 2009

It is uncertain what survives of the longhouse today. The site is no longer recorded on modern mapping but it can be identified on recent aerial photographs (Ordnance Survey Next Perspectives 2009) which indicate it to be under tree and/or scrub cover (M.Ings, 2013)

Enclosure associated with longhouse (PRN 13536), recorded on the 1888 1st edition and 1905 2nd edition Ordnance Survey maps. The site is not shown on modern mapping but is visible as a possible earthwork on recent aerial photographs Ordnance Survey Next Perspectives 2009) (M.Ings, 2013)

- Remove mature trees which are at risk of wind throw and could threaten upstanding remains of the longhouse and enclosure through uprooting (root plate damage) or falling limbs.
- Remove any young trees or vegetation growing out of the wall tops but cutting by hand. Spot treat to prevent re-growth. Do not pull-up by the roots as this is potentially destabilising to masonry bonds.
- Cut any scrub back by hand in order to retain the visibility of the building ruins.
- Where present maintain a canopy of mature trees over the site. This will reduce light reaching the ground, inhibiting scrubby vegetation growth.
