Historic Environment Feature

Management Report:

Abernant Cwta Cottage

Customer Reference Number: A0026781

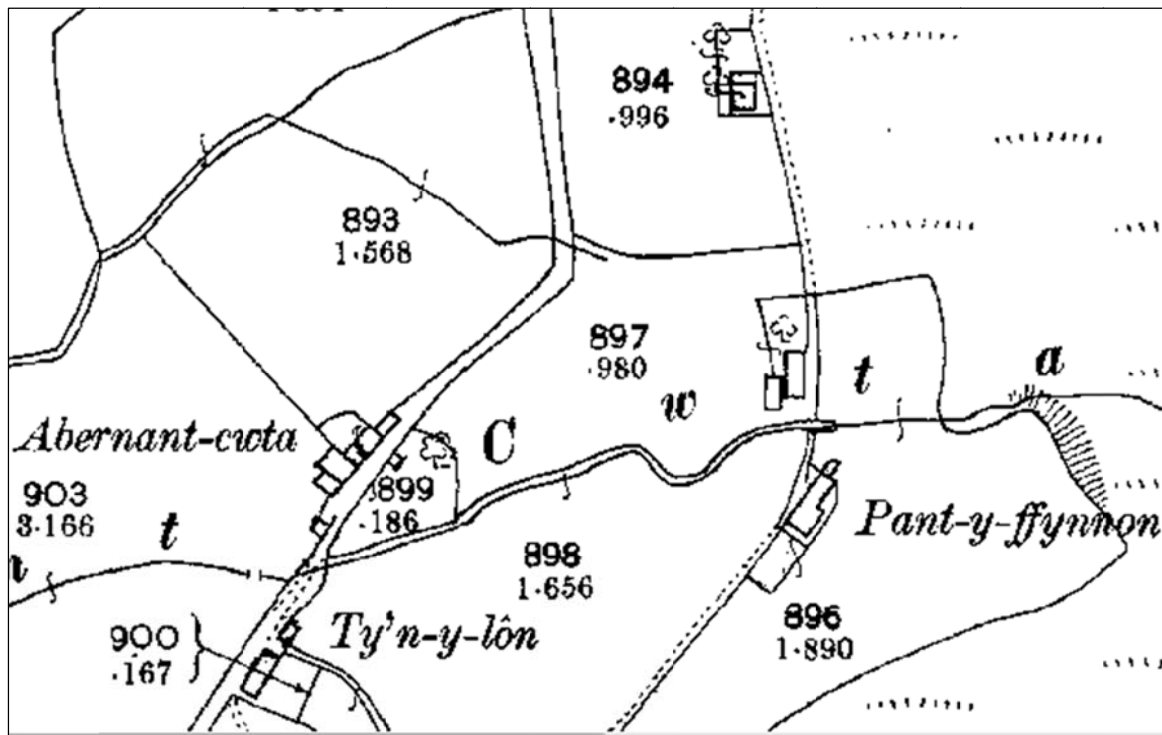
Detail from the Ordnance Survey 1st edition map (1888) showing the cottages. © and database right Crown copyright and Landmark Information Group Ltd (All rights reserved 08/03/2013)
