Historic Environment Feature Management Report: **Waun Dan y Felin**

Customer Reference Number: A0037456

UID: 306,491

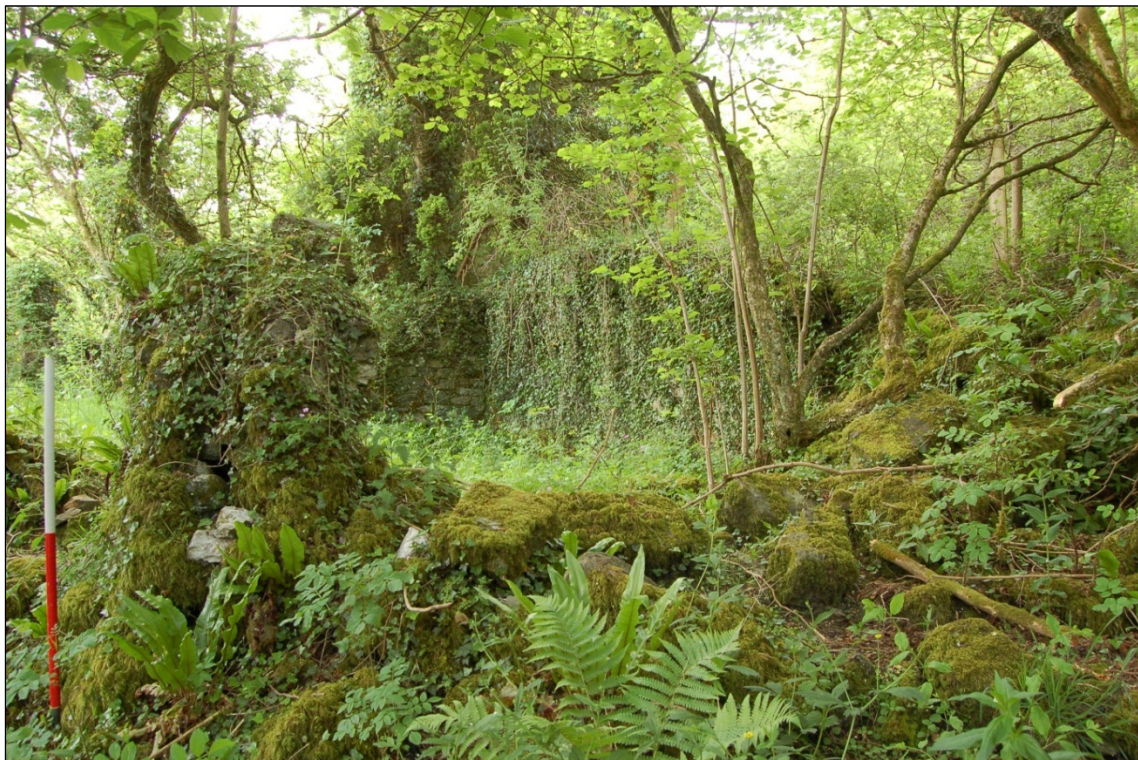
Looking southeast along length of ruinous mill building (©2012, DAT)

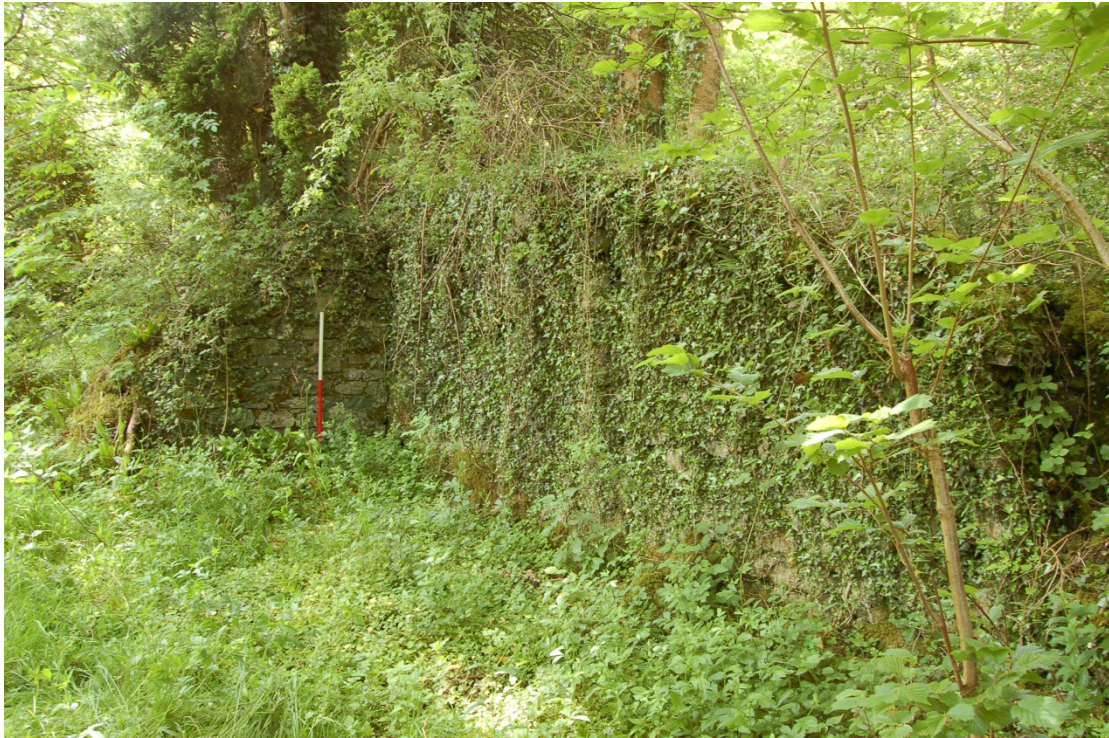
The main management issue for this site is the control of tree and scrub growth which has the potential to damage buried archaeological remains through the disruptive activity of root development, and built structural remains by prising apart masonry bonds or wind throw.

Looking southwest, south interior corner of the mill under thick ivy cover and with saplings and more mature trees growing close to the structure (2012, DAT)

- Remove mature trees which are at risk of wind throw and could threaten upstanding remains of the cottage and mill and associated features through uprooting (root plate damage) or falling limbs.
- Remove any young trees or vegetation growing out of the wall tops but cutting by hand. Do not pull-up by the roots as this is potentially destabilising to masonry bonds.
- Cut any scrub back by hand in order to retain the visibility of the building ruins.
- Maintain a canopy of mature trees over the sites. This will prevent light entering the ground, inhibiting scrubby vegetation growth.
- Only undertake work when ground conditions are dry and avoid causing disturbance to the ground surface.

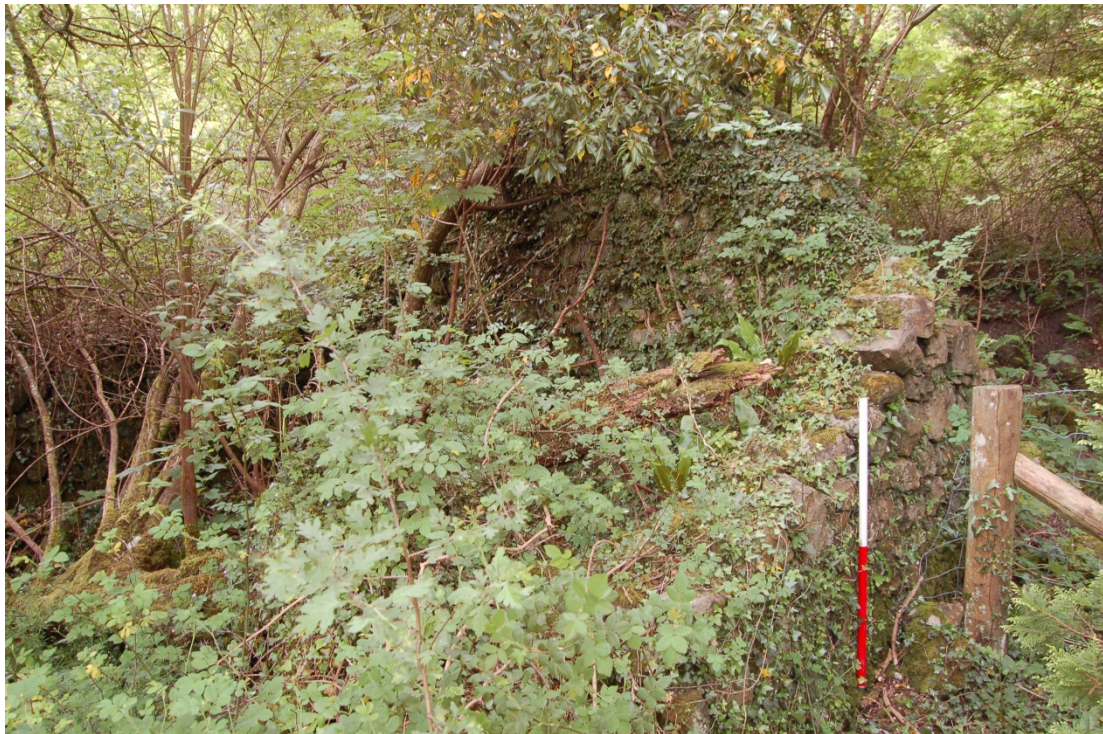
Looking southwest, west gable end of ruinous cottage under thick vegetation, showing tree growing within the building footprint (2012, DAT)

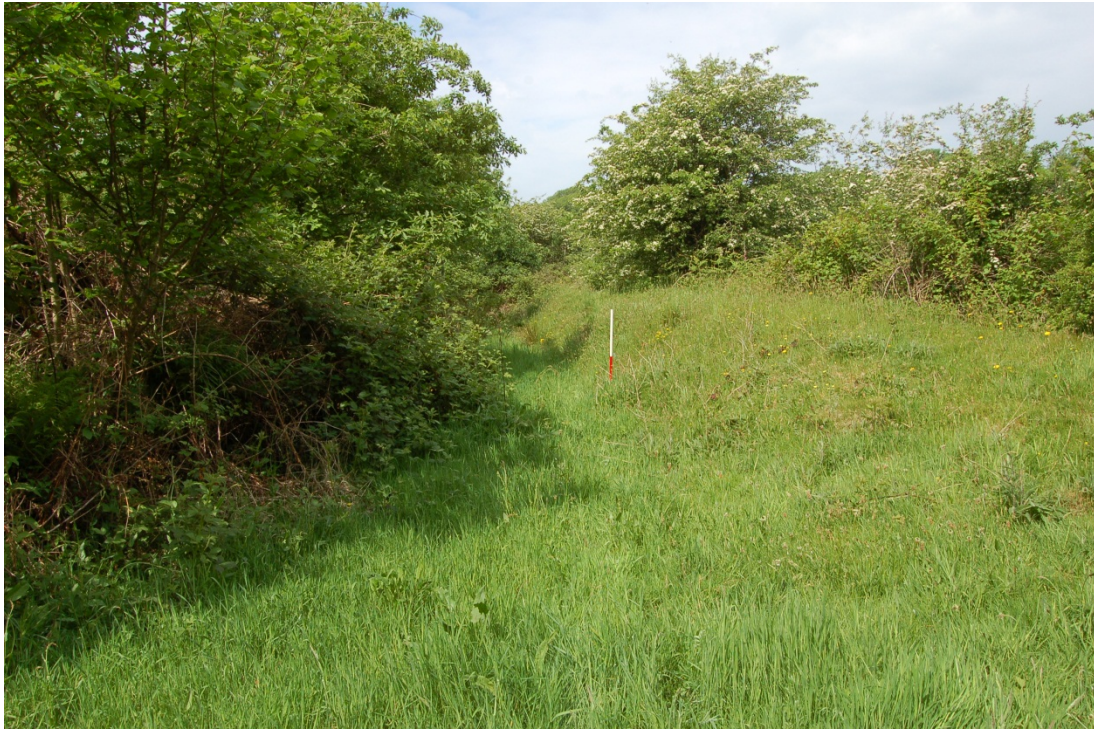
Looking west, from within the mill pond earthwork towards the mill-race (2012, DAT)
