LAND ADJACENT TO HERON'S REST, MARTLETWY, PEMBROKESHIRE: ARCHAEOLOGICAL WATCHING BRIEF (NGR SO 4050 4340)

RHIF YR ADRODDIAD / REPORT NO. 2013/24
RHIF YR DIGWILLIAD / EVENT RECORD NO. 105523

**LAND ADJACENT TO HERON'S REST,
MARTLETWY, PEMBROKESHIRE:
ARCHAEOLOGICAL WATCHING BRIEF**

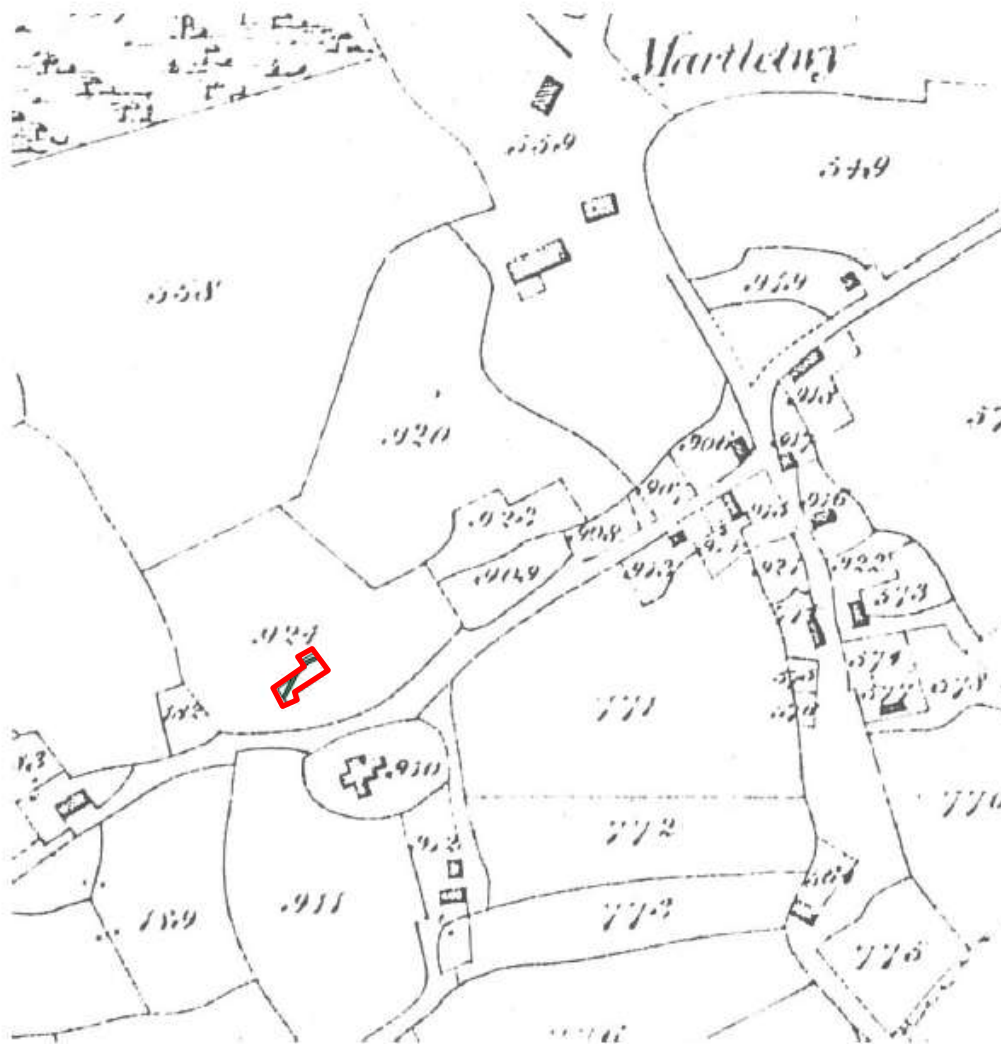
Figure 2: Tithe Map of Martletwy showing watching brief location in red

2.2.6 The 1841 Tithe Schedule records two fields located 220m to the west of Martletwy Church called Upper and Lower Castle (PRN7985) (Figure 2). These

may refer to earlier sites of prehistoric date (the sites of former Bronze Age barrows were recorded in Upper Castle, but have since been ploughed away).

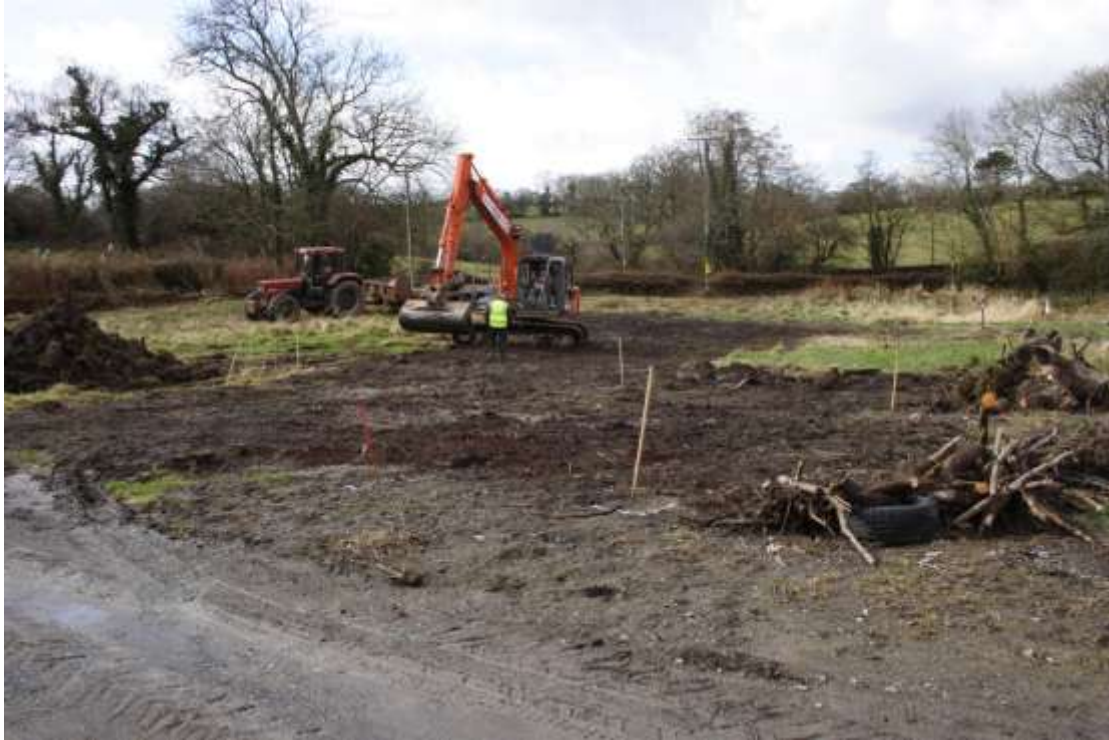
4.1 Following the removal of the topsoil and subsoil, the top of the underlying natural geological levels was exposed which comprised a stiff, orangey-grey, silty-clay interspersed with pockets of soft, degraded coal. Three archaeological features were identified within the area of the footprint of the building.

Photo 1: Topsoil stripping of the building footprint facing southwest

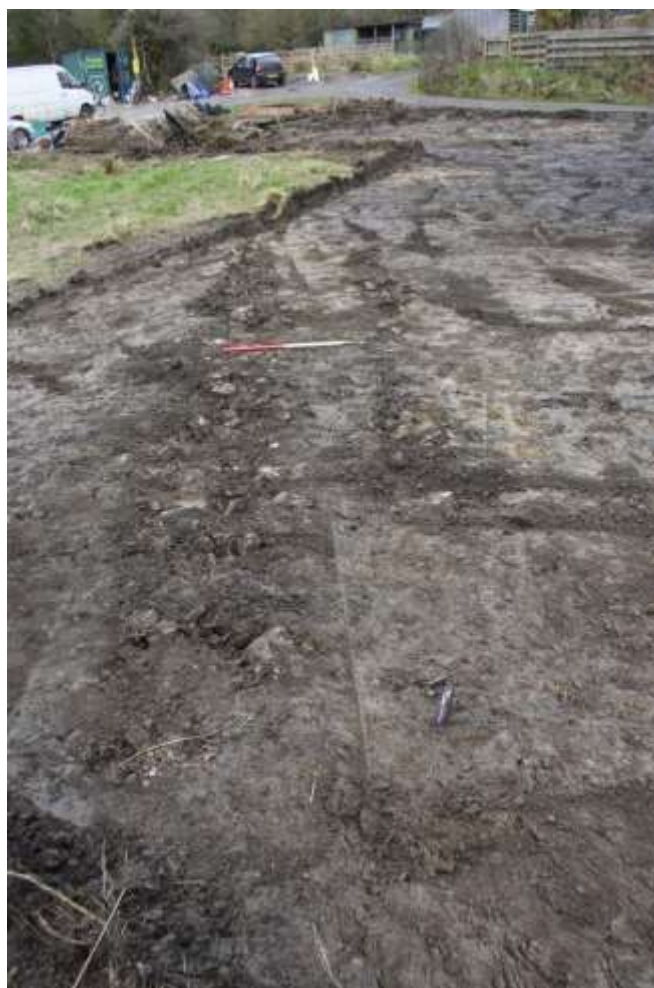
4.2 The largest of these features was a curvilinear ditch (01) measuring 31m long and 1.8m wide (Figures 3 and 4). It emerged from the middle of the western side of the development site, crossing the stripped area in a northeasterly direction for 12.5m where it continued under the north edge of the trench. It re-emerged in the east bay of the building footprint where it headed in an easterly direction for 9m where it passed beneath the eastern side of the stripped area. The western half of the ditch was visible on the surface as an arc of disturbed ground containing a large quantities of stone and occasional brick, breeze block and root action, within a soil matrix of grey-brown, silty clay.

Photo 2: View northeast along the line of ditch (01)
in the western part of the site area

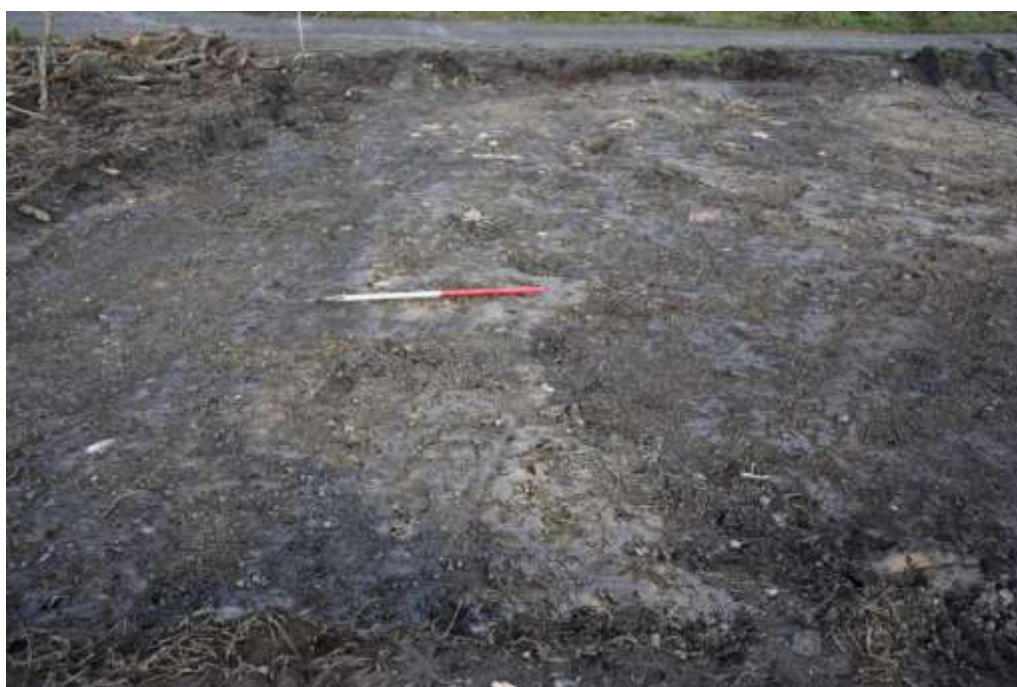
Photo 3: View northeast along the line of ditch (01)
in the eastern part of the site area

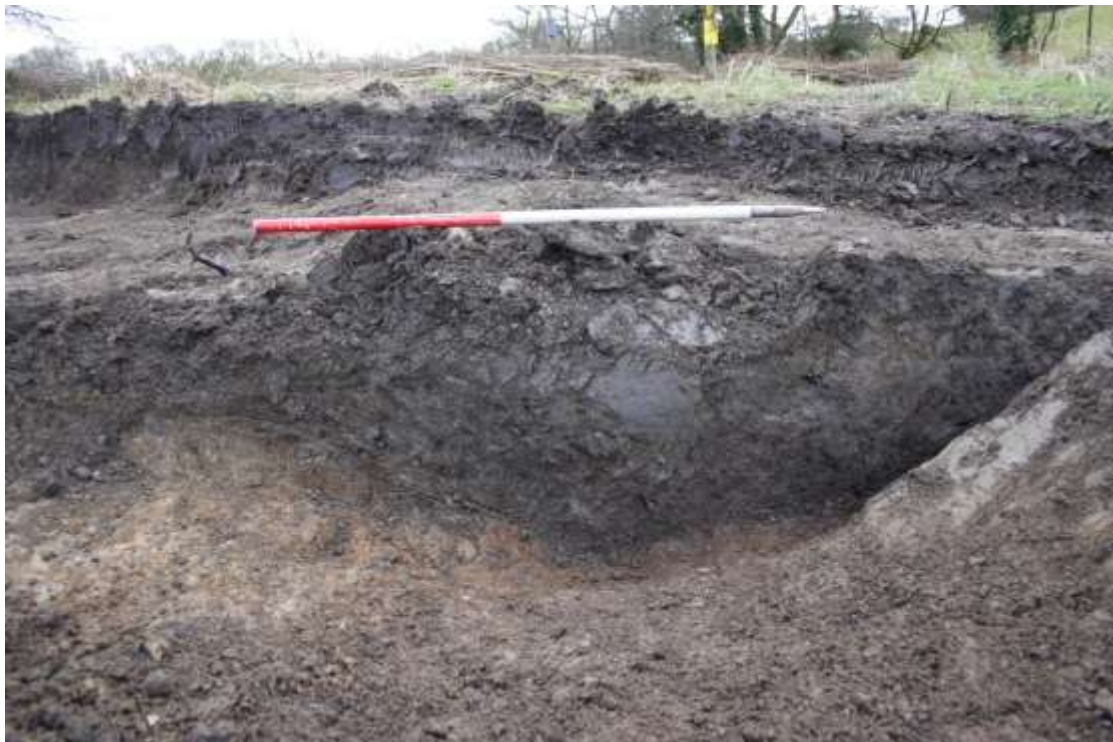
4.3 A section 0.35m wide was excavated across the ditch to determine its profile and stratigraphy (Figure 4). This revealed a shallow round-bottomed ditch with a well-defined break of slope on the southern side. The northern edge in contrast was difficult to discern and might have been truncated or suffered from erosion in the past. The lower of the two fills visible in section, (03), was a dark-grey, silty-clay with traces of orangey-brown silty-clay. A small percentage of coal fragments and small stones were present in the fill. A single pot sherd, tentatively identified as Dyfed gravel tempered ware, a pot with medieval provenance, was recovered from the fill. The upper fill (02) consisted of modern debris; mainly large and small angular stone with occasional brick and breeze block within a light grey, silty-clay matrix. This was mixed with the subsoil and may indicate a later refilling of a sunken hollow above the ditch.

Photo 4: Northeastern facing section through ditch (01)

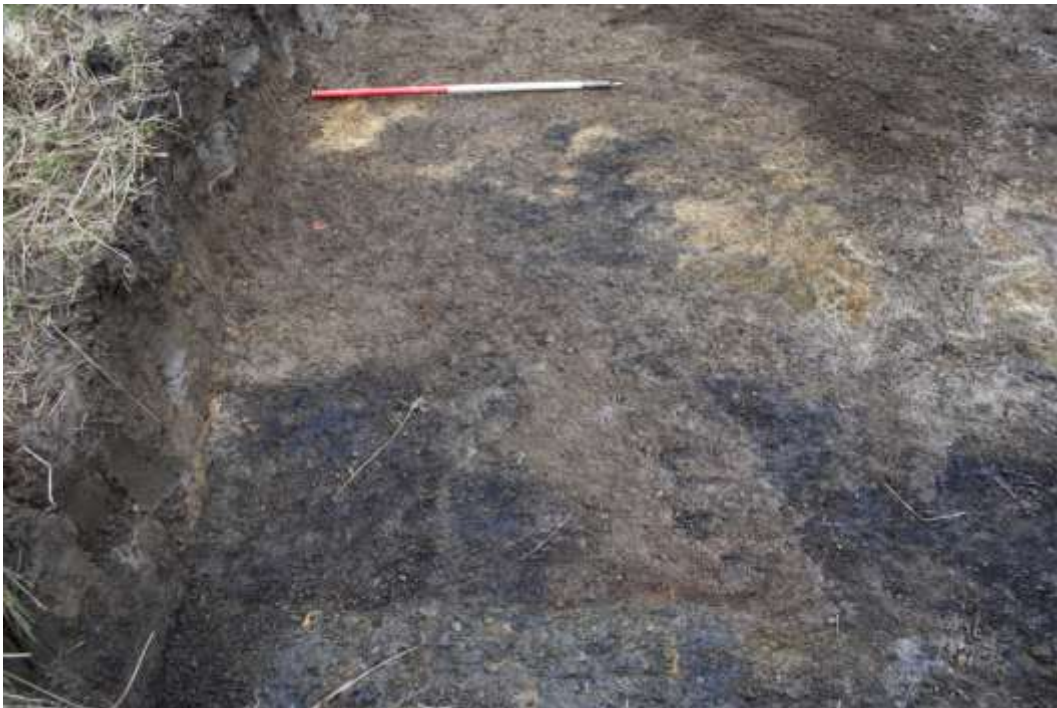
4.5 In the southwestern corner of the proposed footprint of the building two cut features were partially uncovered (Photo 5). Unfortunately not enough was revealed of the cuts to ascertain their function or form. The earliest was a 2m long, 0.6m wide, flat-bottomed, shallow gully (04). It entered the trench on the west side and continued in an easterly direction for 1m then turned sharply to the south for 1m before being truncated by cut feature (06).

Photo 5: Features (04) and (06) in southwestern corner, view north-northwest

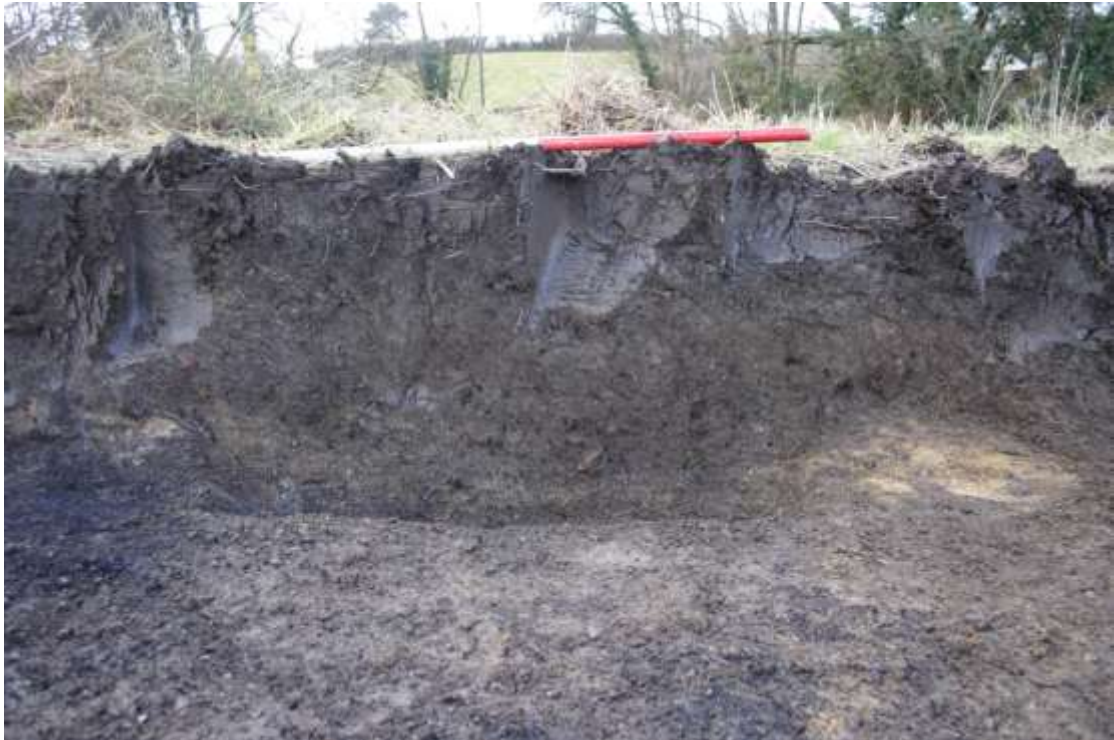
4.6 The fill of (04) was a medium grey-brown, silty-clay with occasional small stones and gravel and was 0.08m thick (05) (Figure 6; Photo 6). Within this fill one potsherd of Dyfed gravel tempered ware was recovered.

Photo 6: East facing section in southwestern corner of proposed building footprint following excavation of (04)
