# Historic Environment Feature Management Report:

## Coppybush Farm, Lime Kiln

UID: 310,403

**PRN 17992 Name** CoppyBush Farm  
**Period** Post-medieval **Site Type** Kiln  
**NGR** SN07080070

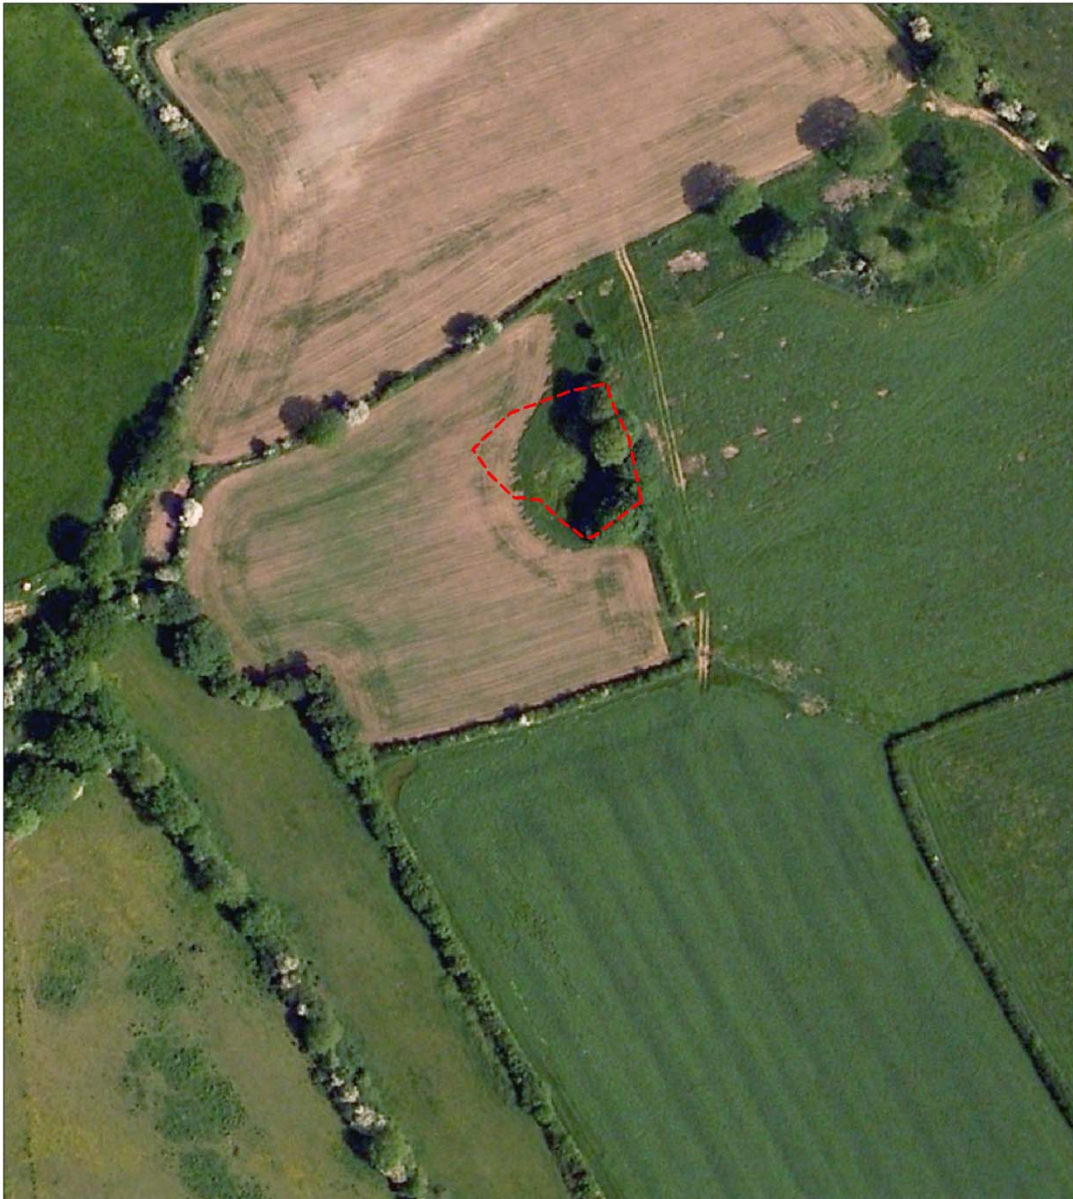
## Aerial Photograph

The kiln is still shown on the most recent Ordnance Survey mapping (Mastermap 2011) as a ruin. The most recent aerial photographs (Next Perspectives, 2009) show the area to be covered in woodland so its current condition is unclear.
