Historic Environment Feature Management Report: Picton Castle, Boathouse

Customer Reference Number: A0030021

UID: 301,558 & 313,783

PRN 40488 **Name** BOATHOUSE
Period Post-medieval **Site Type** Boat house
NGR SN0161312343

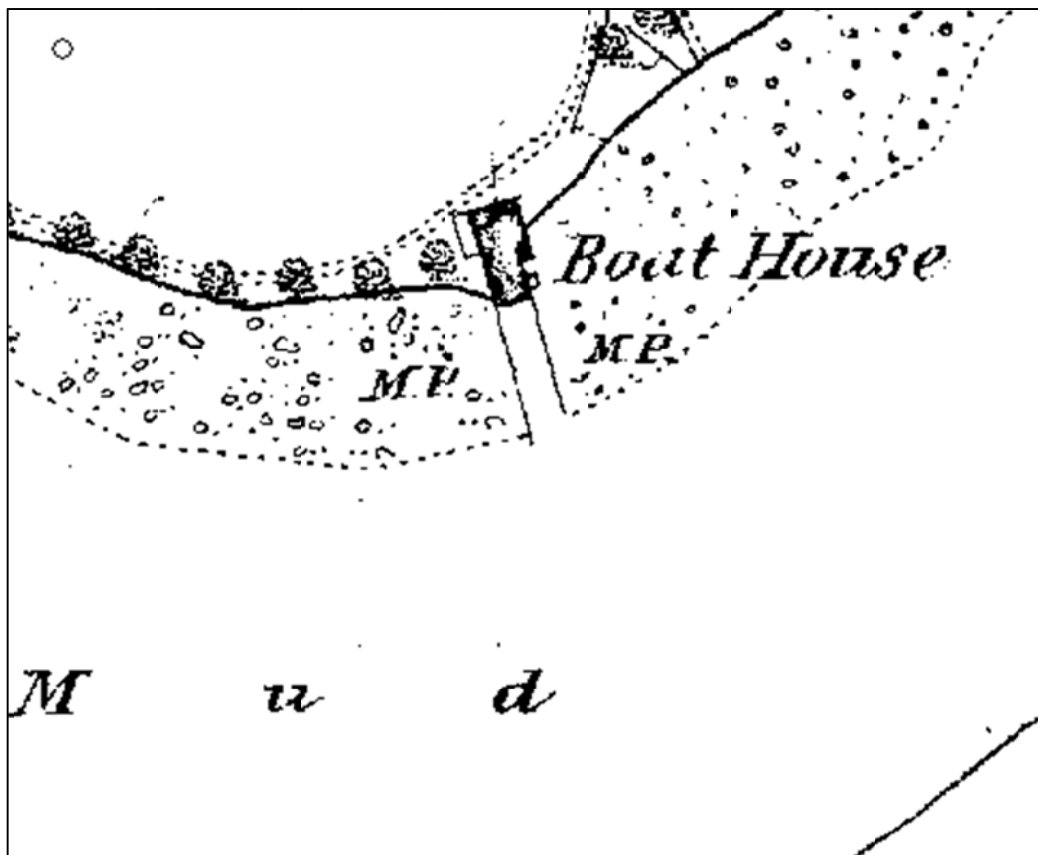
Detail from the Ordnance Survey 1st edition map (1889) © and database right Crown copyright and Landmark Information Group Ltd
(All rights reserved 08/05/2012)

A ruined boat house shown on the 1st edition Ordnance Survey map of 1890 on the northern bank of the Eastern Cleddau. The mapping shows a broadly rectangular structure partly over the mean high water mark and partly within the tidal mud flats. Also included is a slip way, flanked by mooring posts, extending over the mud flats to clear water. Described by CADW as the 'substantial remains of the once-impressive boathouse, rubble built with dressed quoins'. It was part of the Picton Castle Estate presumably for pleasure boating.

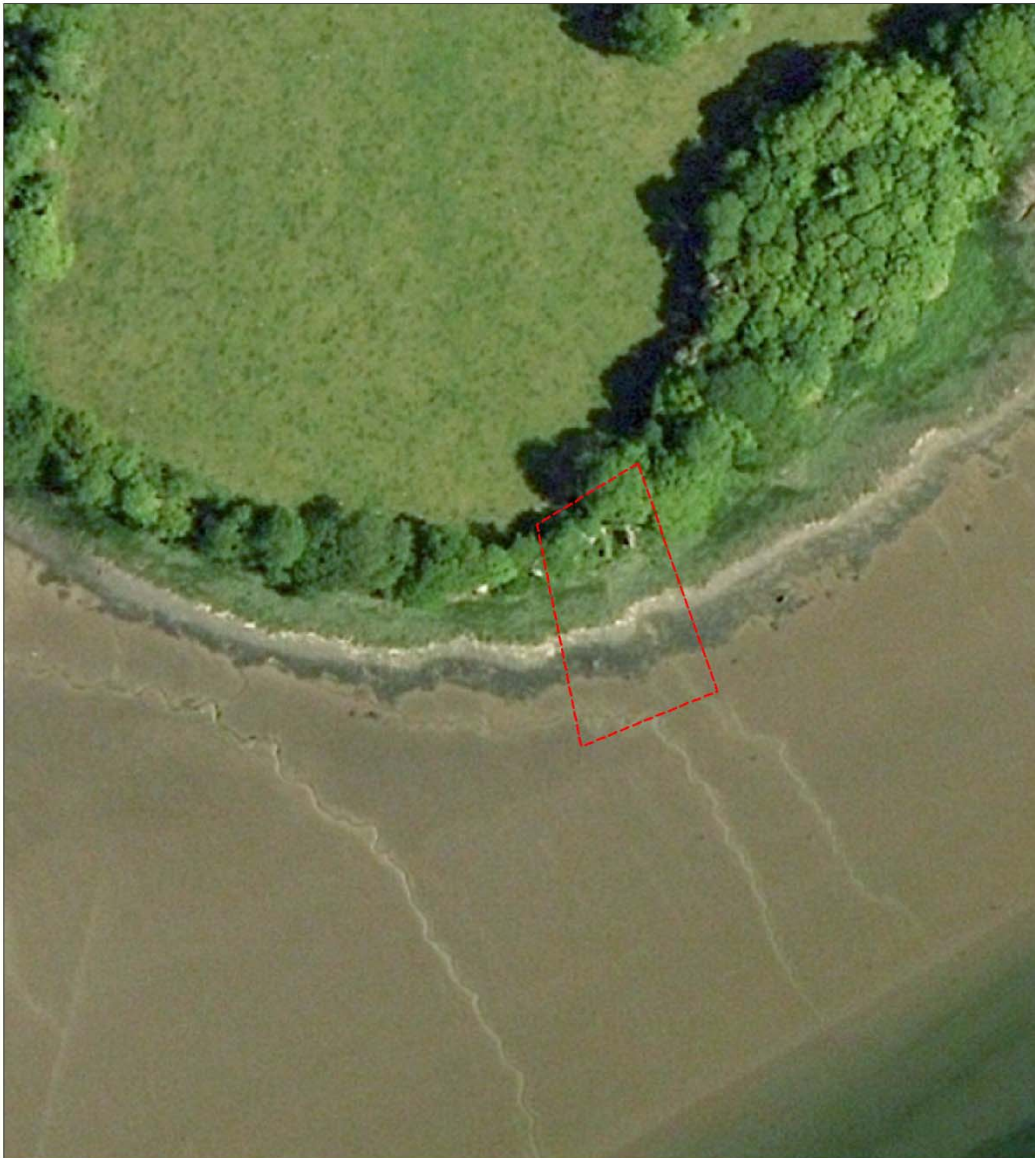
Aerial Photograph

The footprint of the boathouse is still shown on the most recent Ordnance Survey mapping (Mastermap 2011). The most recent aerial photographs (Next Perspectives, 2009) show the ruined structure in an area covered in woodland.
