# Historic Environment Feature Management Report:

## Glan yr Afon, Ruined Farmstead

Customer Reference Number: A0029173

UID: 302,010

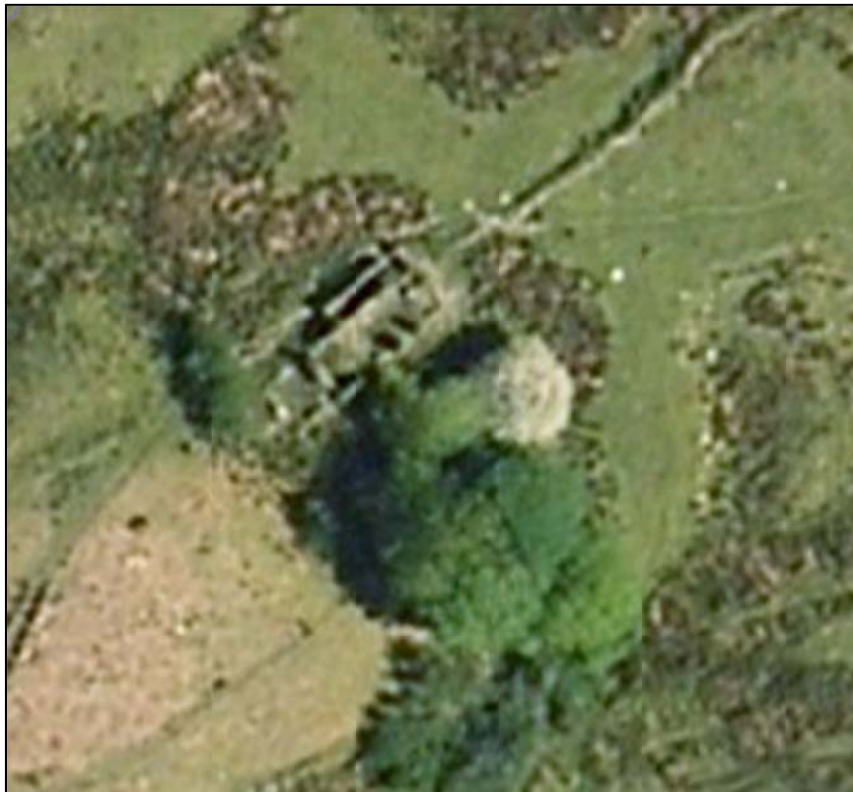
Glan yr Afon is depicted on the most recent Ordnance Survey mapping (Mastermap 2011). Recent aerial photographs (Ordnance Survey Next Perspectives 2009) which show the walls of the farm house and buildings standing to some height.

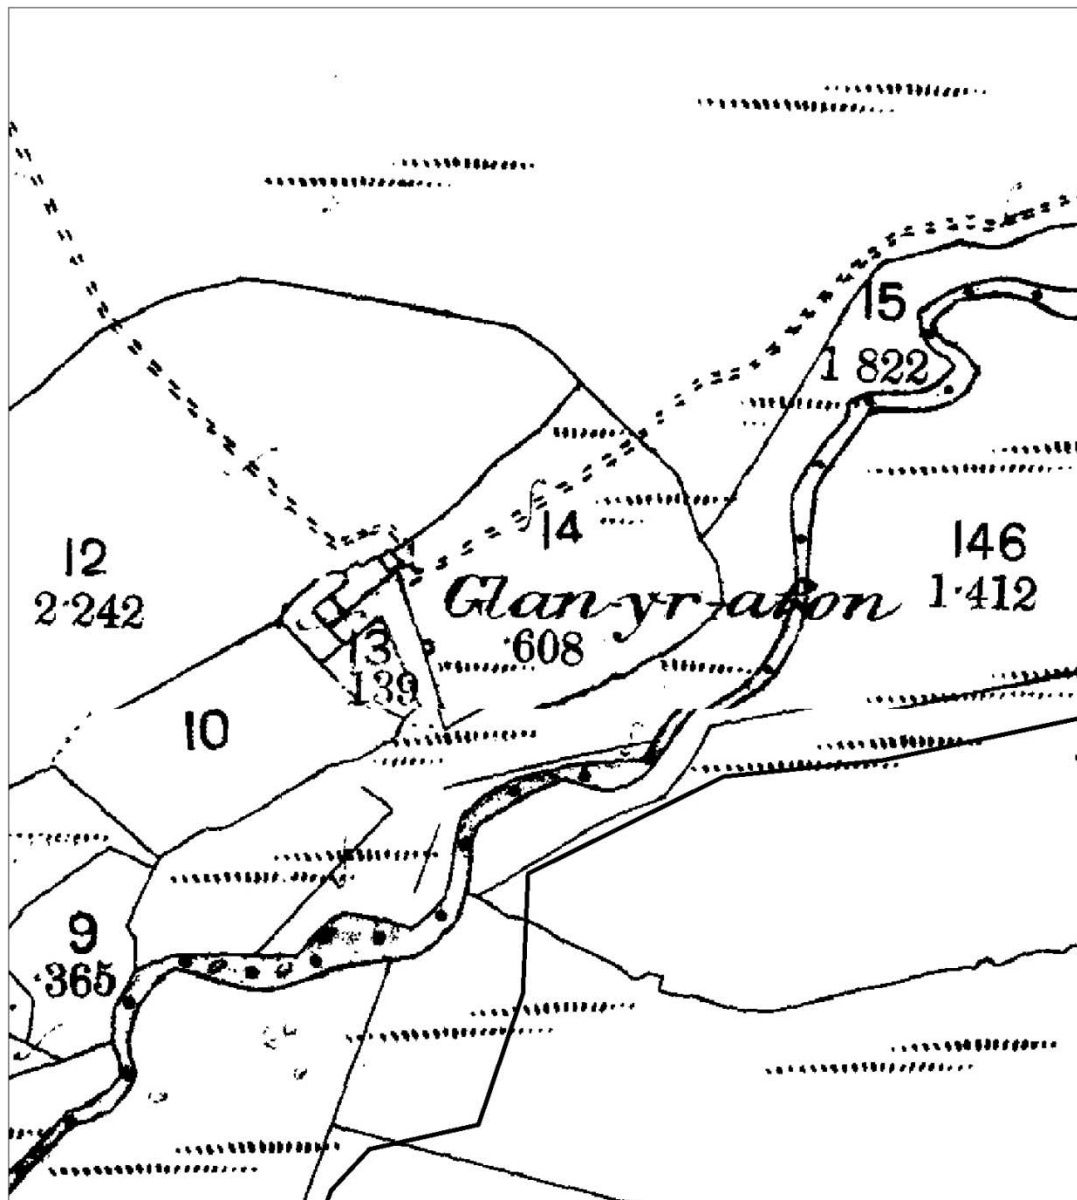
## 1889 Map

A minor farmstead named as Glan yr Afon on the Ordnance Survey 1st edition map (1889). The mapping shows a rectangular 4 cell farmhouse and boundary banks with evidence for lazy beds or ridge & furrow (James 1989). The "Garden" plot on the SE side of the house has a well-defined stone boundary with a walled track way to the NE. It is typical of the expansion into upland areas in the 18th century and subsequent retrenchment in the 20th century. A field visit in 2006 described the garden area as grassed with deciduous trees and the raised beds area to the north and NE of the house as lush green grass but everywhere else there is reed growth and bracken. Drainage is not good between the dwelling and the stream (some 120m to the SE). The thick bracken growth to the south and southwest covers a complex of stone bounded enclosures.

Detail from the Ordnance Survey 1st edition map (1889)  
© and database right Crown copyright and Landmark Information Group Ltd (All rights reserved 08/05/2012)
