Historic Environment Feature Management Report:

Whetstone Hill, WWII Gun Battery **Buildings**

Customer Reference Number: A0028520

UID: 304,019 & 304,020

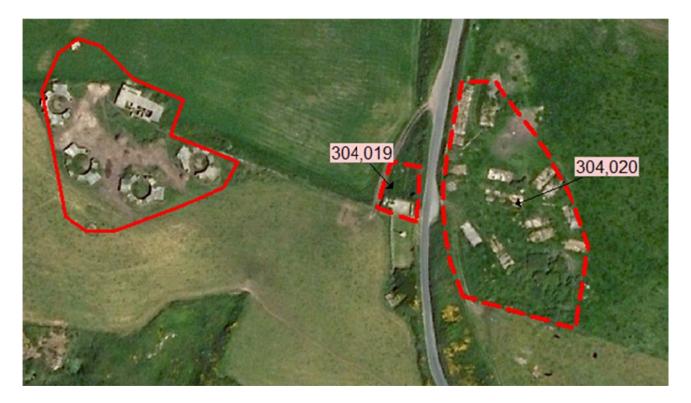
© Next Perspectives. Welsh Assembly Government 2009

The site includes a series of concrete bases and hard standings for ancillary and support structures associated with the Scheduled Whetstone Hill WWII Anti-Aircraft battery (SAM Pe 494; PRN 14355). The features are identifiable on recent aerial photographs (Next Perspectives 2009). There are 14 individual concrete slabs visible on the aerial photograph although a survey in 1993 identified some 35 as part of the wider complex not all which may lie within the two UID polygons. The structures on the concrete bases would have included technical buildings such as a generator house, workshop, stores as well as for domestic support such as accommodation barracks, wash rooms, latrines, mess area, canteen and sick bay. These structures would mostly have been Nissen hut style in timber and corrugated metal. Whilst the bulk of these have long since gone some evidence of their form and materials may still survive such as metal hold fasts set in the concrete and brick footings for internal divisions. Other associated remains are known to survive at similar sites such as paths and tracks, metal stanchions and spikes to support perimeter fencing and earthwork remains of ground defences such as machine gun nests and mortar pits (H Pritchard, 2013).

The aerial photographs show the site is mostly under rough vegetation with some areas of vehicular erosion. Some of the concrete bases are overgrown.

- Cut back by hand any vegetation encroaching onto the structures in order to maintain their visibility
- Clear excessive vegetation and ground cover from the area defined on the map by hand cutting to ground level, allowing the roots to rot in situ.
- Establish a stable grass sward, reseeding if necessary, and managing any subsequent vegetation growth if required.
