Historic Environment Feature Management Report:

Blaen-Waun, Ruined Farmstead

UID: 304,116

PRN 54327 **Name** BLAEN WAUN
Period Post-Medieval **Site Type** Farmstead
NGR SN0135235925

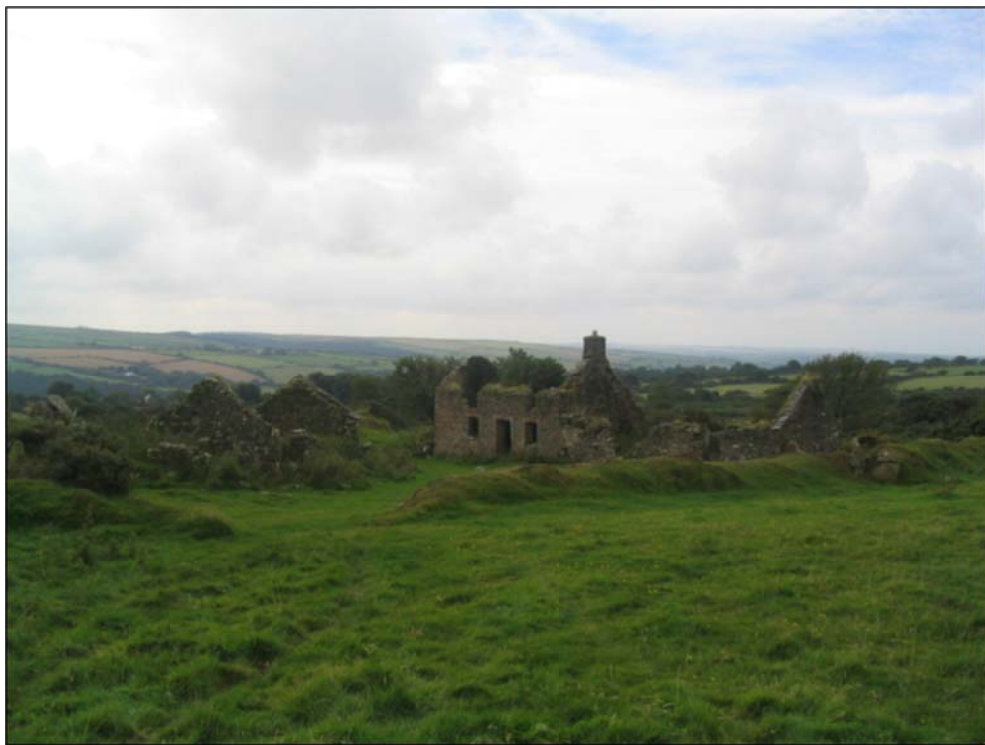
© DAT 2005

A standing but ruined farmstead visible and named as Blaen-Waen on the 1st edition Ordnance Survey map of 1889. The site consists of a mortared rubble built farmhouse, originally 2-storey high with a slate roof. A small barn range is attached to the northern end of the farmhouse, including 3 concrete cattle stalls. Opposite this range stands a detached mortared rubble built barn range. The internal floor and roof of the farmhouse have gone, the interior is rubble filled with a tree growing in the southern end and vegetation covering the rear wall. The attached barn range is greatly ruined. The detached barn range is also greatly ruined and vegetation filled, only the gable and rear walls stand close to their original height. To the front (west) of the farm buildings are two small walled paddocks and the whole complex sits within a wider enclosure. These boundaries survive as ruined walls or grass covered banks. The farmstead complex is not marked on either the old series Ordnance Survey map of 1819 or the tithe map of c1841, suggesting it was built in the mid to late 19th century as it first appears on the 1st edition Ordnance Survey map of 1889. The form of the farmstead is unchanged by the 2nd edition mapping of 1907 but name has altered to Blaen-Waun. It was visited in 2005 and found to be ruinous but standing (Poucher 2005) It is shown on the most recent Ordnance Survey mapping (Mastermap 2011) and recent aerial photographs (Ordnance Survey Next Perspectives 2009) show the walls still survive.

The main management issue for this site is the control of vegetation which has the potential to damage both buried archaeological remains and the built structures through the disruptive activity of root development.

- Remove any young trees or vegetation growing out of the wall tops but cutting by hand. Do not pull-up by the roots as this is potentially destabilising to masonry bonds.
- Cut any scrub back by hand in order to retain the visibility of the building ruins.

It may be desirable to carry out a programme of masonry consolidation and re-pointing in order to make the structure safe. Contact Dyfed Archaeological Trust for further advice.

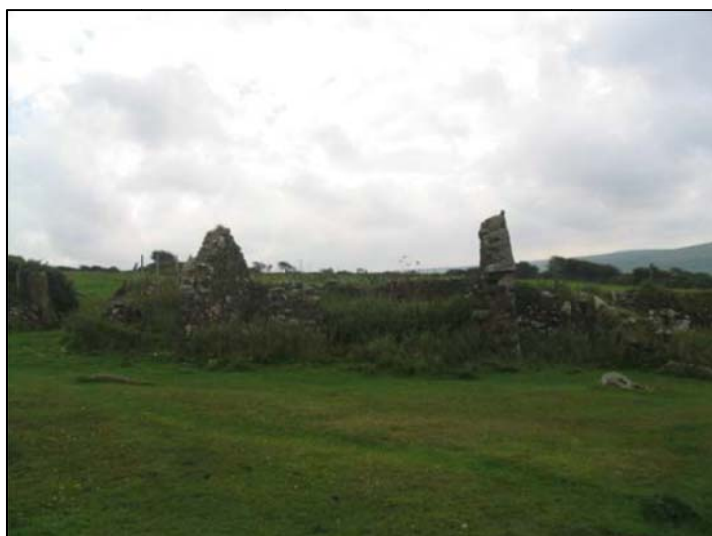
Barn at Blaen Waun © DAT 2005
