Historic Environment Feature Management Report:

Plas Bach, Ruined Farmstead

UID: 308,712

PRN 62687 **Name** PLAS BACH
Period Post-Medieval **Site Type** farmstead
NGR SN58120994

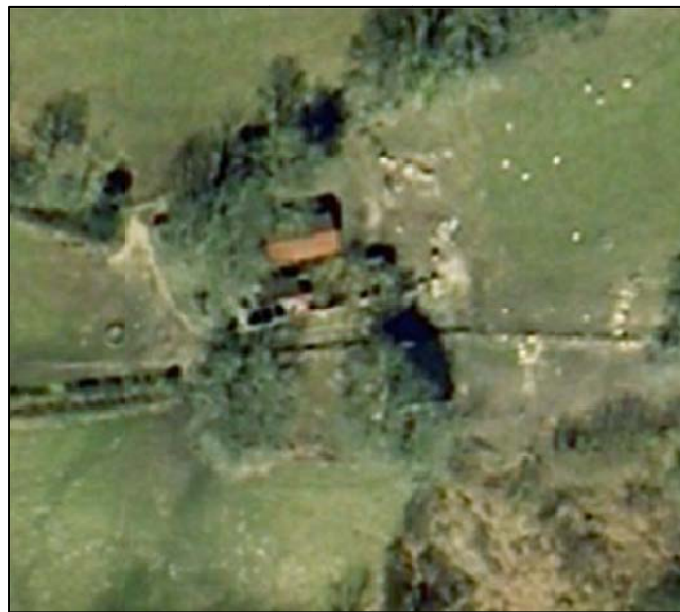
© Next Perspectives. Welsh Assembly Government 2009

Plas Bach is depicted on the most recent Ordnance Survey mapping (Mastermap 2011). Recent aerial photographs (Ordnance Survey Next Perspectives 2009) show the walls of the barn range, including internal divisions, roofless but standing to full height and the northern structure having a corrugated metal roof. The structure to the south east is obscured by trees so its condition is unclear.

- Remove any young trees or vegetation growing out of the wall by cutting by hand. Do not pull-up by the roots as this is potentially destabilising to masonry bonds.
- Cut any scrub back by hand in order to retain the visibility of the building ruins.
- Spot treat to prevent regrowth
- Maintain a canopy of mature trees around the site. This will inhibit scrubby vegetation growth.
