Historic Environment Feature Management Report:

Blaen-waun-henfod, Ruined Farmstead

Customer Reference Number: A0023376

UID: 309,588

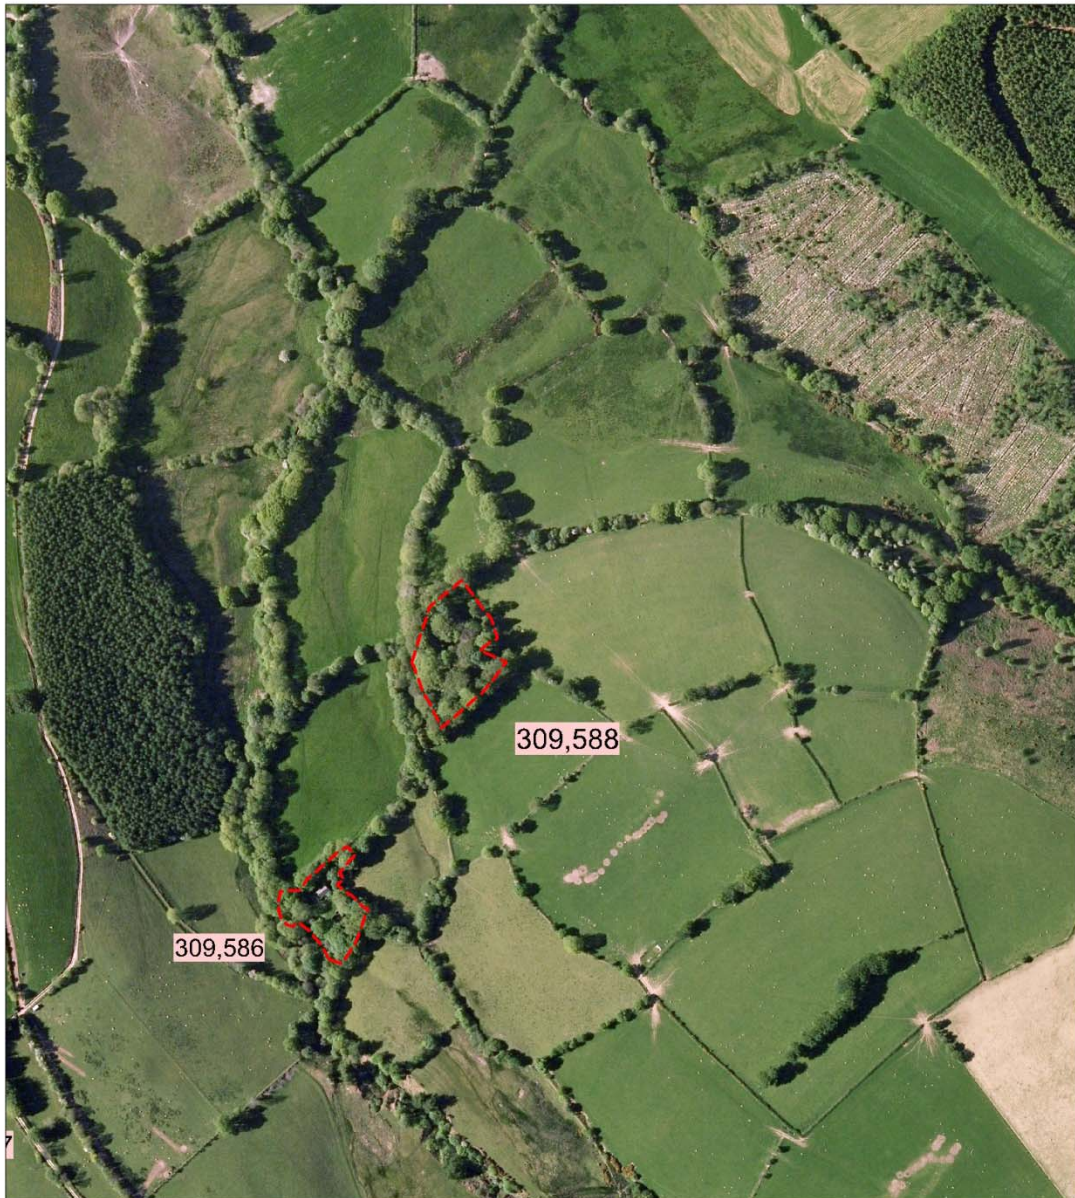
Aerial Photograph

The surviving buildings are depicted on the most recent Ordnance Survey mapping (Mastermap 2011) and a site visit in 2001 recorded most of the buildings as roofless standing ruins. At the time of that field visit the area was used for herding and collecting livestock. Recent aerial photographs (Ordnance Survey Next Perspectives 2009) show the area covered with trees with a thick canopy so the current condition is unclear.
