Historic Environment Feature Management Report:

Groes, Ruined Farmstead

PRN 9221 Name GROES

Period Post-medieval **Site Type** Farmstead

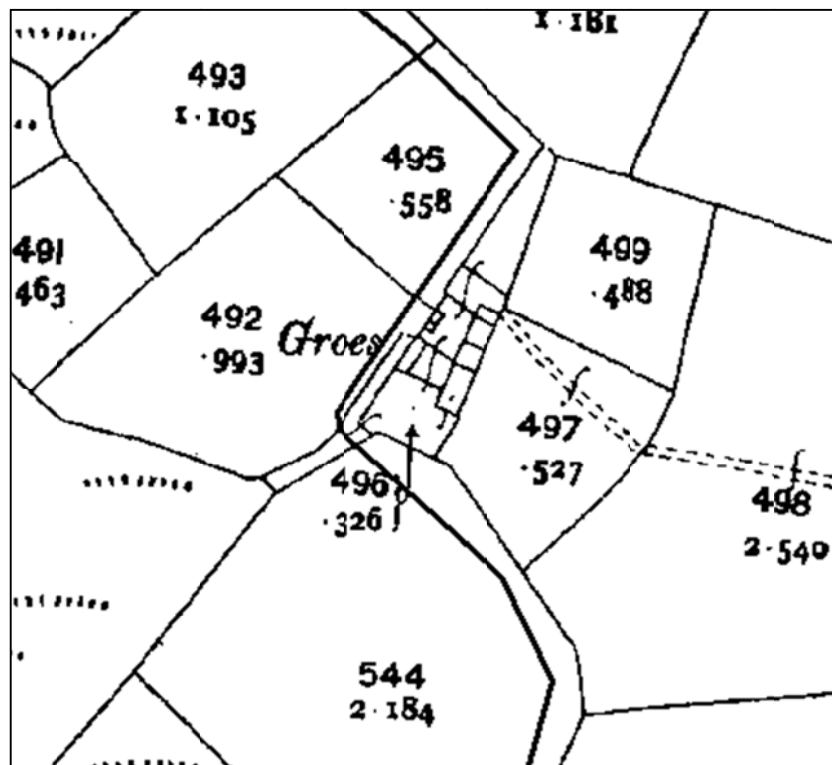
Detail from the Ordnance Survey 2nd edition map (1907) © and database right Crown copyright and Landmark Information Group Ltd (All rights reserved 08/05/2012)

A ruined post medieval farmstead marked as Groves on the 1st edition Ordnance Survey map of 1891. The map shows a four bay rectangular building with smaller structures opposite separated by a central yard area. Also within the area are the walls or field banks defining small paddocks or gardens. By the second edition mapping of 1907 the form of the farmstead is unchanged but the name has been altered to Groes.

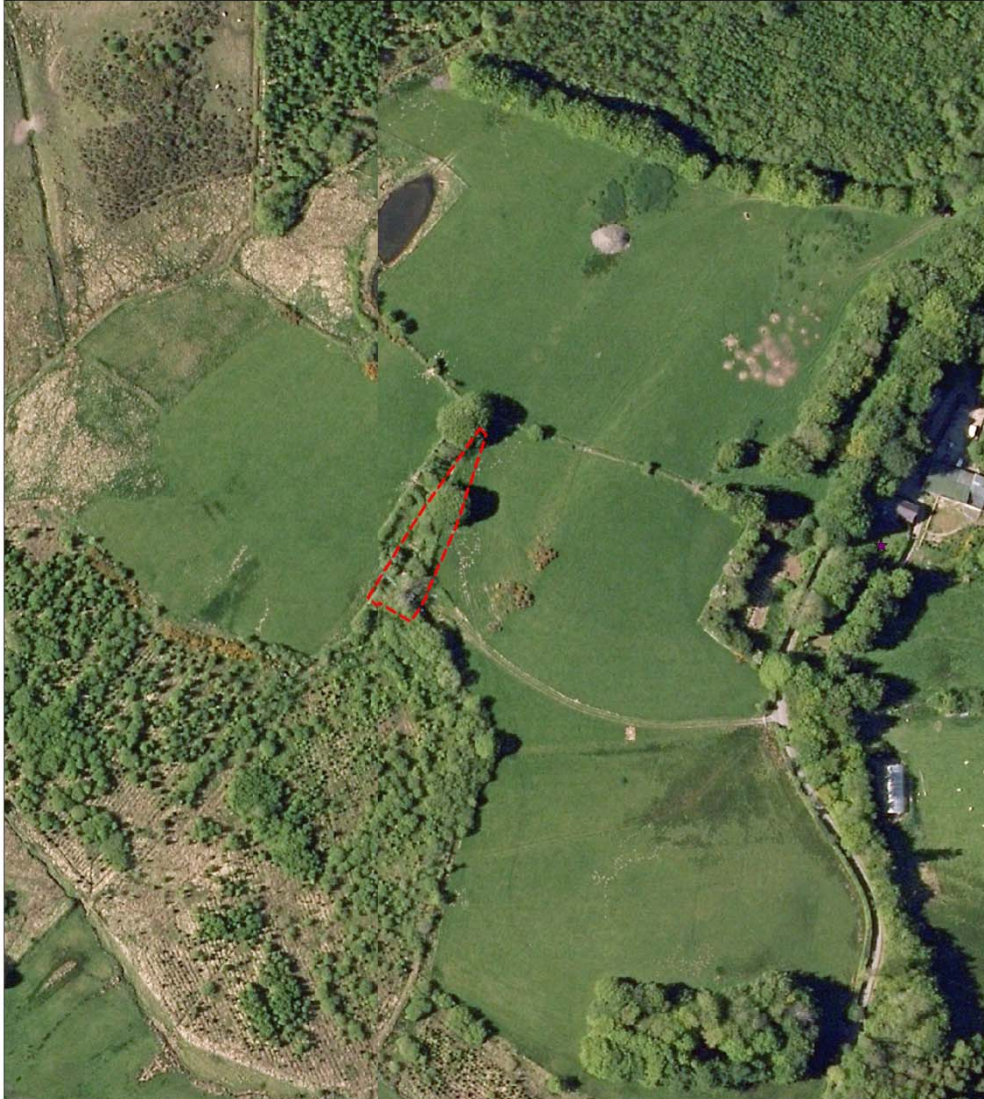
Aerial Photograph

Recent aerial photographs (Ordnance Survey Next Perspectives 2009) show the walls of the farmstead still surviving although the area is masked by trees so the current condition is unclear.

The main management issue for this site is the control of vegetation which has the potential to damage both buried archaeological remains and the built structure through the disruptive activity of root development. Trees can also pose a threat through wind throw or falling limbs.

- Remove any young trees or vegetation growing out of the walls by cutting by hand. Do not pull-up by the roots as this is potentially destabilising to masonry bonds.
 - Cut any scrub back by hand in order to retain the visibility of the building ruins.
 - Spot treat to prevent re-growth
 - Maintain a canopy of mature trees around the site. This will prevent light entering the ground, inhibiting scrubby vegetation growth.
-
