# Historic Environment Feature Management Report:

## Hafod-eidos, Ruined Farmstead

UID: 311,176

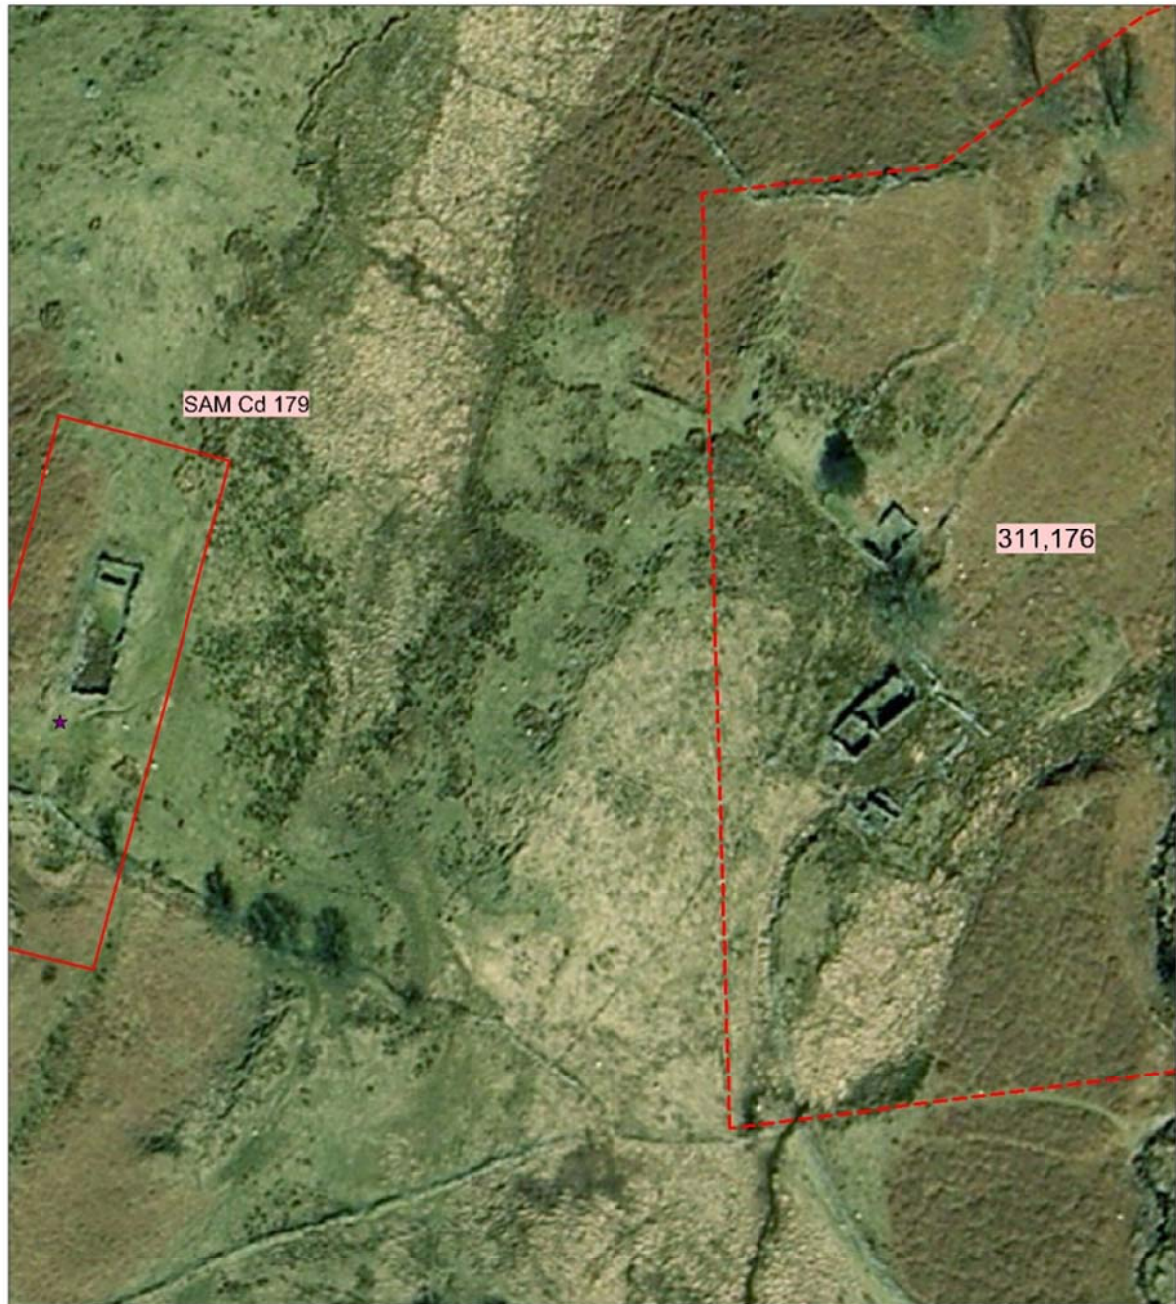
## Aerial Photograph

The remains at Hafod-eidos are clearly visible on aerial photographs (Next Perspectives, 2009). The current land use is unenclosed rough grazing. The ground cover is a mix of grass sward and bracken and some rushes. There are small trees and shrub growth over the standing remains (H Pritchard)
