# Historic Environment Feature Management Report:

## Ty-clawdd, Ruined Farmstead

UID: 312,571

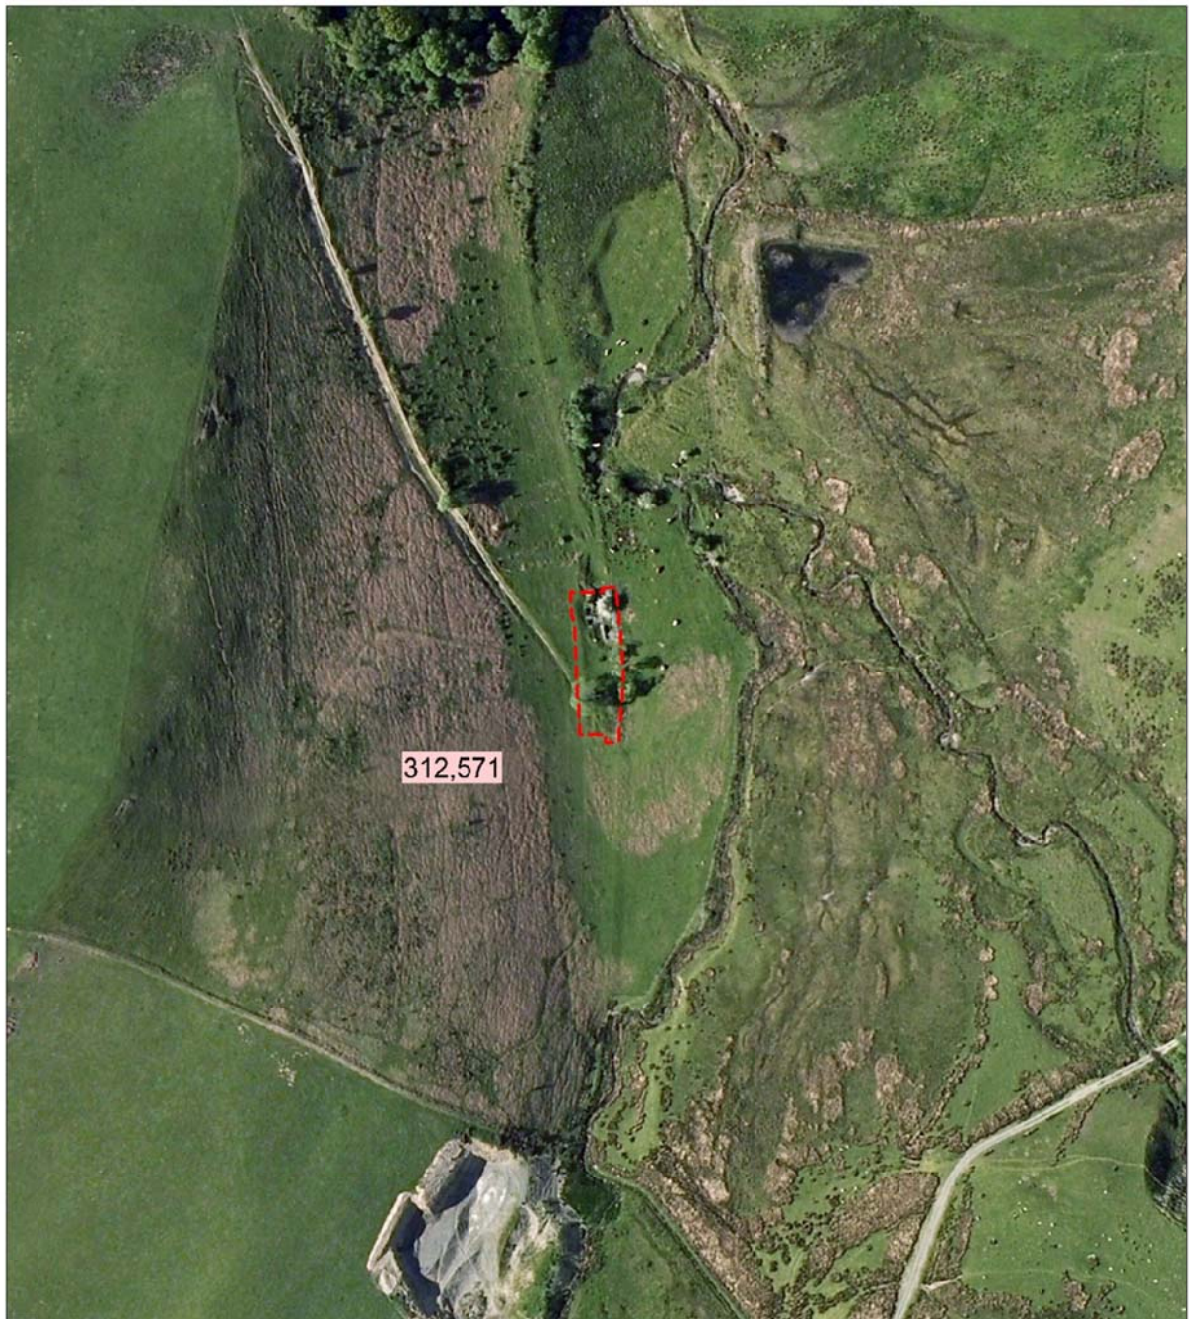
## Aerial Photograph

The remains at Ty-clawdd are clearly visible on aerial photographs (Next Perspectives, 2009). The current land use is unenclosed rough grazing. The ground cover is a mix of grass sward and bracken and some rushes. There are small trees and shrub growth around the standing remains.

- Cut back vegetation by hand in order to prevent further damage and to enhance the visibility of the structure.
- Do not pull-up by the roots as this is potentially destabilising to masonry bonds.
- Spot treat to prevent re-growth
