Historic Environment Feature Management Report:

Ffynnon Wen, Ruined Farmstead

UID: 309,902

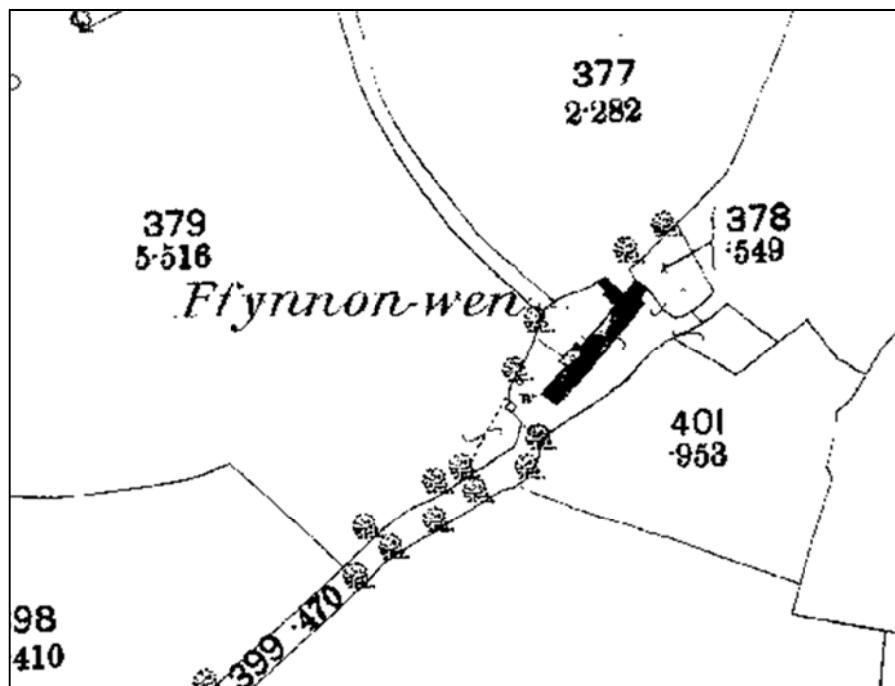
Detail from the Ordnance Survey 1st edition map (1889) © and database right Crown copyright and Landmark Information Group Ltd (All rights reserved 08/05/2012)

A ruined post medieval farmstead shown on the 1st edition Ordnance Survey map (1890) where it is named as. A field visit in 2006 identified it is a single long range (41m NE-SW x 6m NW-SE), now ruinous with walls in a state of partial collapse. The mapping depicts a long rectangular farmhouse with a barn or byre at one end and a small out building opposite. There is a garden plot behind the house and other small enclosure to the north and east. There is a well located in the north west of the property (PRN 19946) which have given the farm its name. The remains at Ffynnon-wen are marked on the most recent mapping (Mastermap 2011) and are partially visible on aerial photographs (Next Perspectives, 2009). The site is covered with trees so the current condition is unclear.
