Historic Environment Feature Management Report:

Talog, Ruined Cottage

UID: 312,338

PRN 55883 **Name** TALOG

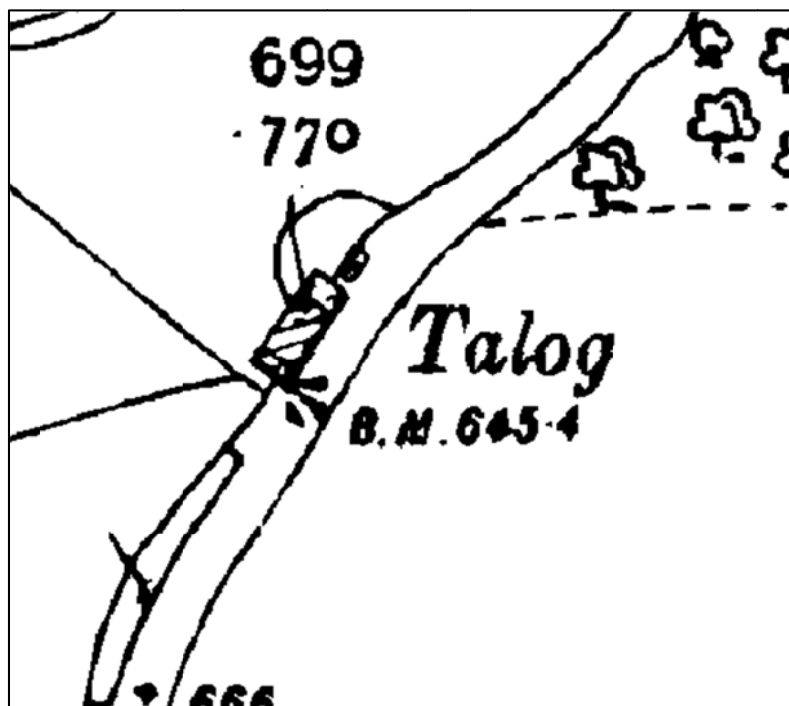
Detail from the Ordnance Survey 1st edition map (1890) © and database right Crown copyright and Landmark Information Group Ltd (All rights reserved 08/05/2012)

A ruinous roadside cottage named as Talog on the Ordnance Survey 1st edition map of 1890. It appears in an unchanged form on the second edition mapping of 1908, although there is now a small semi-circular enclosure attached to the north west side. The cottage was visited in 2006 and described as being in a process of collapse with only the rear wall surviving to eaves height. It has a gable entry plan typical of early (ie. pre- 19th century) construction. Its roadside location and lack of land suggests it could have originated as a squatter development, a common post medieval phenomenon. The site is fenced off from the adjacent land and there are some young trees growing on the walls. The outline of the cottage is shown on the most recent Ordnance Survey mapping (Mastermap 2011) Recent aerial photographs (Next Perspectives 2009) show the ruined walls partly under tree cover.
