Historic Environment Feature Management Report:

Maes-y-bettws farmstead

PRN 9116 Name MAES-Y-BETWS

Period Post-medieval **Site Type** Farmstead

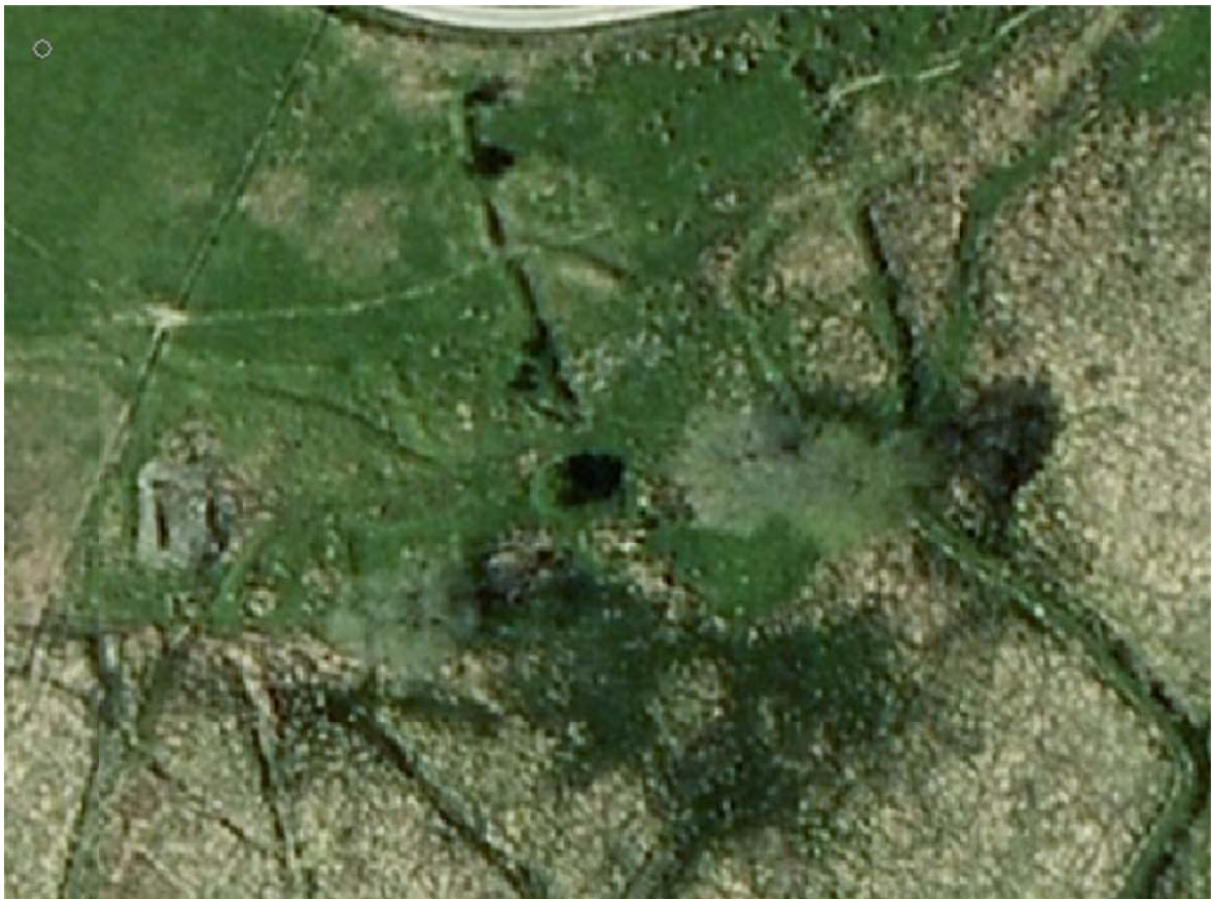
The recent aerial photographs of the site (Ordnance Survey Next Perspectives, 2009) indicate potential archaeological remains, comprising possible enclosure boundaries, extending beyond the Historic Environment Feature polygon (see map below). The following management recommendations should be extended to this area where appropriate

- Remove mature trees which are at risk of wind throw and could threaten upstanding remains of the cottage and mill and associated features through uprooting (root plate damage) or falling limbs.

- Remove any young trees or vegetation growing out of the wall tops but cutting by hand. Do not pull-up by the roots as this is potentially destabilising to masonry bonds.
- Cut any scrub back by hand in order to retain the visibility of the building ruins.
- Spot treat to prevent re-growth
- Maintain a canopy of mature trees over the site. This will prevent light entering the ground, inhibiting scrubby vegetation growth.
