# Historic Environment Feature Management Report:

## **Gwndwn-Gwynau farmhouse**

UID: 311143

PRN 7169 Name GWNDWN-GWYNAU
Period Medieval, Post-medieval Site Type Farmhouse
NGR SN73876288

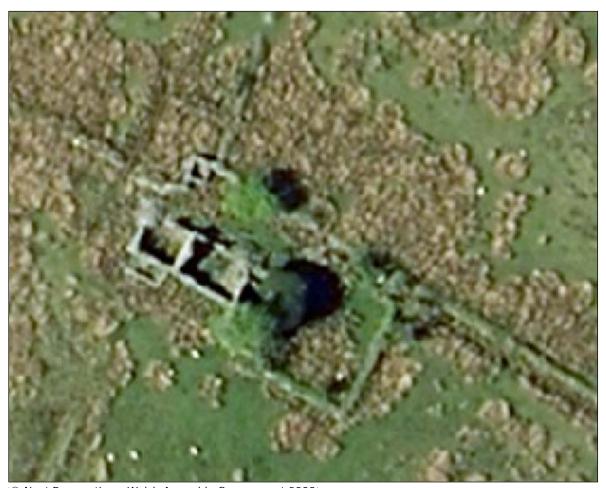
Recent aerial photographs (Ordnance Survey Next Perspectives, 2009) indicate the farmhouse as being ruinous and lying within a grazing area under scrub and tree growth. The main management issue for this site is the control of damaging vegetation which has the potential to damage buried archaeological remains through the disruptive activity of root development, and built structural remains by the prising apart of masonry bonds.

The following management recommendations are required in order to keep the farmhouse remains in a stable condition: Tree and scrub growth is damaging to the long term survival of the site through the disruptive activity of root development.

- Remove mature trees which are at risk of wind throw and could threaten the site through uprooting (root plate damage) or falling limbs.
- Remove any young trees or vegetation growing out of the wall tops but cutting by hand. Do not pull-up by the roots as this is potentially destabilising to masonry bonds. Spot treat to prevent re-growth.
- Cut any scrub back by hand in order to retain the visibility of the cottages.
- If present maintain a canopy of mature trees over the settlement. This will reduce light entering the ground, inhibiting scrubby vegetation growth.
