# Historic Environment Feature Management Report:

## Parc-y-bedw farmstead

Customer Reference Number: A0025288

UID: 312202

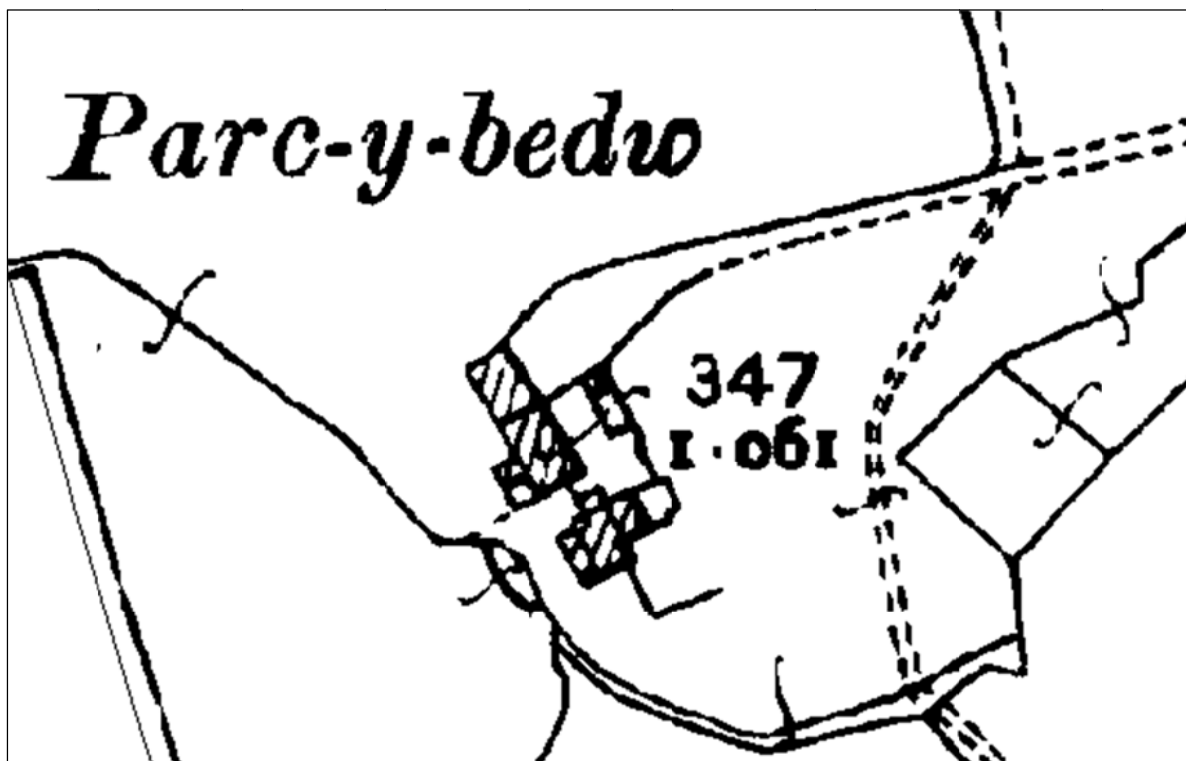
Detail from 1905 2<sup>nd</sup> edition Ordnance Survey map

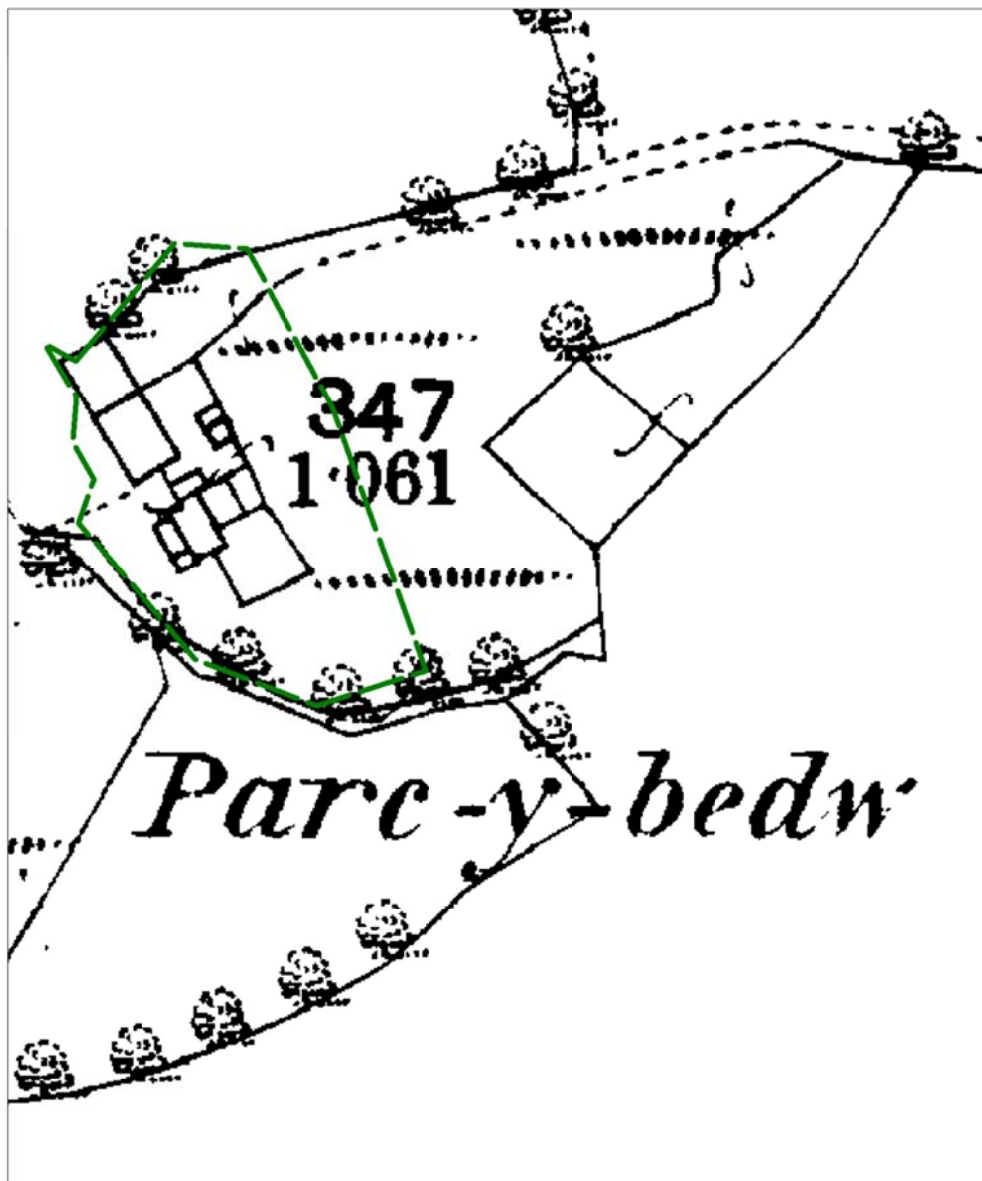
Historic Environment Feature (UID 312202)

*Parc-y-bedw farmstead (PRN 105488) shown on the 1889 1<sup>st</sup> edition Ordnance Survey map*
