# Historic Environment Feature Management Report:

## Waun, Ruined Farmstead

UID: 310,025

**PRN 21814 Name** WAUN

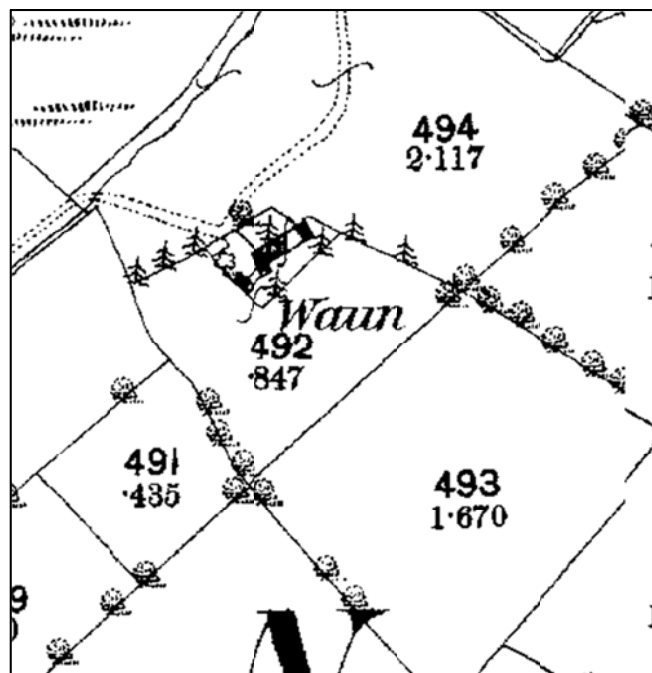
Detail from the Ordnance Survey 1<sup>st</sup> edition map (1891) © and database right Crown copyright and Landmark Information Group Ltd (All rights reserved 08/05/2012)

A late 19th century ruined farm stead, named as Waun on the 1st edition Ordnance Survey map of 1891. It does not appear on the Cellan Tithe Map of the 1840s when the area was all unenclosed common, showing that it was built after this date. It appears again on the 1906 mapping but by this time it is abandoned. The surrounding landscape is composed of small regular fields which were part of the enclosure of that part of the common in the late 19th century. Along with other buildings in the vicinity (PRNs 9489; 9490; 9491; 21813) it was built as an integral part of the enclosing. It is an element of a widespread but short lived expansion of settlement onto the upland margins of open common evidenced by the numerous abandoned farmsteads and cottages indicating the area had a larger population than today. The holding includes three structures within a small enclosure. The main structure, 20m by 5m, is aligned northeast-southwest and is constructed of random coursed rubble stone, partly roofed with corrugated metal. It is four cell structure containing the dwelling house and animal sheds. The dwelling section, is entered from the south west corner, with a half loft over the northeast part, the framework for which still survived in 2000. There is a fireplace in the northeast wall. A small raised garden lies to the northwest side. The other buildings in the enclosure are simple outbuildings.

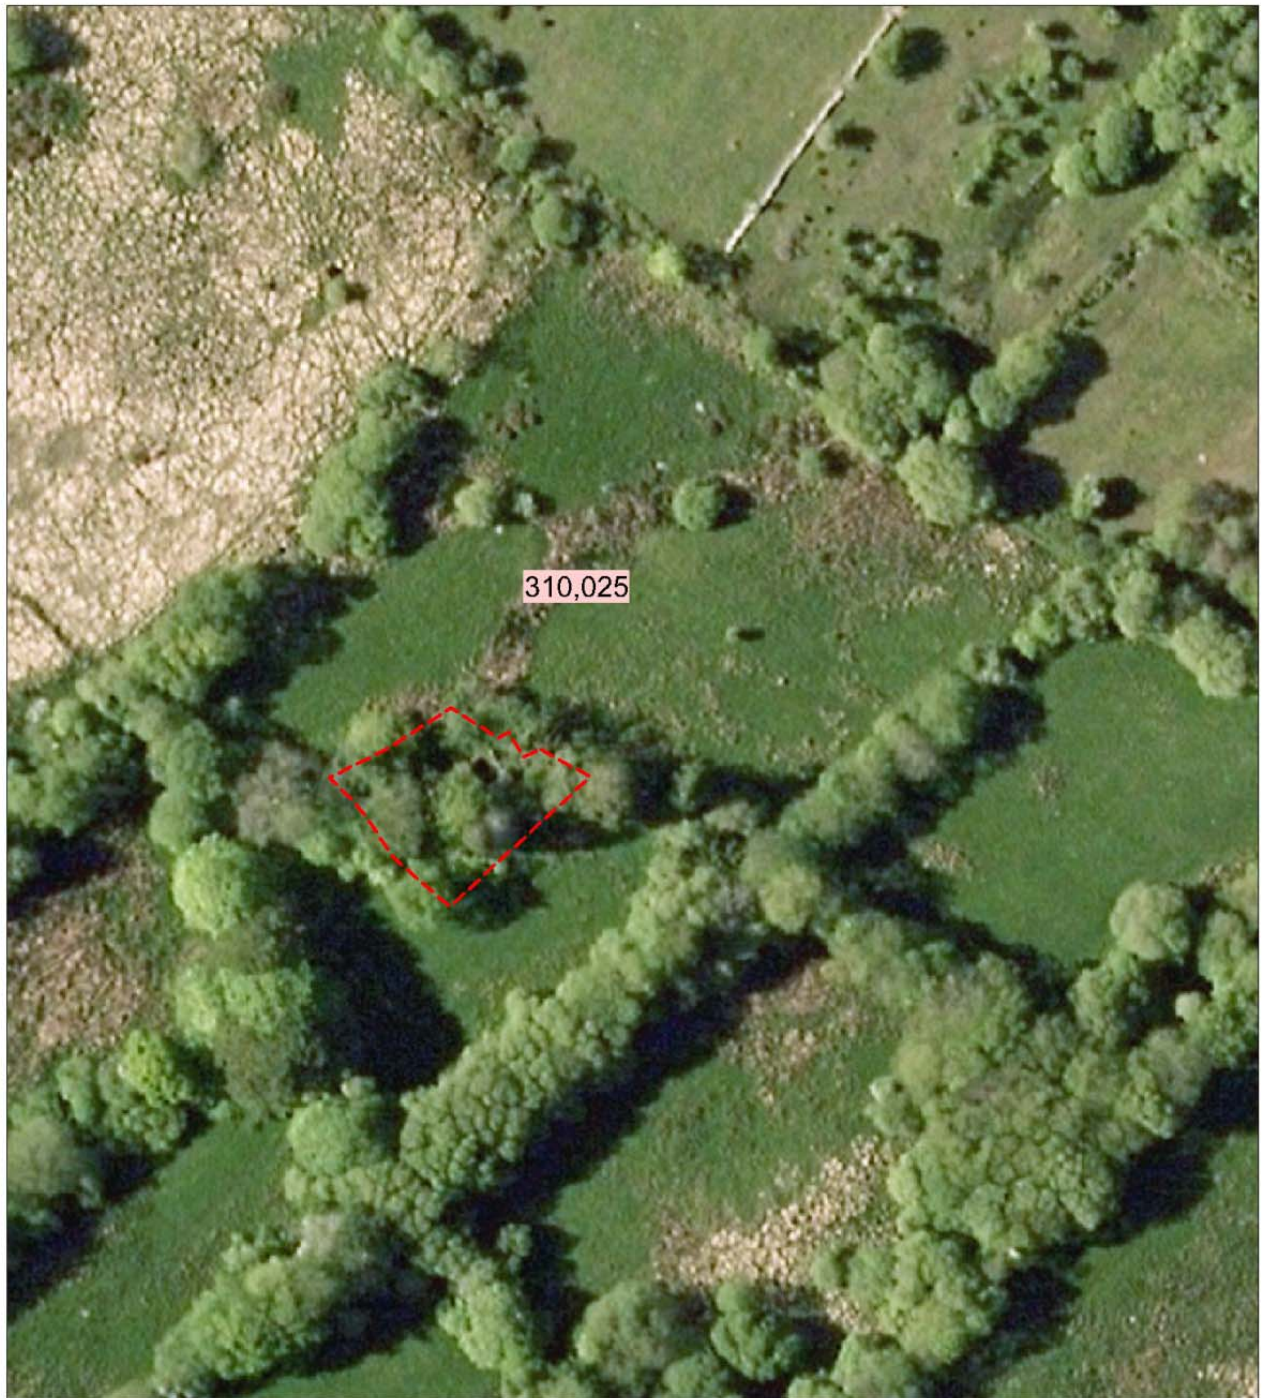
## Aerial Photograph

It was visited by DAT in 2000 and was found to be substantially intact. The complex is shown on the most recent Ordnance Survey Mapping (Mastermap, 2011). On aerial photographs (Next Perspectives, 2009) the complex is obscured by vegetation so the current condition is unclear.

- Cut back vegetation by hand in order to prevent further damage and to enhance the visibility of the structure.
  - Do not pull-up by the roots as this is potentially destabilising to masonry bonds.
  - Spot treat to prevent re-growth
  - Secure any existing viable corrugated roof coverings to prevent further degradation of the stonework
-
