Historic Environment Feature Management Report:

Cabin Adda, Ruined Cottage

UID: 310,046

PRN 9483 Name CABIN-ADDA

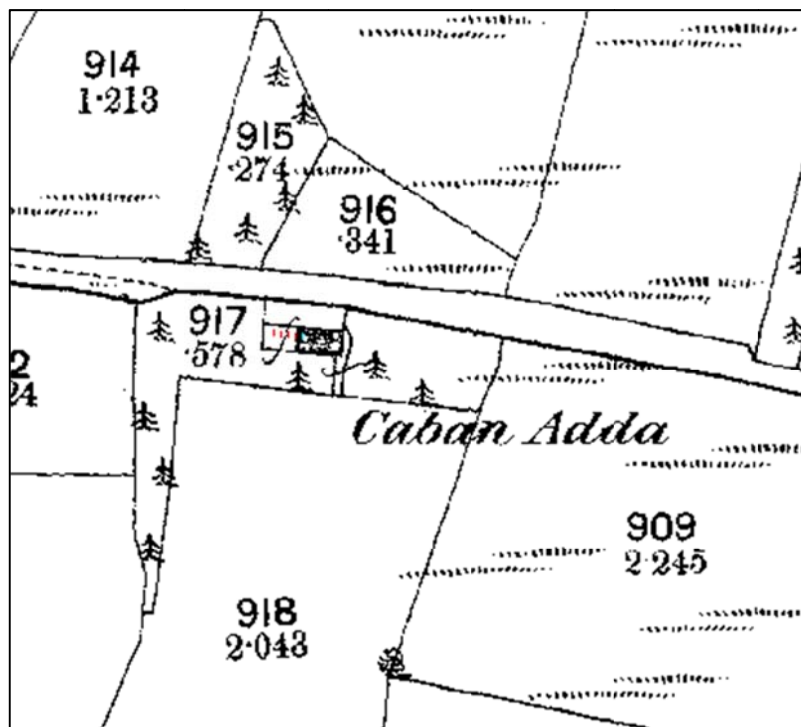
Detail from the Ordnance Survey 1st edition map (1891) © and database right Crown copyright and Landmark Information Group Ltd (All rights reserved 08/05/2012)

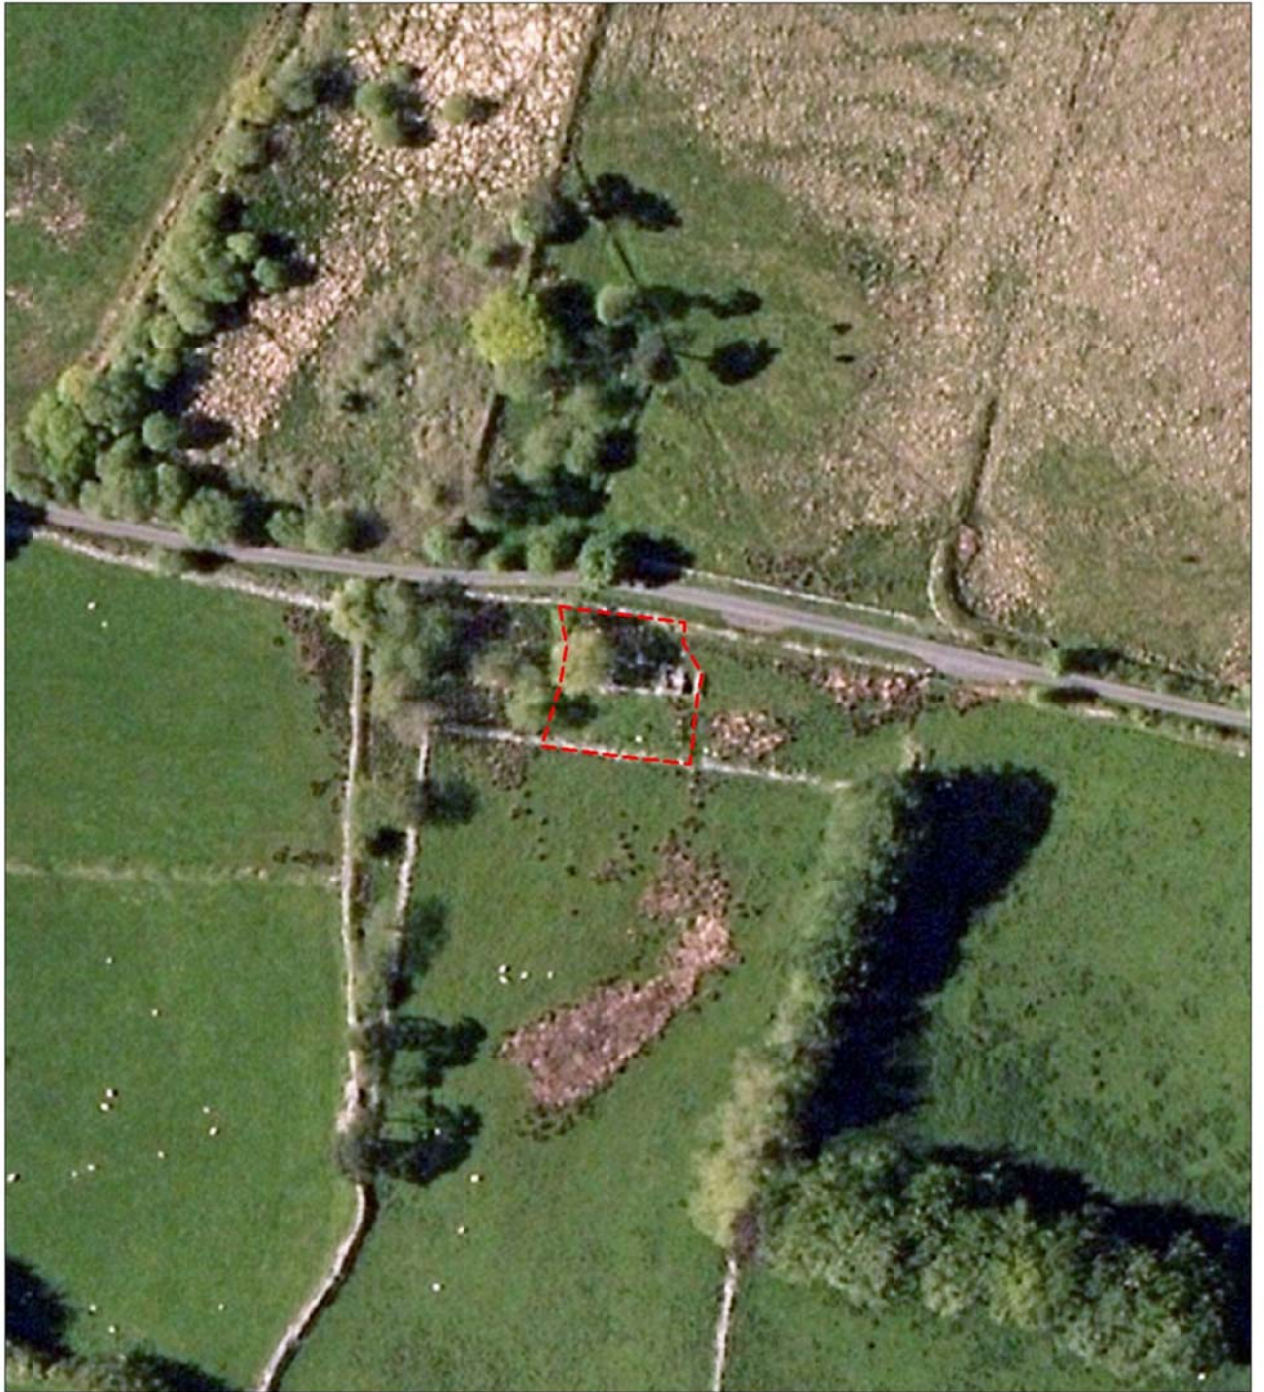
Aerial Photograph

The holding includes the remains of a three cell cottage and associated outbuildings within a walled enclosure. At a field visit in 2000 the walls survived to a height of 1.5m. The outbuilding appears to have been an open sided lean to structure and only the east wall survived to any height. The building is shown on the most recent Ordnance Survey Mapping (Mastermap, 2011). On aerial photographs (Next Perspectives, 2009) the complex is partly obscured by vegetation but surviving stone walls can be identified.

- Cut back vegetation by hand in order to prevent further damage and to enhance the visibility of the structure.
 - Do not pull-up by the roots as this is potentially destabilising to masonry bonds.
 - Spot treat to prevent re-growth – Secure any existing viable corrugated roof coverings to prevent further degradation of the stonework
-
