Historic Environment Feature Management Report:

Tir Bach, Ruined Farmstead

UID: 310,130

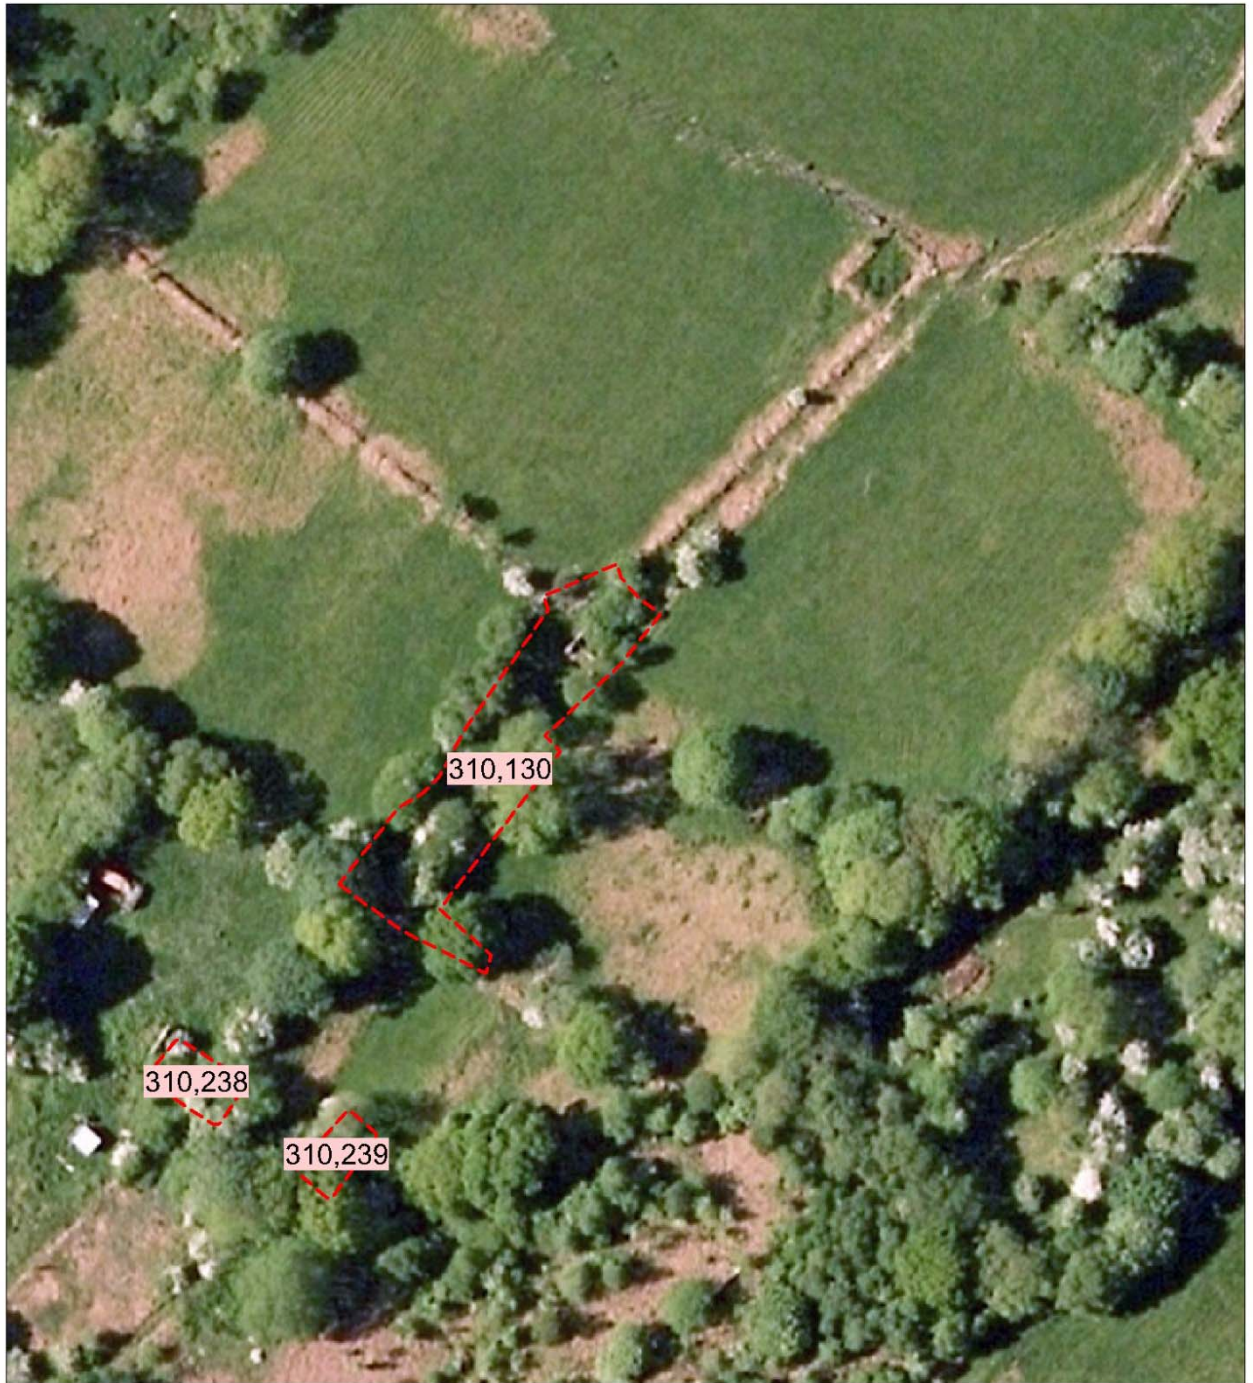
Aerial Photograph

The building is shown on the most recent Ordnance Survey Mapping (Mastermap, 2011). On aerial photographs (Next Perspectives, 2009) the complex is partly obscured by vegetation but surviving stone walls can be clearly identified.

- Cut back vegetation by hand in order to prevent further damage and to enhance the visibility of the structure.
- Do not pull-up by the roots as this is potentially destabilising to masonry bonds.
- Spot treat to prevent re-growth
