Historic Environment Feature Management Report:

Nant Maenllwyd, Ruined cottage

Customer Reference Number: A0028400

UID: 310,173

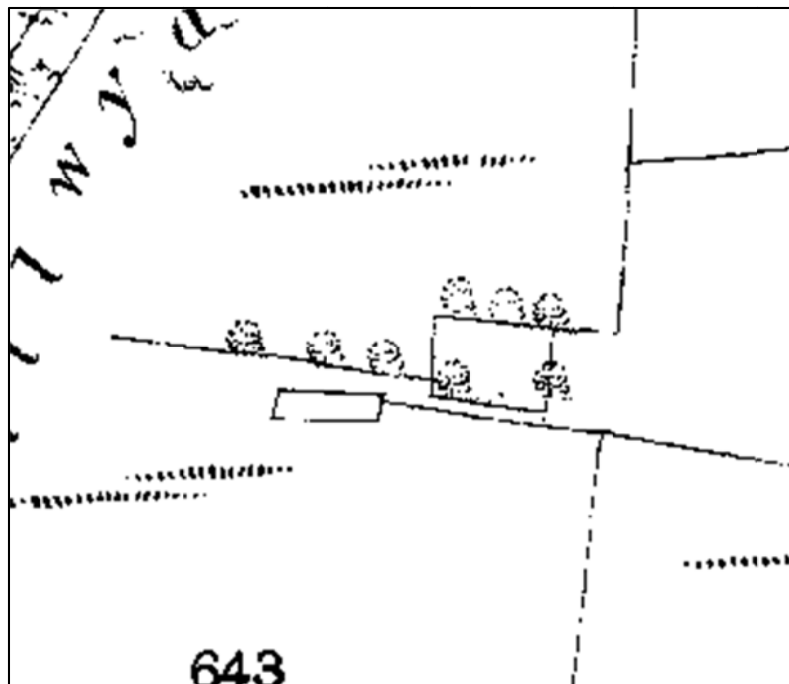
Detail from the Ordnance Survey 1st edition map (1891) © and database right Crown copyright and Landmark Information Group Ltd (All rights reserved 08/05/2012)

A post medieval ruined cottage unnamed but marked on the 1st edition Ordnance Survey map of 1891. It is a 2 cell rectangular structure with a long section being the domestic range and a smaller room at one end. There is no evidence of a barn/byre suggesting it was a simple cottage. Given its size and form and location in an isolated upland position it may have origins as a hafod site or shepherds hut for the management of livestock grazing the uplands during the summer months. Such sites were often fully occupied during the 19th century when there was a widespread but short lived expansion of settlement onto the upland margins of open land evidenced by the numerous abandoned farmsteads and cottages indicating the area had a larger population than today. There is an embanked enclosure opposite the cottage which would have served as a garden plot or paddock.

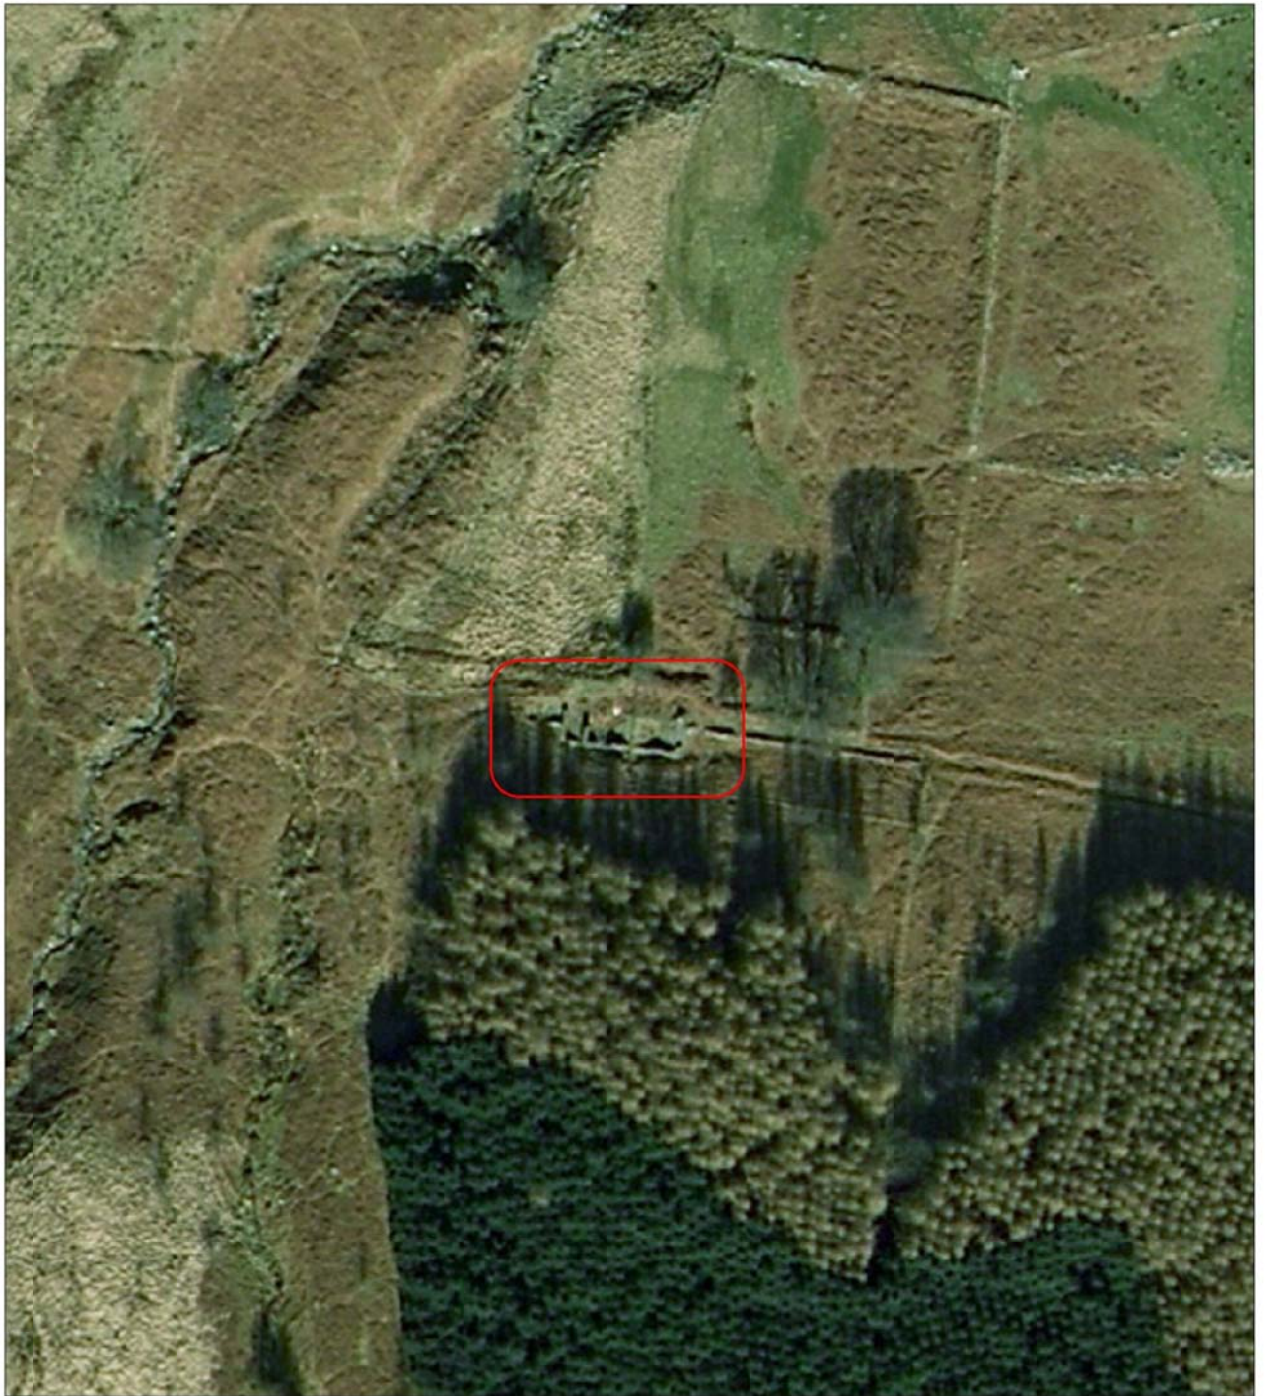
Aerial Photograph

The surviving buildings are depicted on the most recent Ordnance Survey mapping (Mastermap 2011). Recent aerial photographs (Ordnance Survey Next Perspectives 2009) show the area of the cottage surrounded by trees and the enclosure boundaries surviving as grass covered banks.

- Cut back vegetation by hand in order to prevent further damage and to enhance the visibility of the structure.
- Do not pull-up by the roots as this is potentially destabilising to masonry bonds.
- Spot treat to prevent re-growth
