# Historic Environment Feature Management Report:

## Argoed fach, Ruined FRarmstead

UID: 312,820

**PRN** 52742 **Name** Argoed fach  
**Period** Post-Medieval **Site Type** farmstead  
**NGR** SN65588793

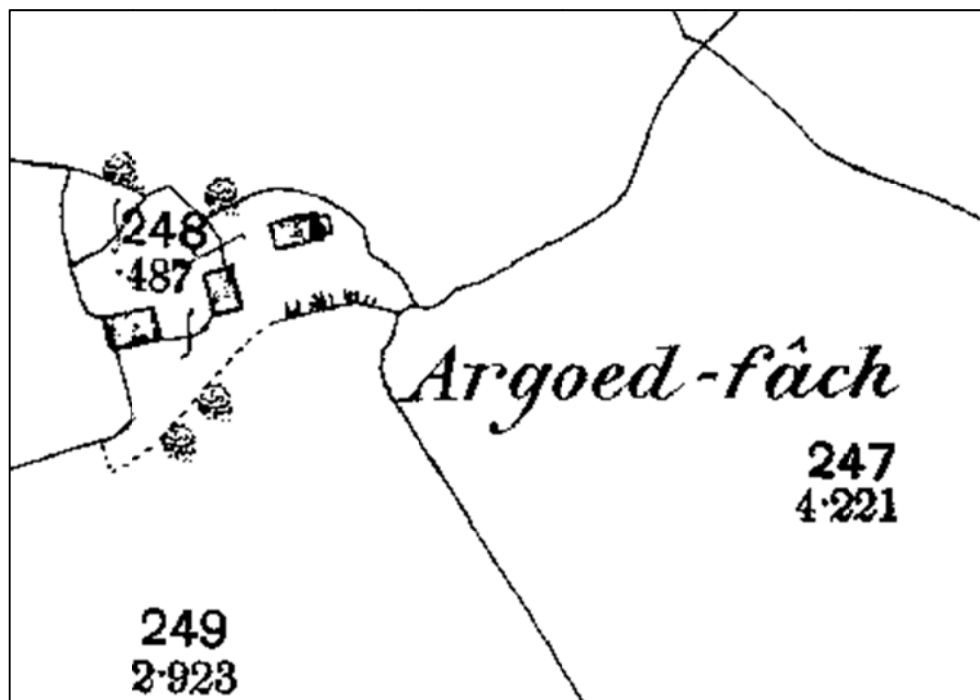
Detail from the Ordnance Survey 1<sup>st</sup> edition map (1890) © and database right Crown copyright and Landmark Information Group Ltd (All rights reserved 08/05/2012)

A minor farmstead named as Argoed-fach on the Ordnance Survey 1st edition map (1889). It is depicted as a set of three buildings within two enclosures. To the east there is a single cell rectangular building in an enclosure assumed to be the farm house set in a garden area. West of this is a pair of rectangular at right angles to each other with an enclosed yard between, assumed to be the farm buildings. By the 1907 2nd edition mapping the complex appears to be abandoned.

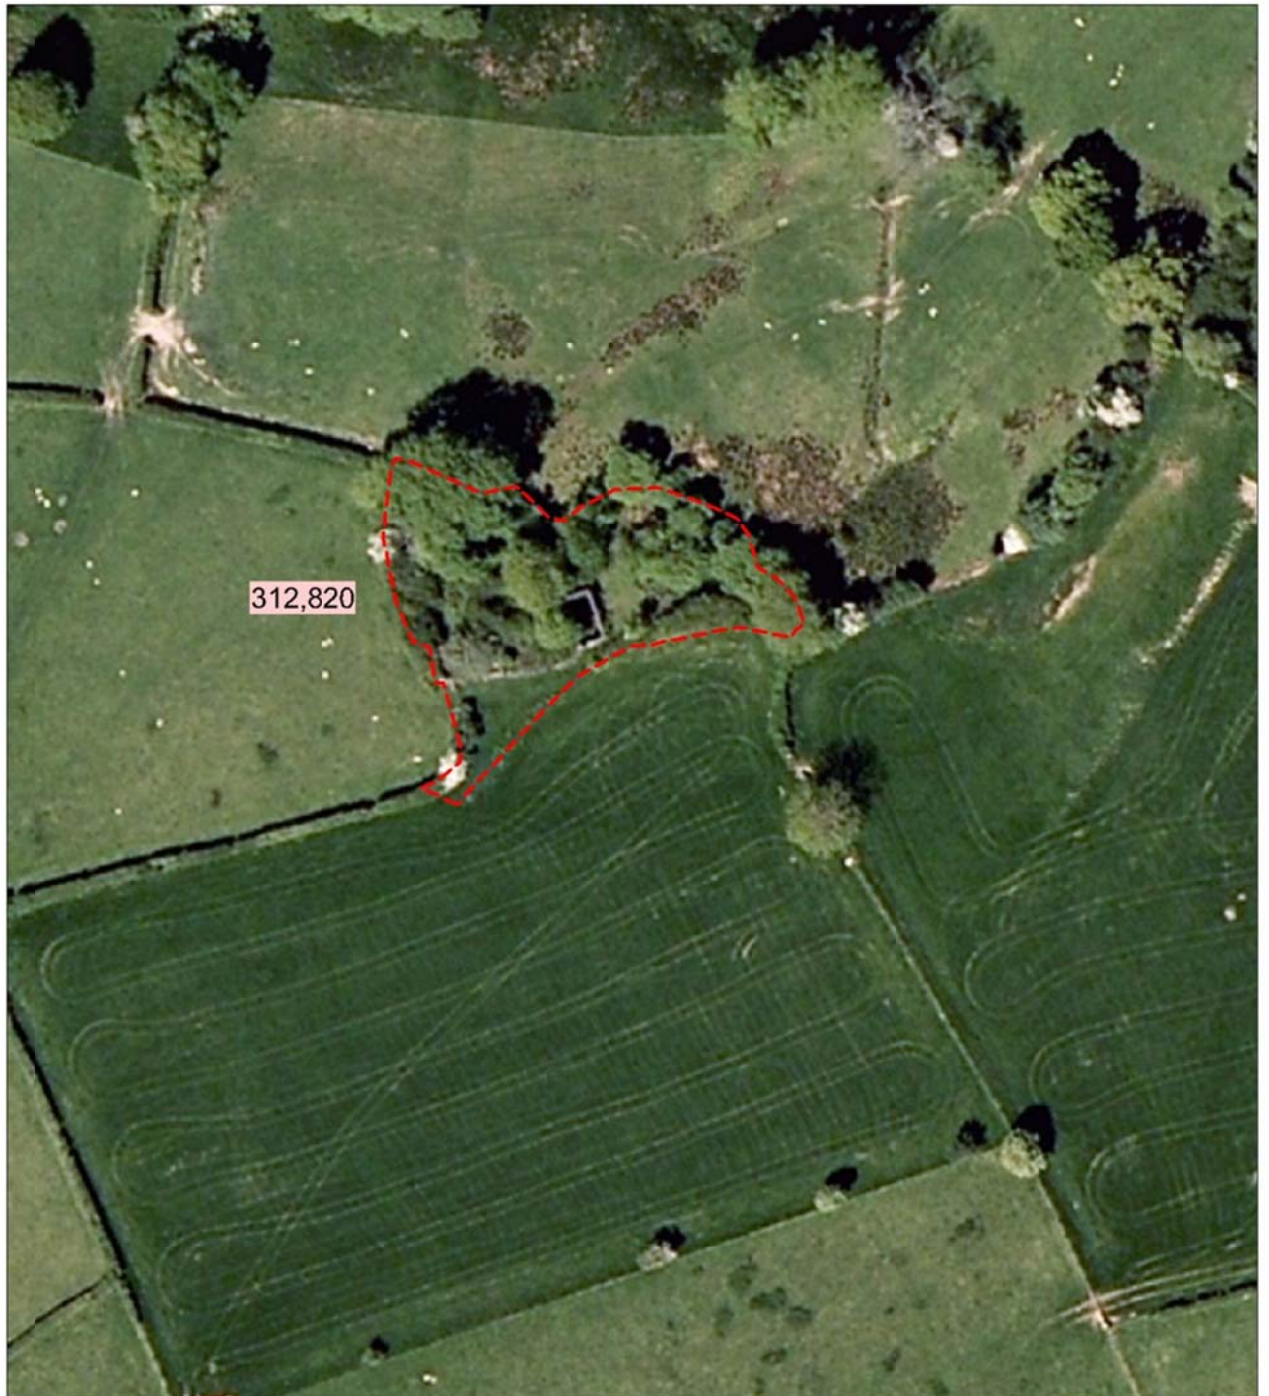
## Aerial Photograph

Argoed fach is depicted on the most recent Ordnance Survey mapping (Mastermap 2011). Recent aerial photographs (Ordnance Survey Next Perspectives 2009) show the area surrounded by trees but although the full picture is unclear some walls of the buildings and enclosure boundaries are clearly visible (H Pritchard).

- Remove any young trees or vegetation growing out of the walls and within the interior of buildings by cutting by hand. Do not pull-up by the roots as this is potentially destabilising to masonry bonds.
- Cut any scrub back by hand in order to retain the visibility of the building ruins.
- Spot treat to prevent regrowth – Maintain a canopy of mature trees around the site. This will inhibit scrubby vegetation growth.
- If livestock shelter within the structures to discourage their presence through fencing
