Historic Environment Feature Management Report:

Garn Ganol, Ruined Farmstead

UID: 306,000

PRN 27894 **Name** GARN-GANOL
Period Post-medieval **Site Type** Farmstead
NGR SN47071266

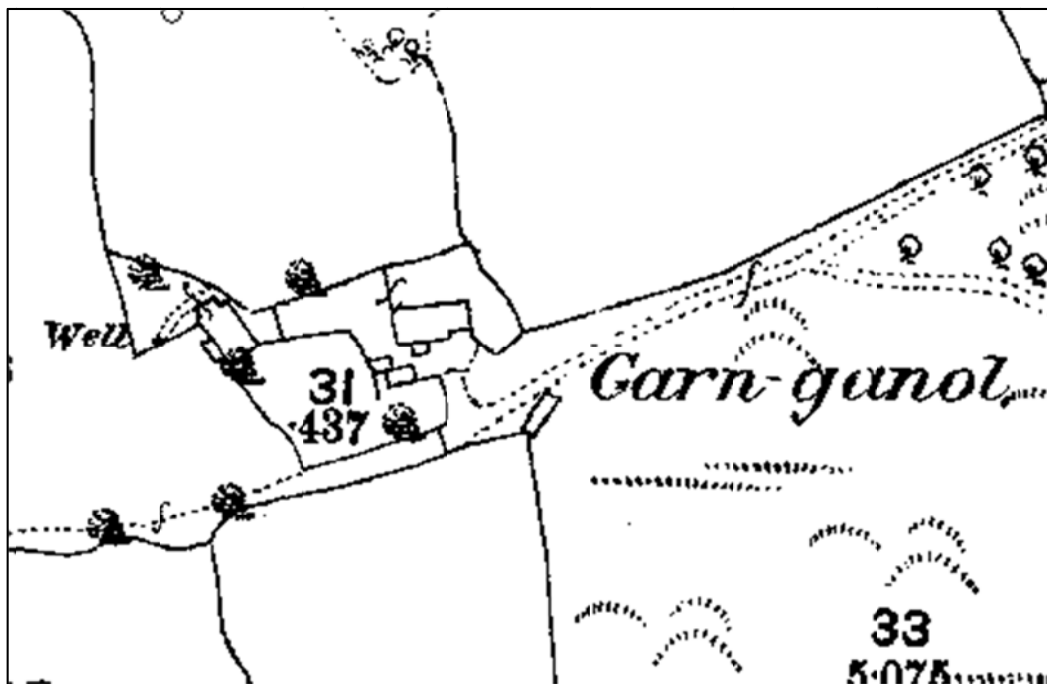
Detail from the Ordnance Survey 1st edition map (1891) © and database right Crown copyright and Landmark Information Group Ltd (All rights reserved 08/05/2012)

Ruined farmstead shown on 1st edition Ordnance Survey map (1891). The depiction shows a farmhouse, separate barn and outhouses all set within various yards and enclosures. By the second edition map of 1906 a further barn had been built on the eastern side of the complex. It was still occupied at the time of the 1922 map but was abandoned by the mid 20th century and the buildings are now ruinous. One building though to be the house has been internally partitioned by a crude concrete wall, creating a small shed with animal stalls inside. The outline of some of the buildings is shown on the most recent mapping (Mastermap, 2011). Recent aerial photographs (New Perspectives, 2009) show the area under trees which mask the site and although some walls can be seen the current state is unclear (H Pritchard, 2013).
