Historic Environment Feature Management Report:

Blaen Milwyn, Ruined Farmstead

UID: 311,268

PRN 9401 Name BLAEN MILWYN

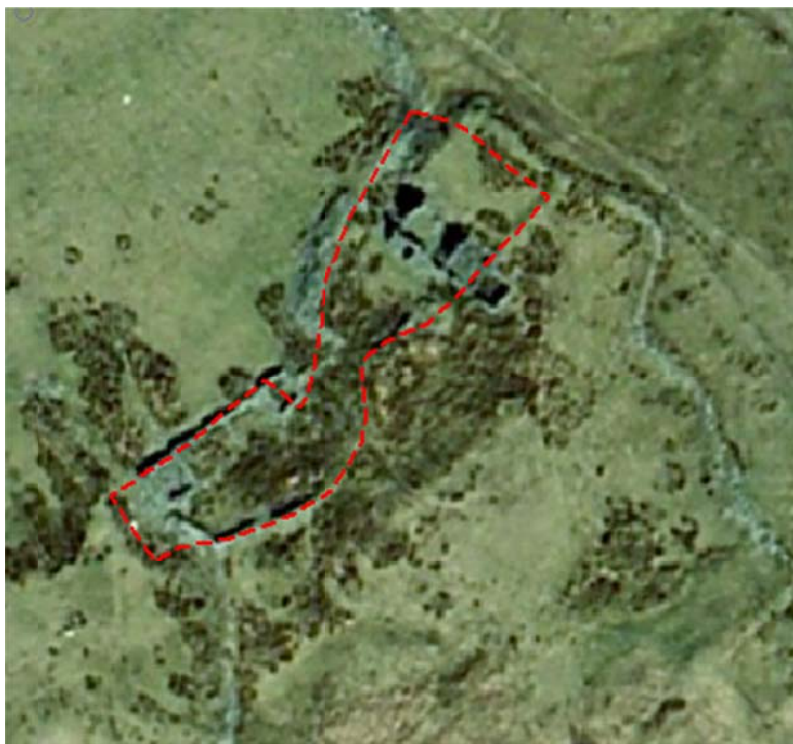
Ruined farmstead known as Blaen Milwyn shown on 1st edition Ordnance Survey map (1888) and abandoned by the early 20th century. The farmstead includes two groups of buildings, one including a rectangular two cell farmhouse and the second a group of small rectangular farm buildings in a walled yard to the SW. The outline of the buildings is shown on the most recent mapping (Mastermap, 2011) and recent aerial photographs (New Perspectives, 2009) show the walls of the farm and outbuildings survive to a reasonable height. The farmstead is one of a number of similar ruined dwellings in the surrounding area which had been leased for agriculture since the 16th century. Some of these were also related to lead mining. By the late 19th century both mining and agriculture were in decline and the settlements were abandoned.

The farmstead lies in an area The surrounding area is under rough grass (H Pritchard,2013).

The main management issue for this site is the control of vegetation and livestock which have the potential to damage buried and standing archaeological remains through the disruptive activity of root development, and the action of animal traffic which can dislodge masonry. built structural remains by the prising apart of masonry bonds. Excessive vegetation can also lead to archaeological features being obscured from sight.

The following management actions are required in order to keep the structure in a stable condition:

- Cut back intrusive vegetation by hand in order to prevent further damage and to enhance the visibility of the structure.
- Do not pull-up by the roots as this is potentially destabilising to masonry bonds.
- Rebuild any significant areas of collapse using original stone where available.
