# Historic Environment Feature Management Report:

## Magwyr-Las, Ruined Farmstead

Customer Reference Number: A0032193

UID: 311,186

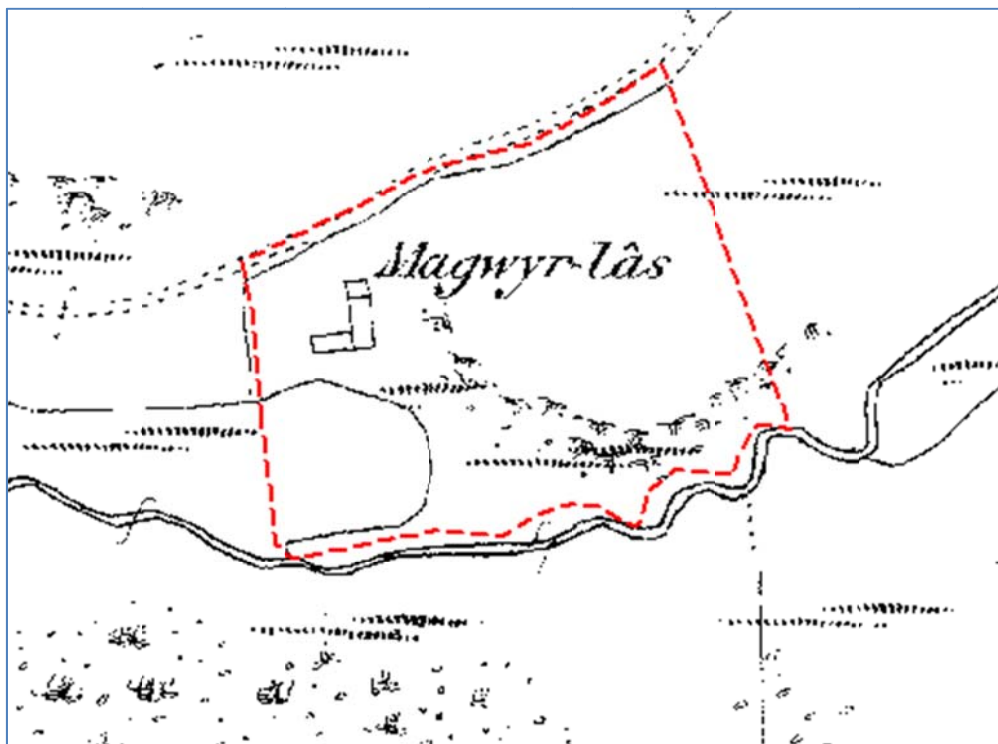
Detail from the Ordnance Survey 1<sup>st</sup> edition map (1888) © and database right Crown copyright and Landmark Information Group Ltd (All rights reserved 08/05/2012)

A stone built farmstead and associated field boundaries, named as Magwyr-las on the 1st edition Ordnance Survey map (1888) enclosed in-field. By the second edition of 1907 the outline of the structure is shown although it is no longer named suggesting it may have been abandoned by this date. The building was a reverse L shape in plan with each of the axes having a smaller room division at each end. It is not known whether the whole was domestic or one arm was an animal house. The outline of the building is shown on the most recent Ordnance Survey mapping (Mastermap 2011) and recent aerial photographs (Ordnance Survey Next Perspectives 2009) show the walls still survive. (H Pritchard)
