# **PARK COTTAGE, CRESSELY, PEMBROKESHIRE: ARCHAEOLOGICAL WATCHING BRIEF 2013**

Prepared by Dyfed Archaeological Trust  
For: Acanthus Holden

RHIF YR ADRODDIAD / REPORT NO. 2013/39  
RHIF Y PROSIECT / EVENT RECORD NO. 105638

# PARK COTTAGE, CRESSELY, PEMBROKESHIRE: ARCHAEOLOGICAL WATCHING BRIEF

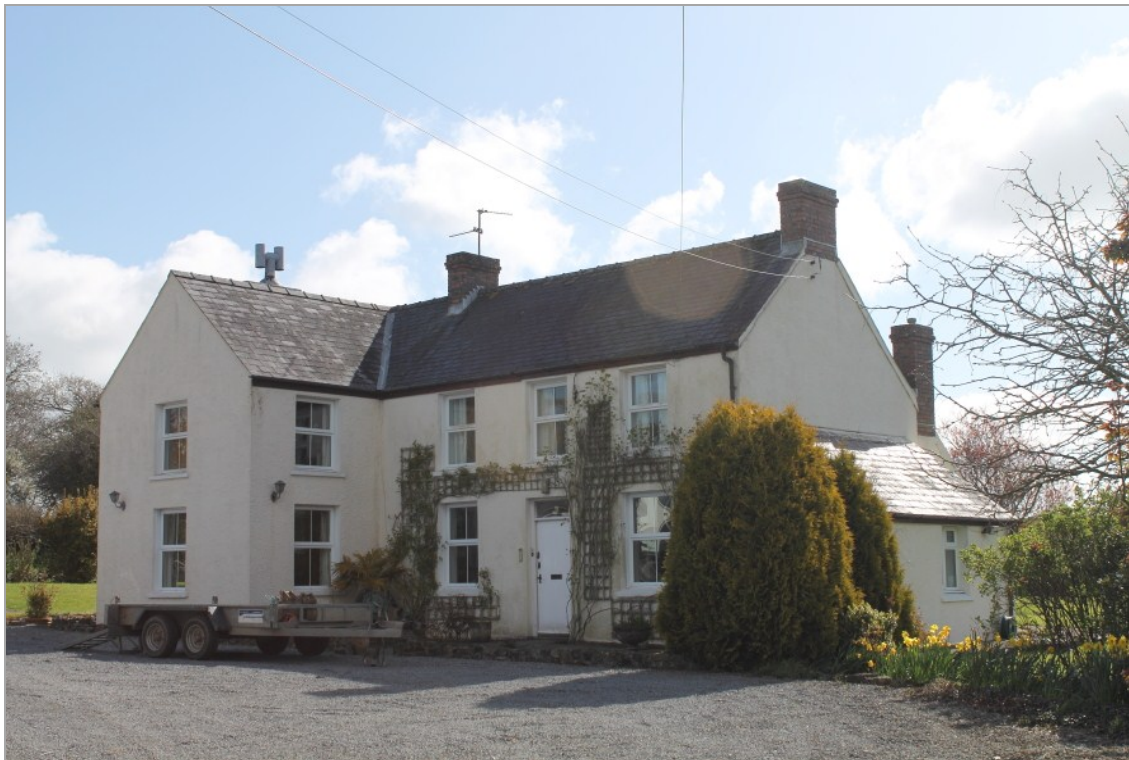
**Photo 1:** Park Cottage, near Cresselly.

- 2.1.2 Park Cottage is a single dwelling with some small outbuildings, including a former pigsty, set within 0.7 hectares of land (Photo 1). This includes Park Rath, an Iron Age defended enclosure and Scheduled Ancient Monument, which lies immediately to the south of the house, the house itself lying on the line of the former outer defensive bank of the defended enclosure. The proposed development area lies to the north of the house, 50m from the defended enclosure, in a relatively level square enclosed field or paddock surrounded by earth banks topped by a denuded and grown-out hedgerow.

- 2.2.4 The history of Park Cottage (Photos 1 & 3) itself has not been researched in detail, but the current house appears to have developed from a pair of adjoining 19<sup>th</sup> century single-storey cottages. It appears on an Ordnance Survey map of 1865 as a range of attached buildings, possibly representing the two cottages with attached animal sheds. An outbuilding lies to the west, now used as an open garage and wood store. At some point in the late 19<sup>th</sup> or early 20<sup>th</sup> century a small stone-built pigsty was added. A small enclosure, or paddock, lay to the north of the house, with an orchard to the east of the house. The house has been modified during the 20<sup>th</sup> century, with a 2<sup>nd</sup> storey and additions around the southern end added in the 1920s/1930s. The formerly attached northern building has also been removed and in the 1980s a two-storey north wing was also added. The enclosed field to the north remains, but the orchard has since been redesigned as a garden area.

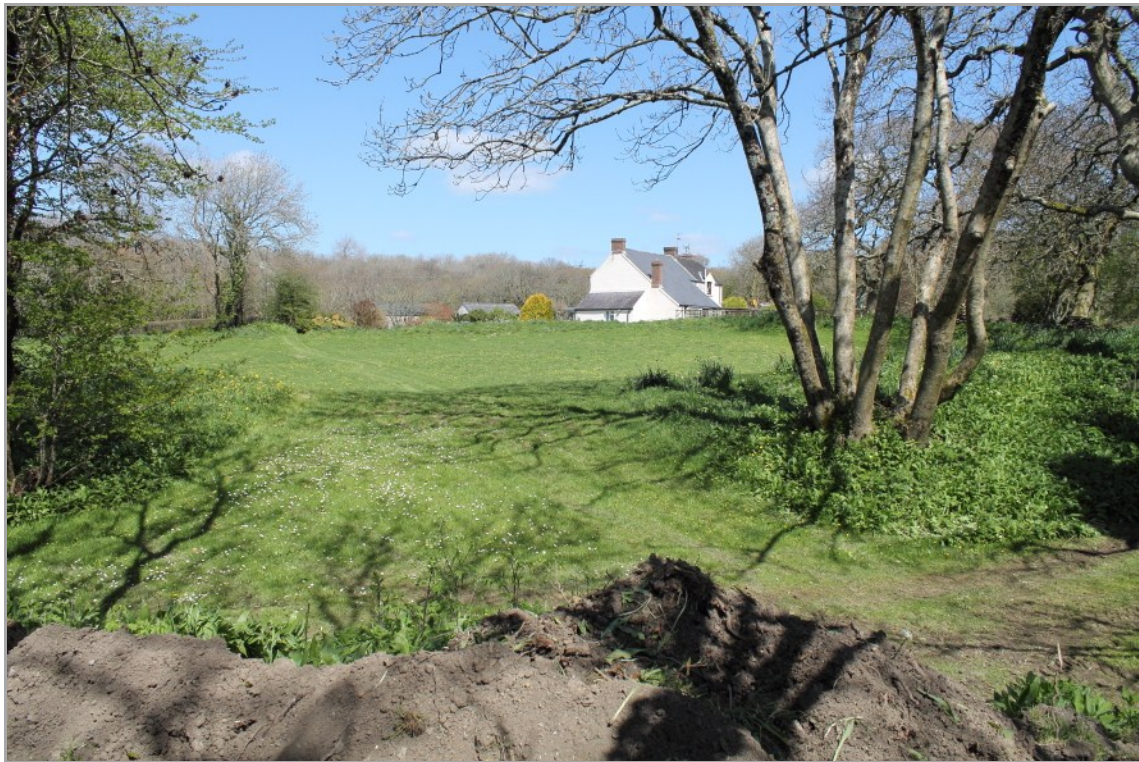
*Park Rath is a circular, earthwork defended enclosure lying on a gentle south-facing slope at 60m above sea level. To the northeast the land rises by c. 10m onto a rounded summit 250m distant. The slightly dished internal area is c. 60m in diameter and is defined by a bank, ditch and bank. The internal bank rises 0.3m to 0.6m above the interior and 0.6m to 1.0m above the ditch. A boundary bank runs along the outer bank, which is 0.3m to 0.6m high. This outer bank may be a counterscarp, but a slight depression outside indicates that the site may be bivallate. The outer bank is interrupted by Park House on the north side. A simple gap on the south side marks a simple entrance. There are two modern cuts through the defences on the north side, although the one on the northwest side may be also be original. The defences are covered with trees and scrub. The internal area is under pasture.*

**Photo 2:** General shot looking north across Park Rath Iron Age defended enclosure (PRN 3522) with Park Cottage in the background.

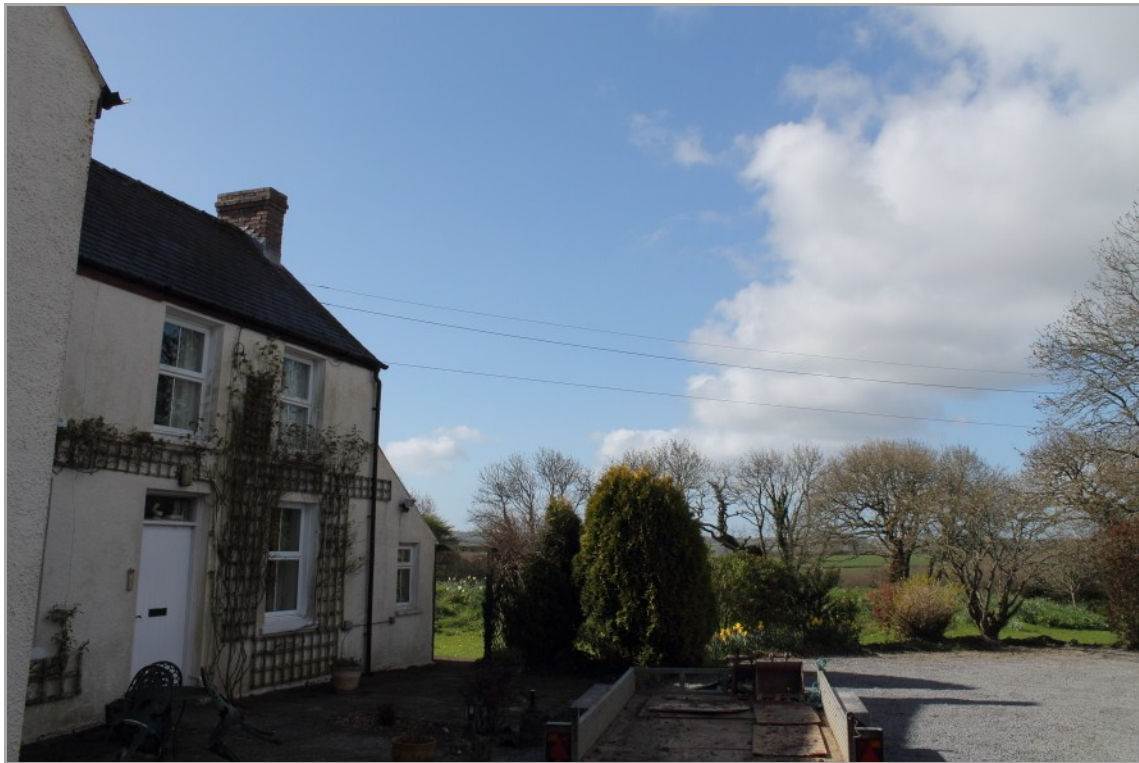
**Photo 3:** General shot looking south past Park Cottage on the left with Park Rath (PRN 3522) visible as the grassed area in the background.

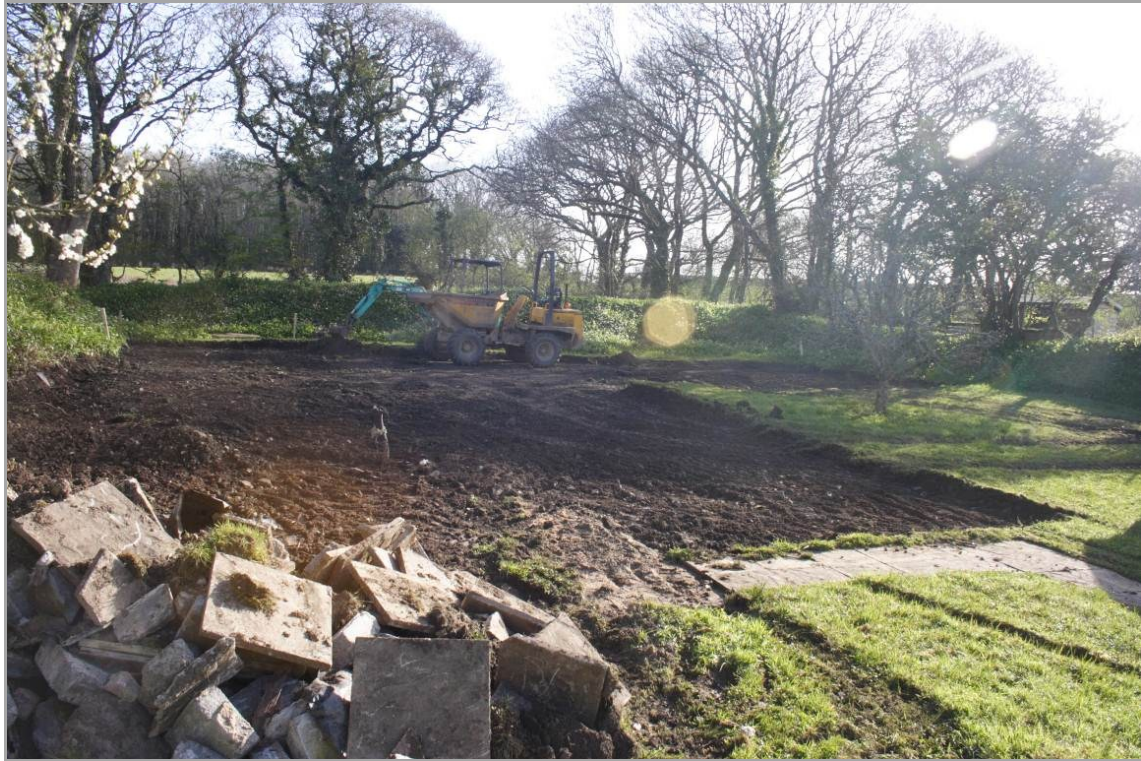
**Photo 4:** Looking north-east across the development site during the topsoil removal.

- 4.2 The topsoil consisted of a dark-grey clayey-silt, 0.3m thick, containing fragments of early to mid-20<sup>th</sup> century pottery and glassware.

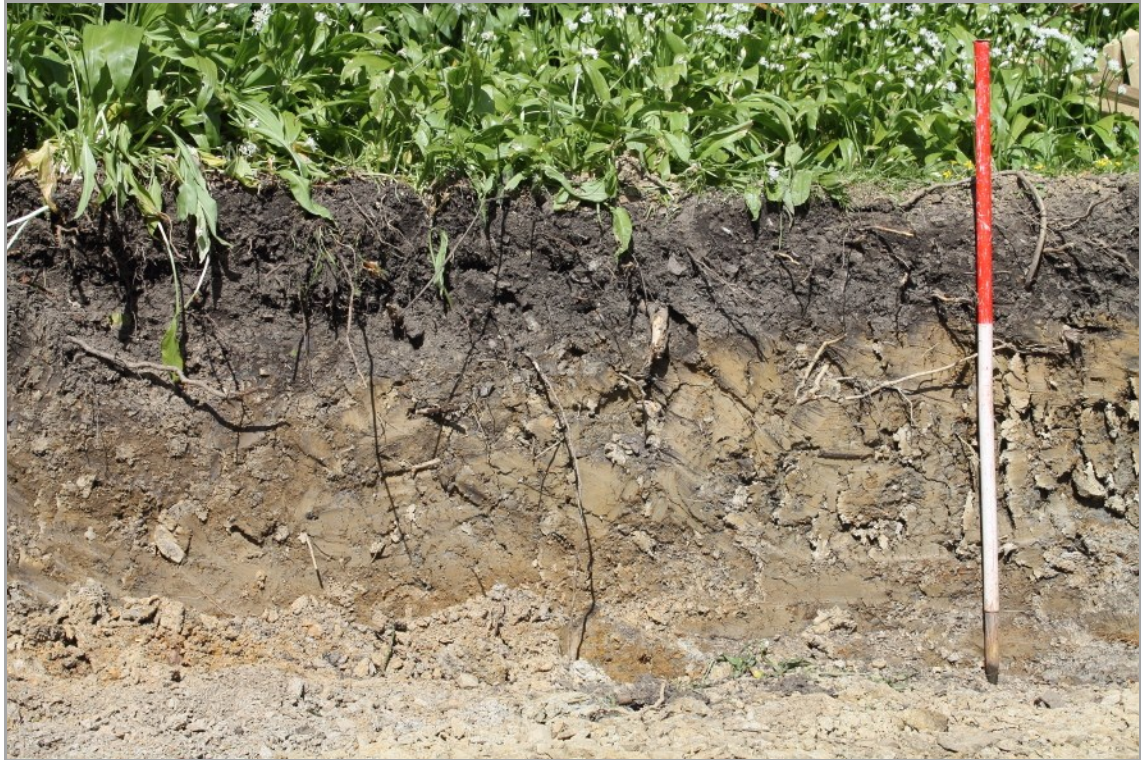
- 4.3 At the northern end of the site the topsoil overlay a deposit of mid orange-brown clay, at most 0.5m thick (Photo 5). This extended approximately 2.0m to 3.0m into the development area from the north and appeared to represent naturally occurring fluvial deposits. Boggy ground is visible in the field immediately to the north of the development area and this clay deposit is likely to be a former extension of that wet ground.

**Photo 5:** View, looking northwest, of deposits revealed at the northern end of the site. Below the topsoil lies a band of naturally-occurring fluvial clays with the stony subsoil/fragmented bedrock at the base. 1m scale

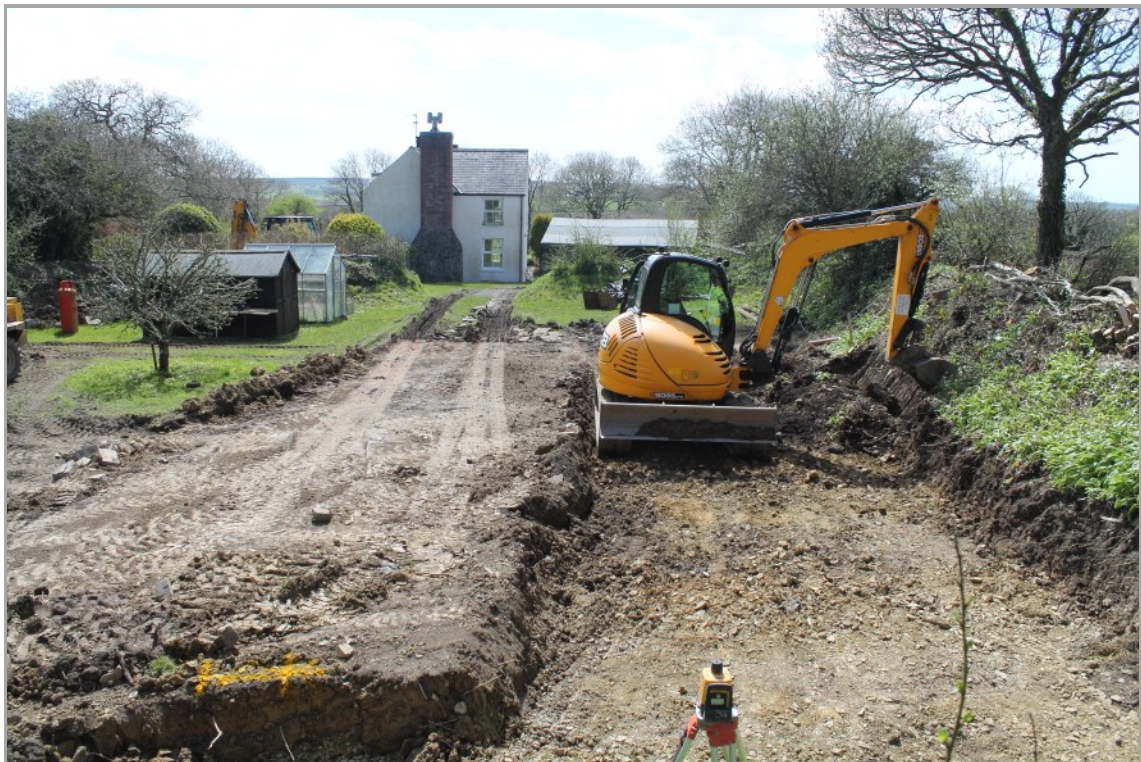
- 4.4 Elsewhere the topsoil overlay naturally deposited fragmented stony subsoil, with bands of broken bedrock visible within it (Photo 6).
- 4.5 The development area lay within a small square enclosed field or paddock surrounded by banks. Where the groundwork exposed parts of these banks they were shown to consist largely of former topsoil, intermixed with some stone and fragments of brick and coal.

**Photo 6:** Looking southwest across the development site during the excavation to formation levels. A naturally-occurring stony subsoil/fragmented bedrock is visible throughout. Park Cottage can be seen in the background.
