**ST DAVID'S CHURCH, LLANARTHNEY,
CARMARTHENSHIRE
ARCHAEOLOGICAL WATCHING BRIEF
OCTOBER 2013 and NOVEMBER 2015
(SN 53437 20264)**

Prepared by Dyfed Archaeological Trust
For: Mr Grey, St David's Church

RHIF YR ADRODDIAD / REPORT NO. 2013/62
RHIF Y DIGWYDDIAD / EVENT RECORD NO. 105807 (October 2013)
RHIF Y DIGWYDDIAD / EVENT RECORD NO. 108838 (November 2015)

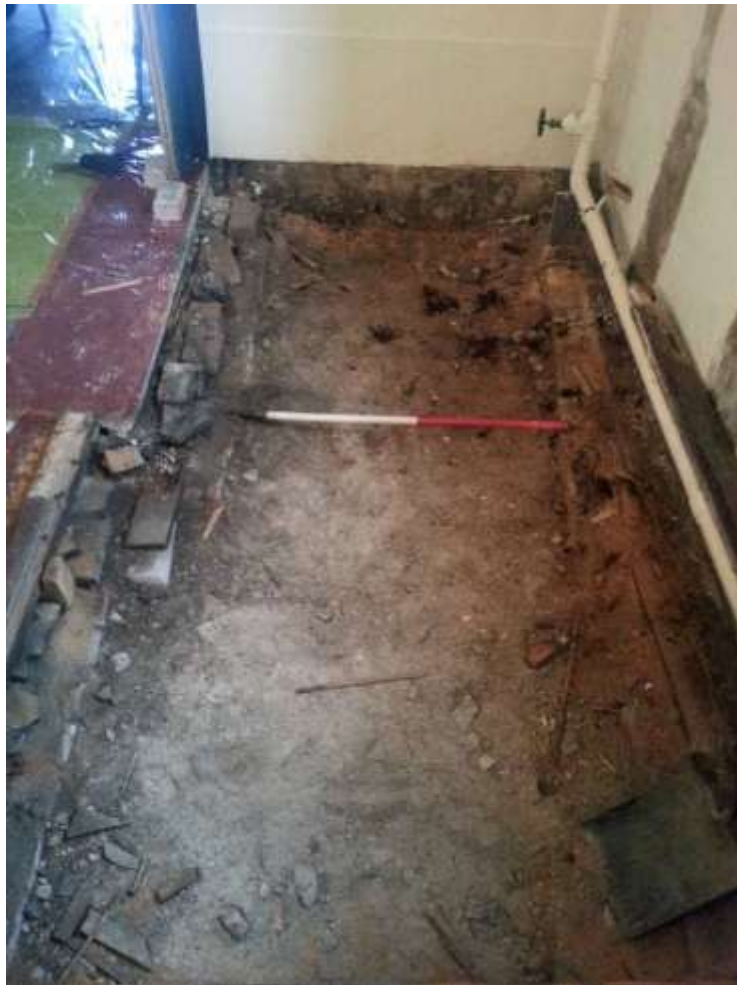
Photo 1: West facing view of area following removal of pews and timber floor

4.1.2 On arrival it was found that three church pews and the timber boarding which they were sat on had been removed from the excavation area, revealing a 0.15m deep void beneath. Beneath the void a mortar rich ground surface was visible, along with two brick and stone dwarf walls to support the overlying pews (Photo 1). Following hand cleaning of this ground surface it was found to consist of a compacted lime mortar rich deposit with no indication of any grave cuts (Photo 2).

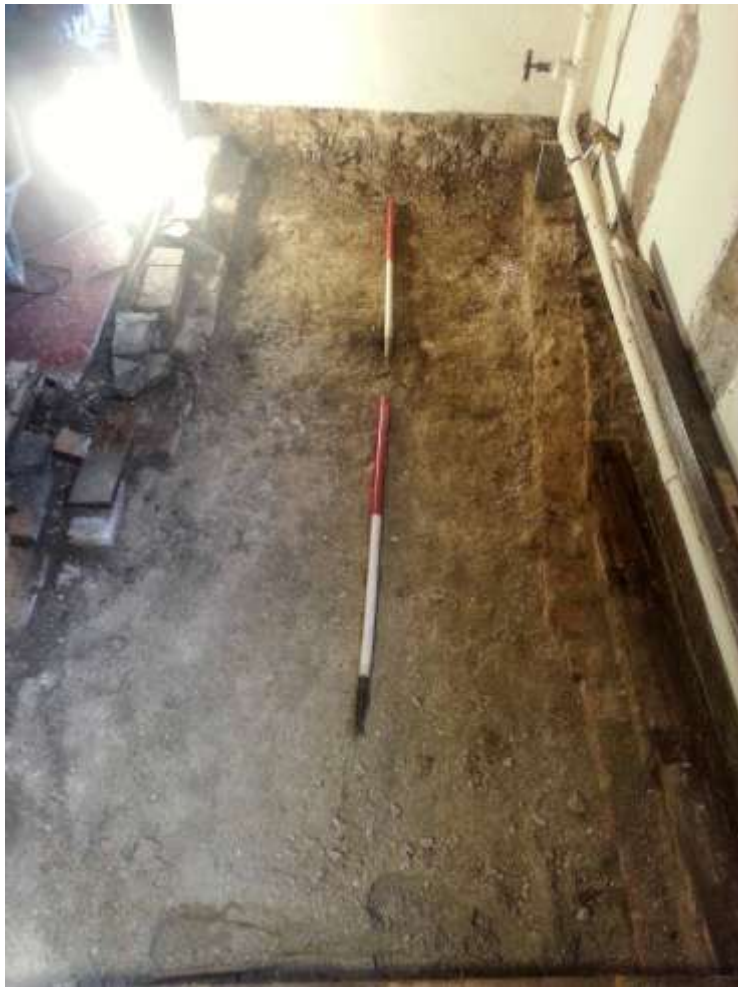
Photo 2: West facing view showing mortar deposit and dwarf walls

4.1.3 Following hand cleaning of this ground surface it was found to consist of a compacted lime mortar rich deposit with no indication of any grave cuts (Photo 2). Excavation of this mortar rich layer recorded it to be 0.02m deep overlying a mid-brown clay silt of moderate compaction. This second layer was 0.16m deep and contained substantial quantities of disarticulated human bone along with occasional fragments of building stone, coal fragments and a single stone roof tile. The human bone was collected and taken to the church vestry for future re-interment in the churchyard. Underlying this layer was a heavily compacted dark brown silty clay with frequent mortar inclusions which is considered to represent a former floor surface (Photo 3). No grave cuts were identifiable within.

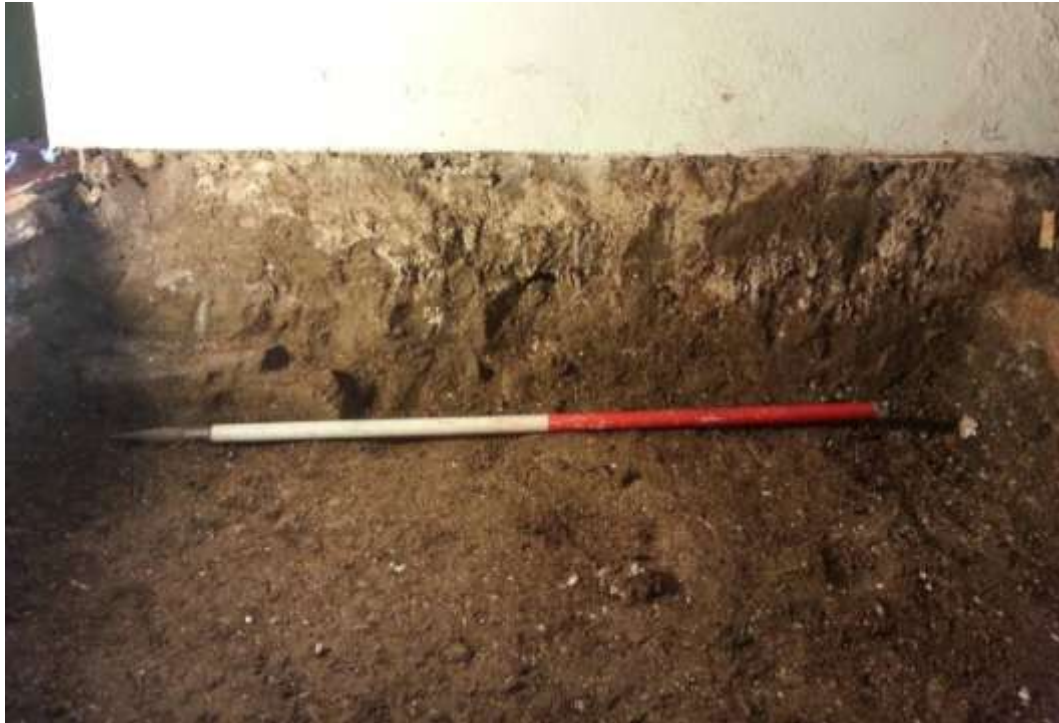
Photo 4: East facing section showing wall footing

4.1.4 At the western end of the excavation area part of the footings of the nave wall were revealed (Photo 4). The footings are very likely to date from the medieval period.

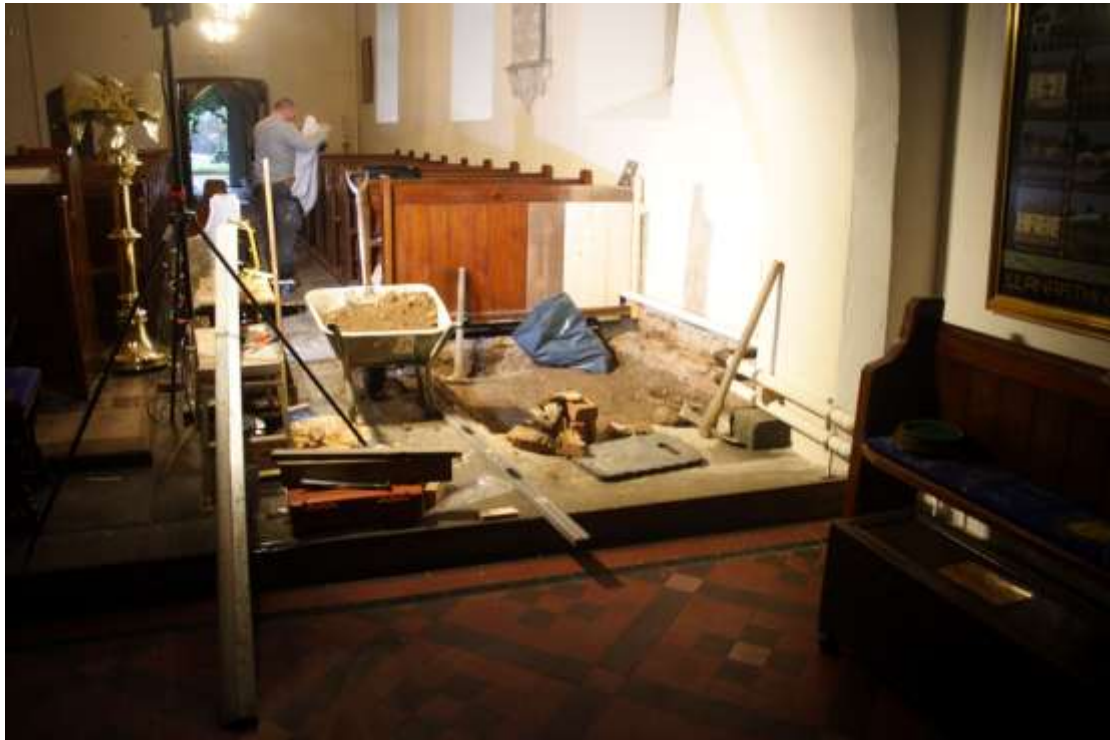
Photo 5: Photo showing clearly the location of the excavated area in relation to the Chancel arch. Facing west.

4.2.1 On 26th November a site visit was undertaken to monitor excavation works in the northeast of the Nave in preparation for the re-siting of the lectern (Watching Brief Area 2, Figure 4). An area of 2.5m by 2m was to be excavated by Mr Cennydd Jones by hand to a proposed depth of up to 0.35m. The area was located close to the chancel arch of the church on its northern side (Photo 7).

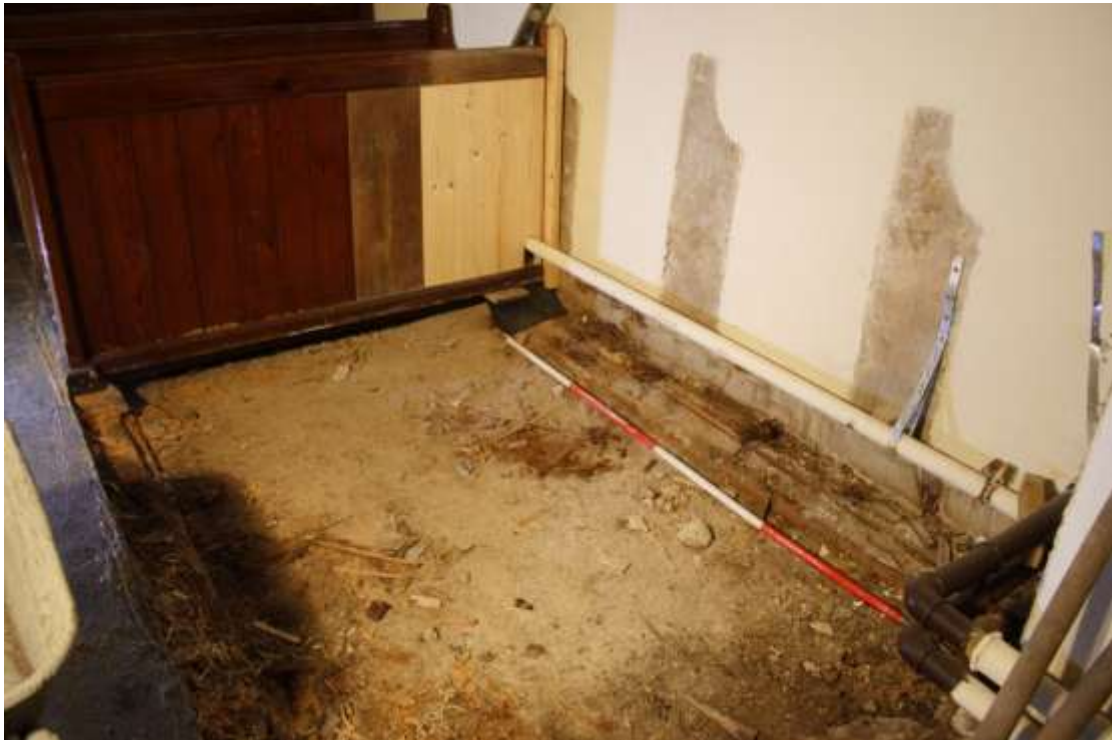
Photo 6: View northwest of excavation area after pews and flooring had been removed, prior to excavation. Facing northwest.

4.2.2 The pews and suspended wooden flooring had been removed on the preceding day in preparation for the ground works. The gap between the suspended floor and the ground beneath was 0.15m across the site. A rough mortar floor surface was visible at the commencement of works (Photo 6).

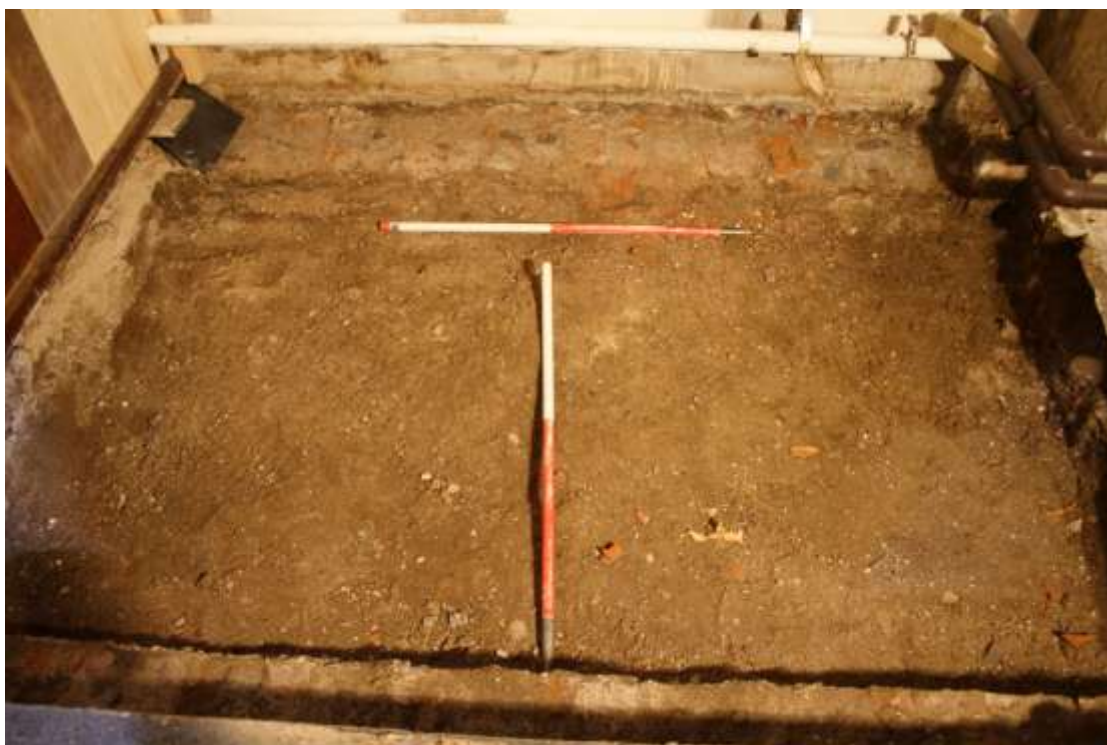
Photo 7: Post excavation shot of site. Facing north.

4.2.6 Some of the recovered bone was vertically deposited, and extended lower than the intended depth of 0.35m below floor level. These were removed with as little disturbance as possible, in order for them to be removed safely for reburial, however this indicates strongly that the depth of this deposit is much greater than at the west end of the church. Once the excavation had been completed to the required depth the surface was cleaned and observed for any further features or finds, although none were present (Photo 7).
