ST MARY'S CHURCH FOOTPATHS, KIDWELLY, CARMARTHENSHIRE: ARCHAEOLOGICAL WATCHING BRIEF (SN 4084 0675)

DYFED ARCHAEOLOGICAL TRUST
RHIF YR ADRODDIAD / REPORT NO. 2014/10
RHIF Y PROSIECT / PROJECT RECORD NO. 106465

**ST MARY'S CHURCH FOOTPATHS, KIDWELLY,
CARMARTHENSHIRE:
ARCHAEOLOGICAL WATCHING BRIEF**

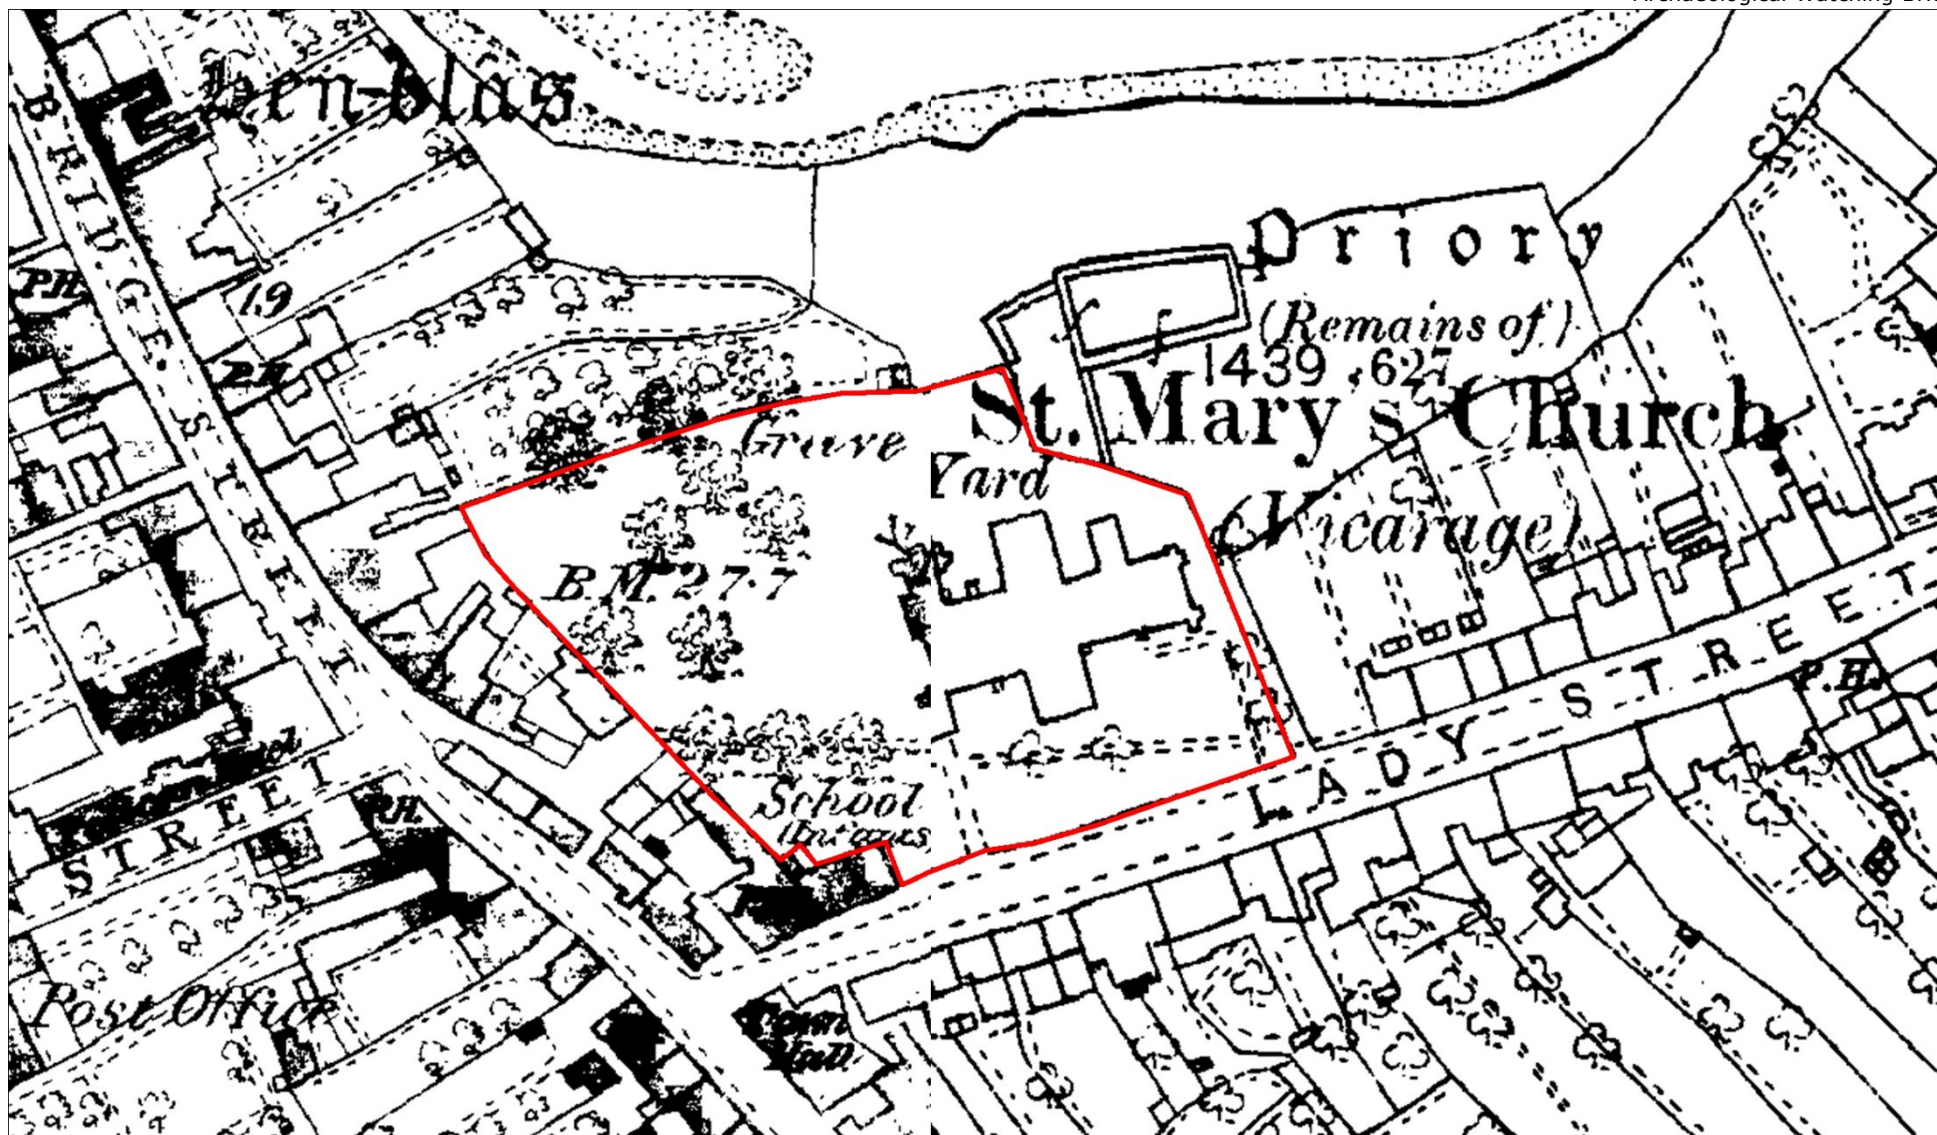
Figure 2: Extract from 1:2500 scale OS map of 1889.

2.2.2 The first edition Ordnance Survey map of 1889 which shows the church (Figure 2) indicates that no paths were present at that time around the northern side of the church, although a few paths were located to the south leading to Lady Street. This layout remains unaltered on the 1906 Ordnance survey map (Figure 3).

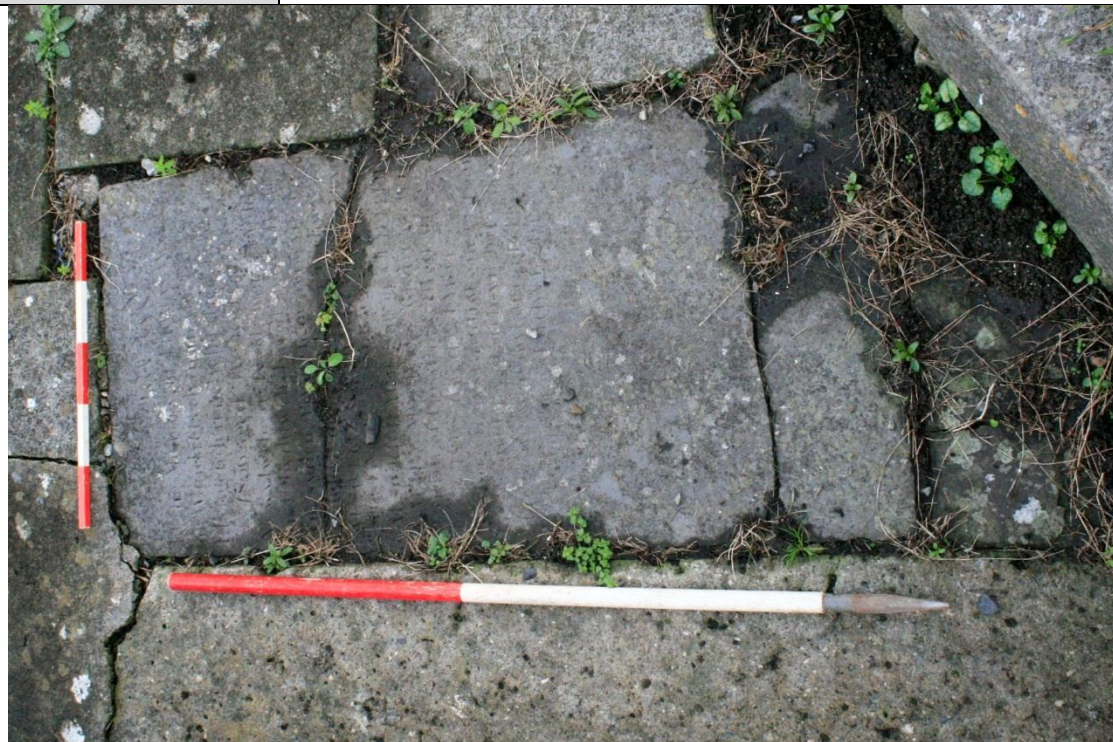
Table 3: Grave stone 1.

Number		1	
Alignment	E -W	Material	Slate
Dimensions	1.56m x 0.61m	Condition	Damaged
Decoration	None		
Inscription	<p style="text-align: center;">SACRED</p> <p style="text-align: center;">To The Memory of THOMAS WALTER</p> <p style="text-align: center;">Of..... in the Parish of</p> <p style="text-align: center;">Llan.... who died Feb 11th</p> <p style="text-align: center;">1866.....</p> <p style="text-align: center;">(remainder of inscription illegible)</p>

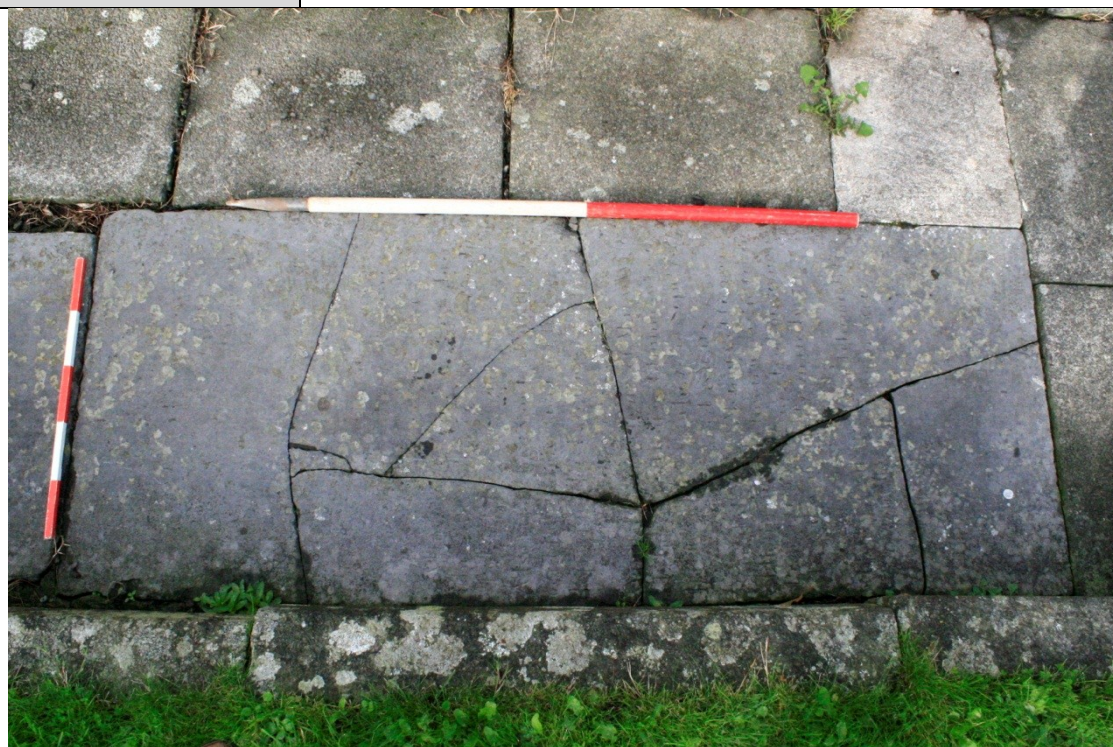
Table 4: Grave stone 2.

Number		2	
Alignment	E -W	Material	Slate
Dimensions	1.72m x 0.70m	Condition	Damaged
Decoration	None		
Inscription	Completely illegible

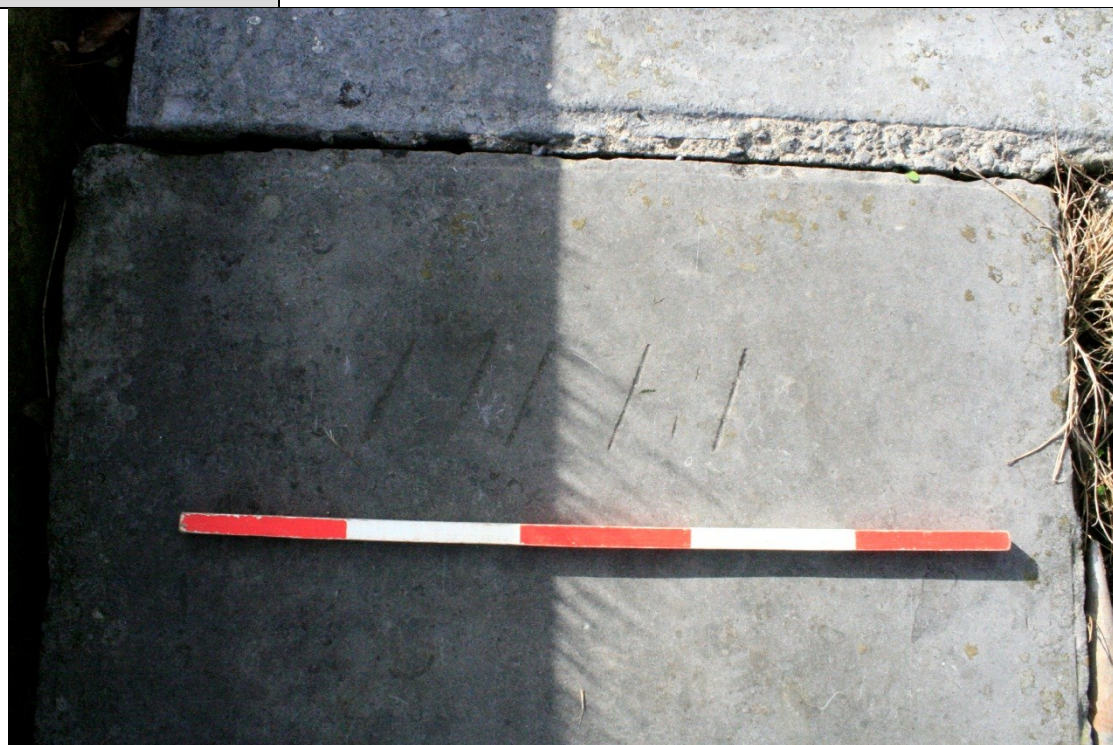
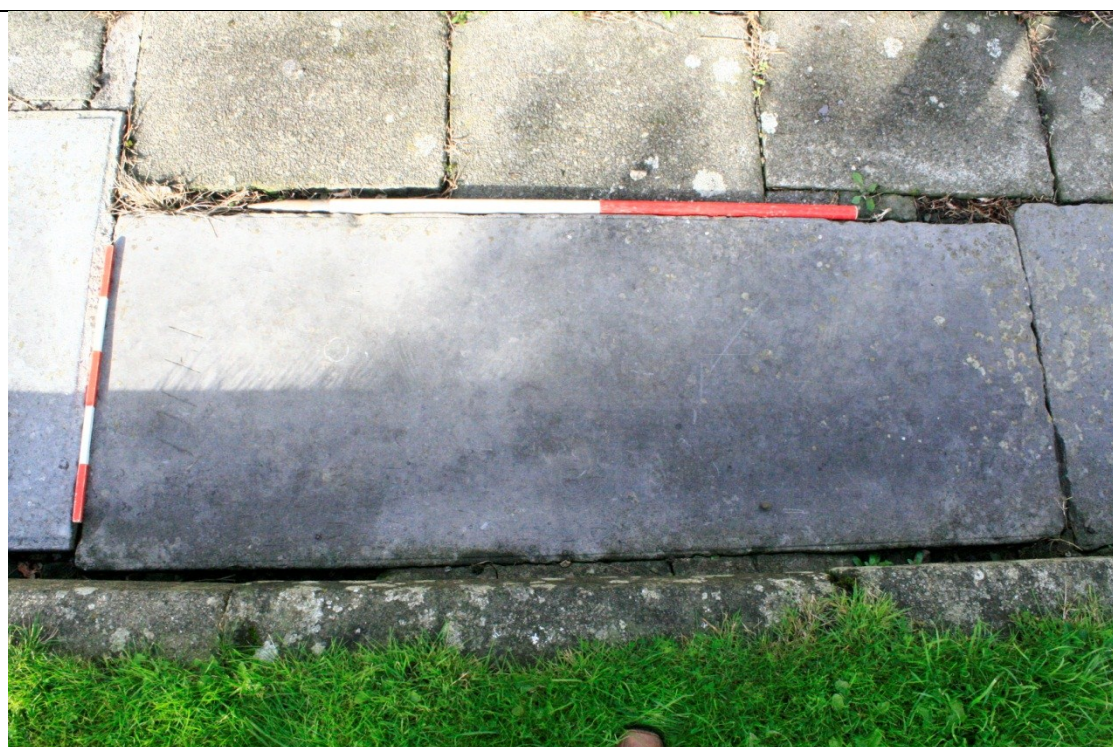
Table 5: Grave stone 3

Number		3	
Alignment	E -W	Material	Slate
Dimensions	1.73m x 0.64m	Condition	Intact
Decoration	None		
Inscription	///// (slab lying face down)

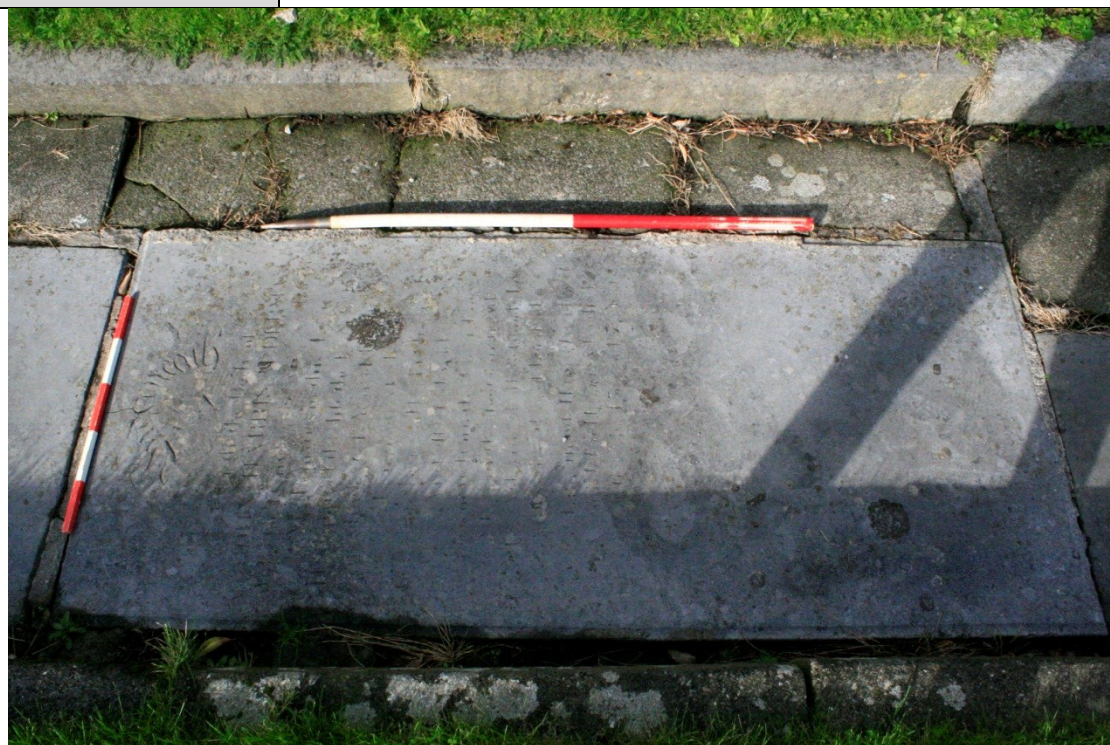
Table 6: Grave stone 4.

Number		4	
Alignment	E -W	Material	Slate
Dimensions	1.83m x 0.84m	Condition	Intact
Decoration	Chamfered edges		
Inscription	<p>SACRED (in semi-circle) (remainder of inscription illegible)</p>

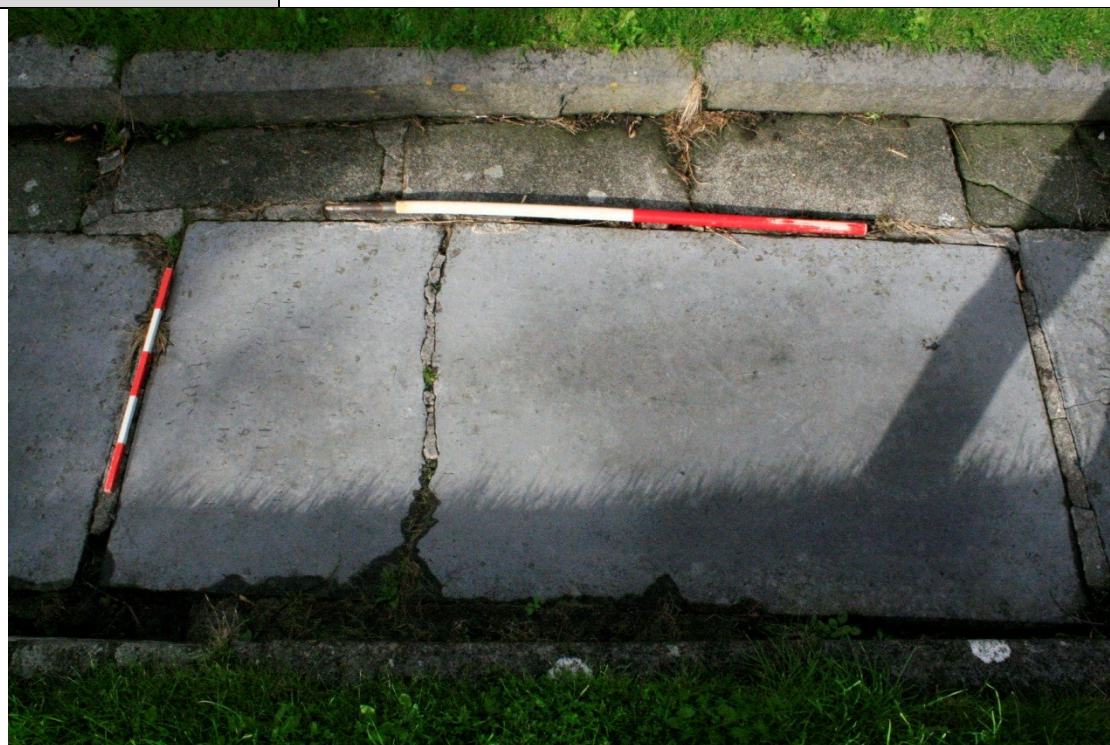
Table 7: Grave stone 5.

Number		5	
Alignment	E -W	Material	Slate
Dimensions	1.80m x 0.81m	Condition	Damaged
Decoration	Chamfered edges		
Inscription	<p style="text-align: center;">SACRED (remainder of inscription illegible)</p>

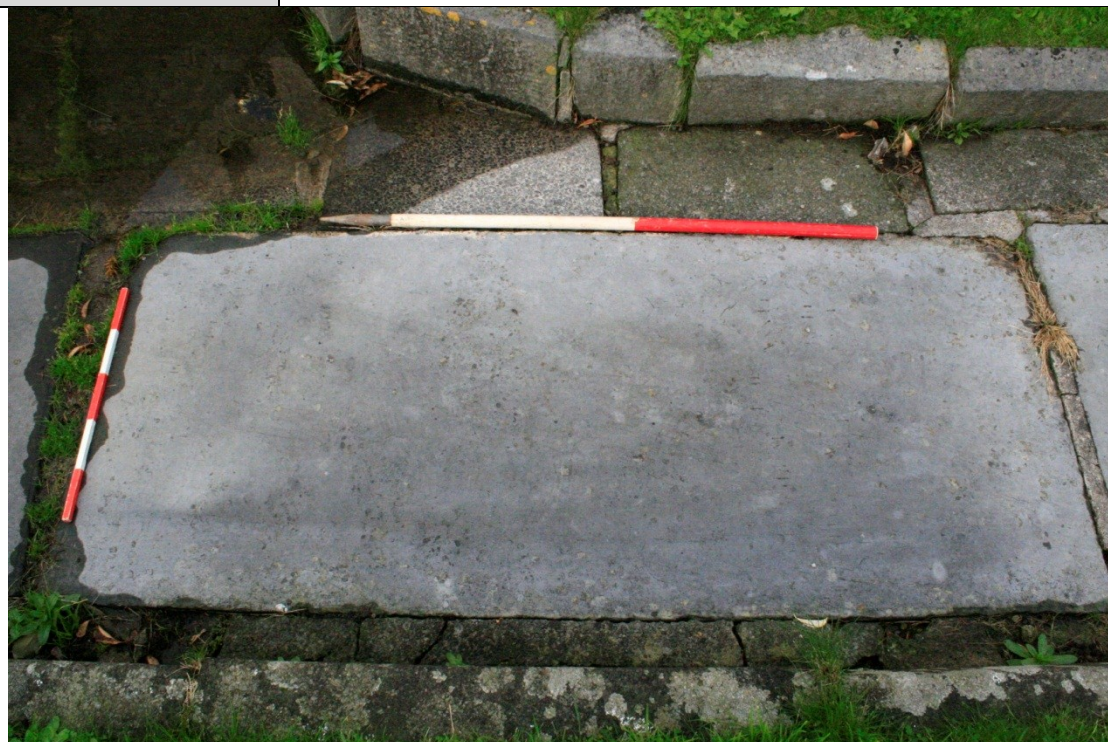
Table 8: Grave stone 6.

Number		6	
Alignment	E –W	Material	Slate
Dimensions	1.84m x 0.84m	Condition	Damaged
Decoration	None		
Inscription	Completely illegible

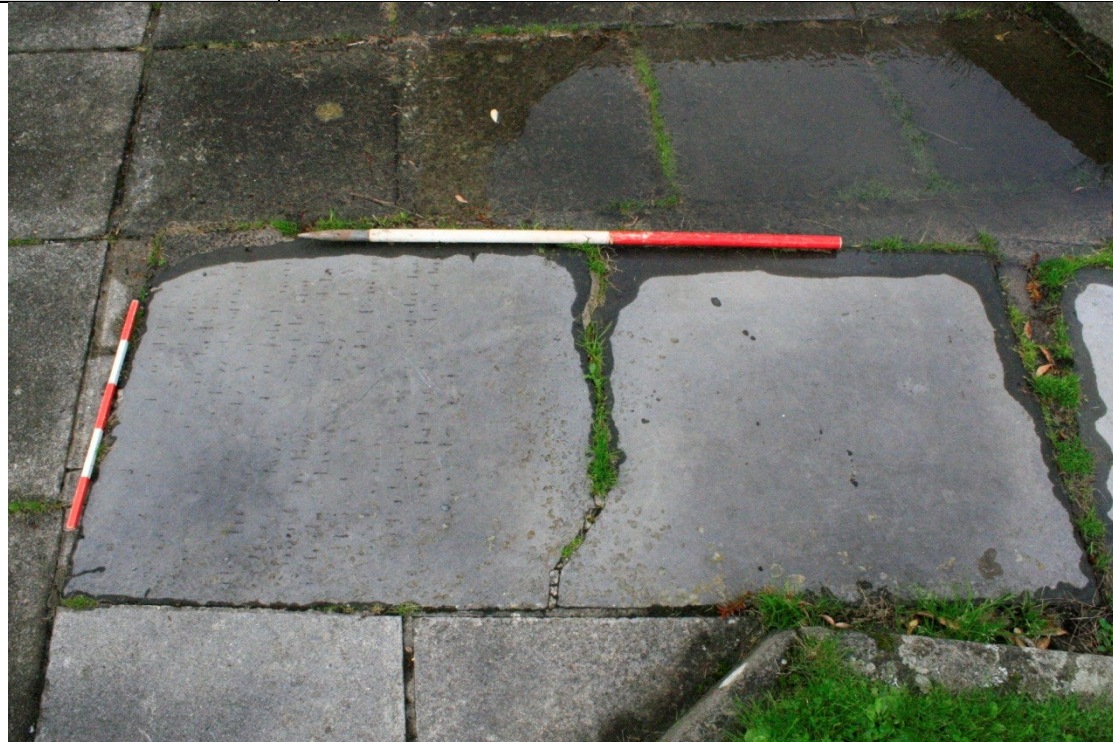
Table 9: Grave stone 7.

Number		7	
Alignment	E – W	Material	Slate
Dimensions	1.83m x 0.84m	Condition	Damaged
Decoration	Chamfered edges		
Inscription	Completely illegible

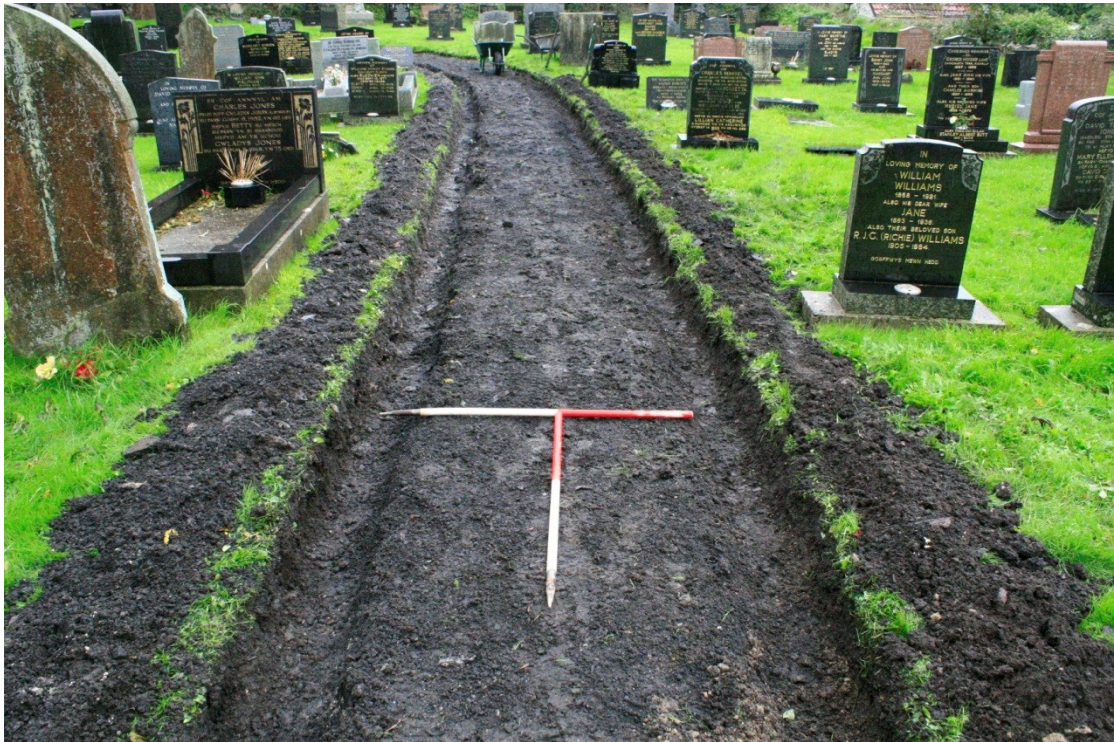
Photo 1: West facing view of path on S side of the church

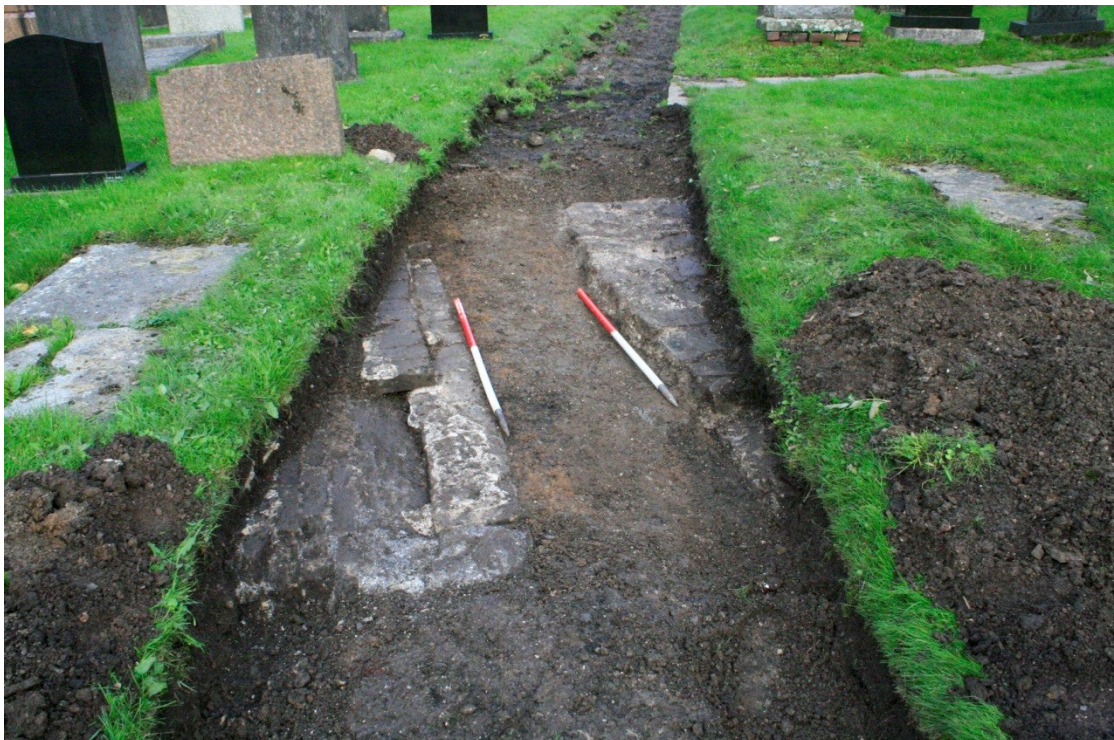
4.3 The two remaining archaeological features that were revealed during the course of the ground works associated with the path renewal were identified on the north side of the church yard (NGR SN 40811 06769; Figures 4 & 5). Both features consisted of two probable burial vaults exposed beneath the removed path surface (Photo 2).

4.4 Vault one was revealed on the south side of the path and was constructed of mortared stone on a NE – SW alignment. The vault measured 2.7m x 0.70m and continued beyond the edges of the path. Vault two was also on a NW – SE alignment and measured 2.6m x 0.80m and like vault one continued beyond the edges of the path. Vault two was of brick construction with an arched roof of stretcher bond brickwork laid on edge, with a further single course of stretcher bond brickwork laid on bed overlying this. Neither burial vault was opened as a result of the path renewal works. A ledger stone was noted c.1m to the south of Vault one with a second ledger lying c.0.50m to the north of Vault two. It is considered likely that these ledger stones relate to the vaults revealed during the ground works but have been moved from their original positions. No inscriptions were visible on either ledger.

Photo 2: Burial vaults revealed on S side of church. Possible ledger stones associated with the vaults visible to left and right.
