LAND WEST OF 44 CHURCH ROAD, ROCH, PEMBROKESHIRE: ARCHAEOLOGICAL WATCHING BRIEF

Prepared by: DAT Archaeological Services

RHIF YR ADRODDIAD / REPORT NO 2014/17 RHIF Y DIGWILLIAD / EVENT RECORD 106479

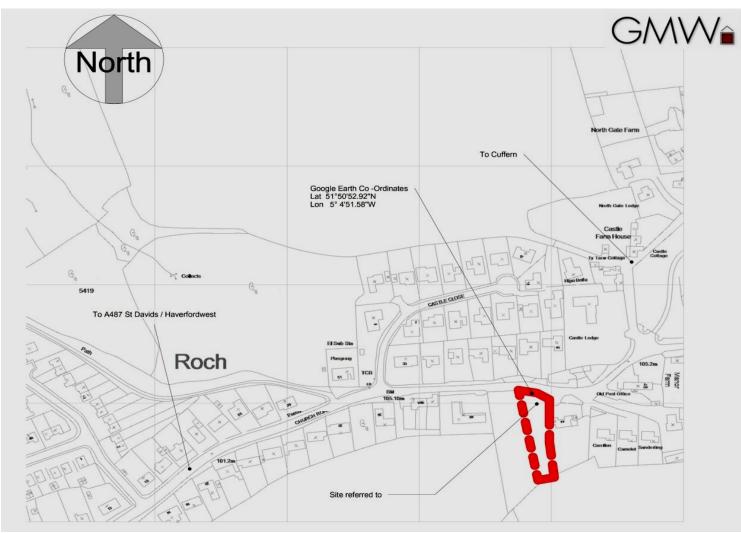
Figure 1: Location of development area within the village of Roch (plan supplied by client).

- 2.1.1 The development is located at NGR SM 87880 21070 in a semi-rural setting (Figure 1). It is a relatively flat, grassed area, bounded by a hedge on the north side that runs alongside Church Road, and a garden fence and concrete wall on the other three sides (Photo 1). The faint outline of a grassed-over ditch runs parallel with the hedge bank. Roch Castle (PRN 2804) and St Mary's Church (PRN 2803) are situated 180m and 220m respectively to the NW and West respectively. (Figure 3, Photo 1).
- 2.1.2 Prior to development the site formed part of the gardens for an adjacent property and contained no structures.
- 2.1.3 The underlying geology of the area is the Treffgarne Volcanic Formation. An igneous bedrock formed during the Ordovician Period.

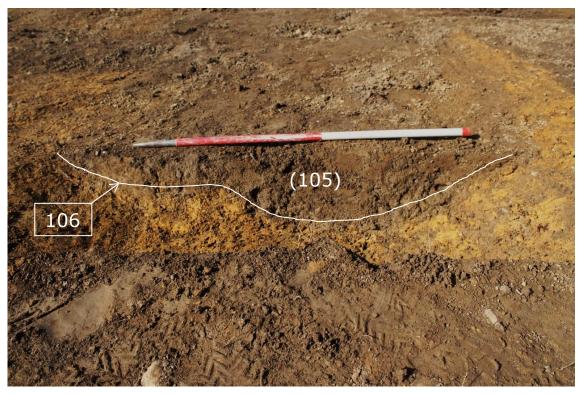
Photo 5: Section 2: south facing section of ditch cut [106].

- 4.6 Extending from beneath the east side the trench was a soil mark (108). This dark brown, silty-clay fill was noticeably damper than other fills on site. In plan it was approximately 5m wide and extended 3m into the trench. This could be an irregular terminus to a ditch or a large pit. (Photo 5)
