LAND ADJACENT TO BRYN DOLAU, FFARMERS, CARMARTHENSHIRE: ARCHAEOLOGICAL EVALUATION (NGR SN 65006 44310)

Prepared by Dyfed Archaeological Trust
For: Mr Gareth Thomas

RHIF YR ADRODDIAD / REPORT NO. 2014/25
RHIF Y PROSIECT / PROJECT RECORD NO. 106670

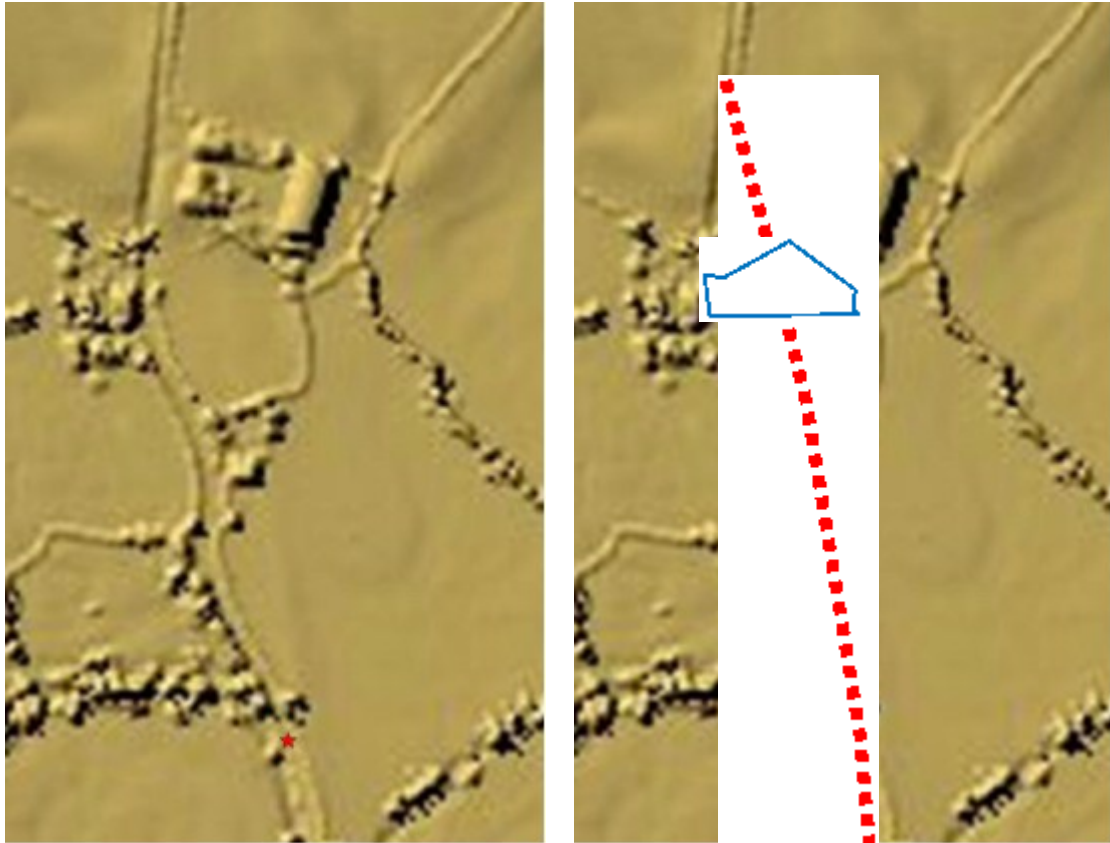
Figure 2: (Left) LIDAR data plot of site area, (right) LIDAR data plot with projected Roman road and approximate site of proposed dwelling.

- 2.2.3 Analysis of LIDAR data supports evidence of a possible Roman road section diverging from the modern highway (See figure 2 and 3). At the point at which the modern road curves north westwards a subtle linear feature can be seen to continue north passing beneath the proposed development site before re-joining the modern road just to the north of Bryn Dolau.

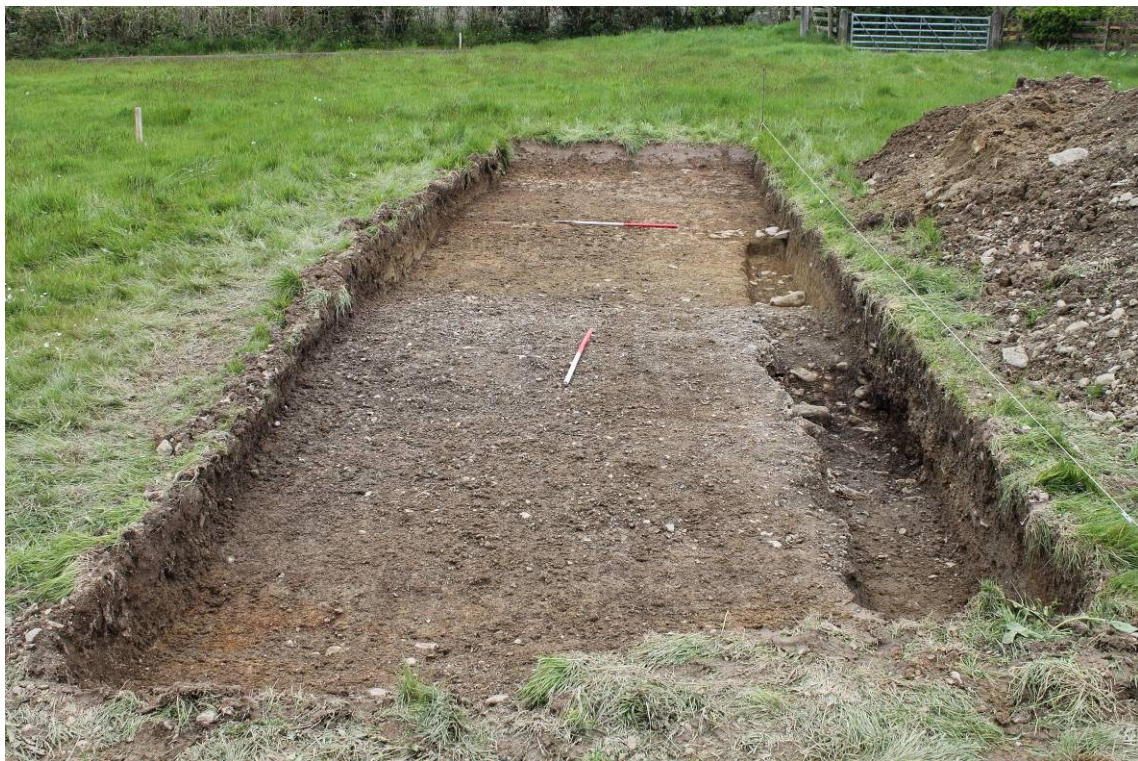
- 4.5 Below 002, at a depth of approximately 0.4m, a friable, grey, gritty layer (008) with small stone inclusions was encountered at the eastern end of the trench (Photo 1). In profile 008 had a convex appearance and could be seen to cover an approximately 5m length across the trench. This gravel like layer appeared to make up the upper most layer of the surviving Roman road surface. A sample excavation slot was excavated along the northern edge of the trench to obtain a profile through the road and its make-up deposits. Close inspection revealed the layer was made up of a number of micro lenses, possibly a result of re-surfacing.

Photo 1: Excavated trench looking west. 1m scales. Road visible as grey coloured feature.

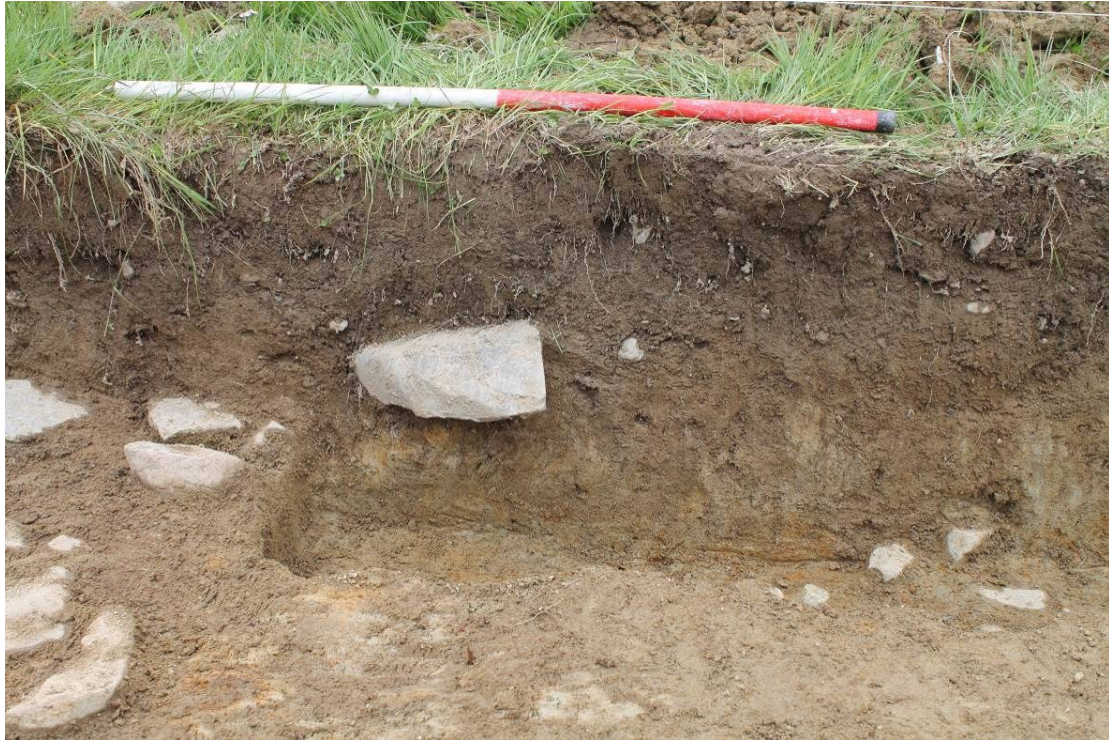
- 4.6 Layer (008) overlay two other discrete layers that provide built layers for the road construction, that create its agger (raised profile) (Photo 2). The earliest of this, 010, lies at a depth of approximately 1.20m and consists of a dark red/brown organic material forming the base of the Roman road. Layer (009) was found between (010) and (008). It shared similar characteristics to (008), varying only in colour to a light brown and with slightly larger stone inclusions.

Photo 2: Representation of midsection of south facing section.

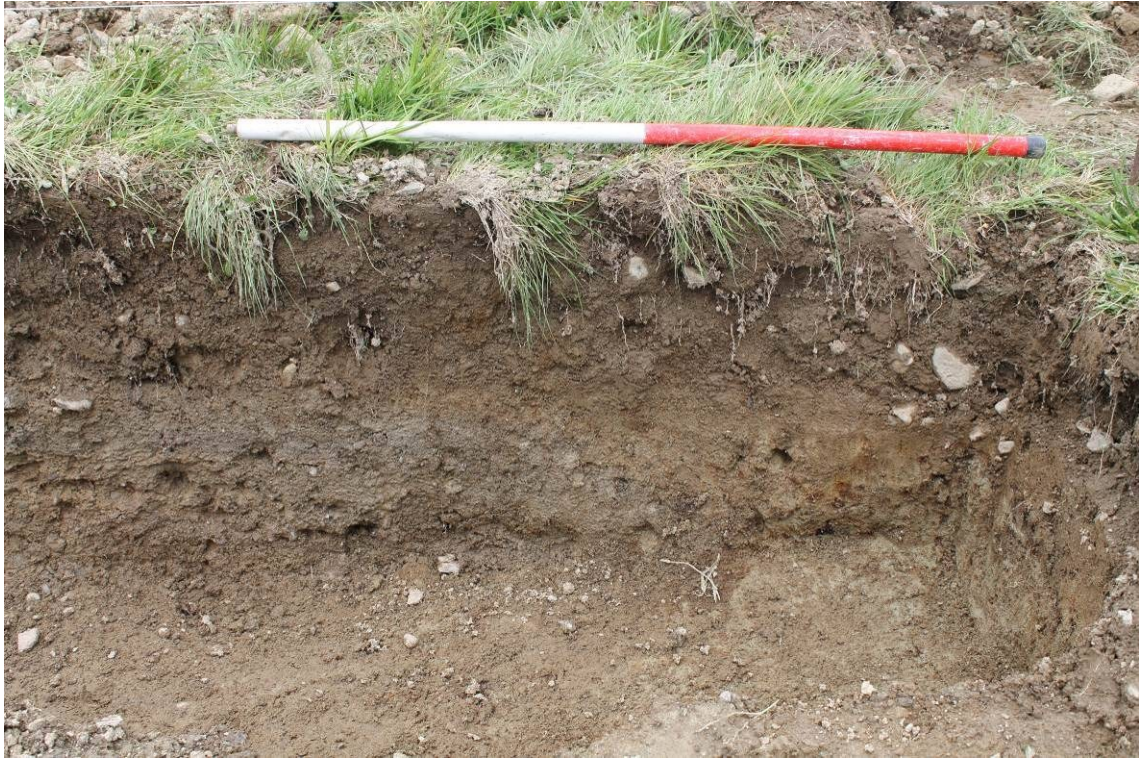
- 4.8 Adjacent to the road on both the east and west sides, directly below (002) a fine sandy silt material (003) and (004) appears to have accumulated in former gullies flanking the road sides (Photo 3).

Photo 3: Eastern edge of trench south facing section.
Sandy silt (003) visible forming the infill of possible roadside gully. Grey banding (008) forming upper road layer also visible at mid-section.

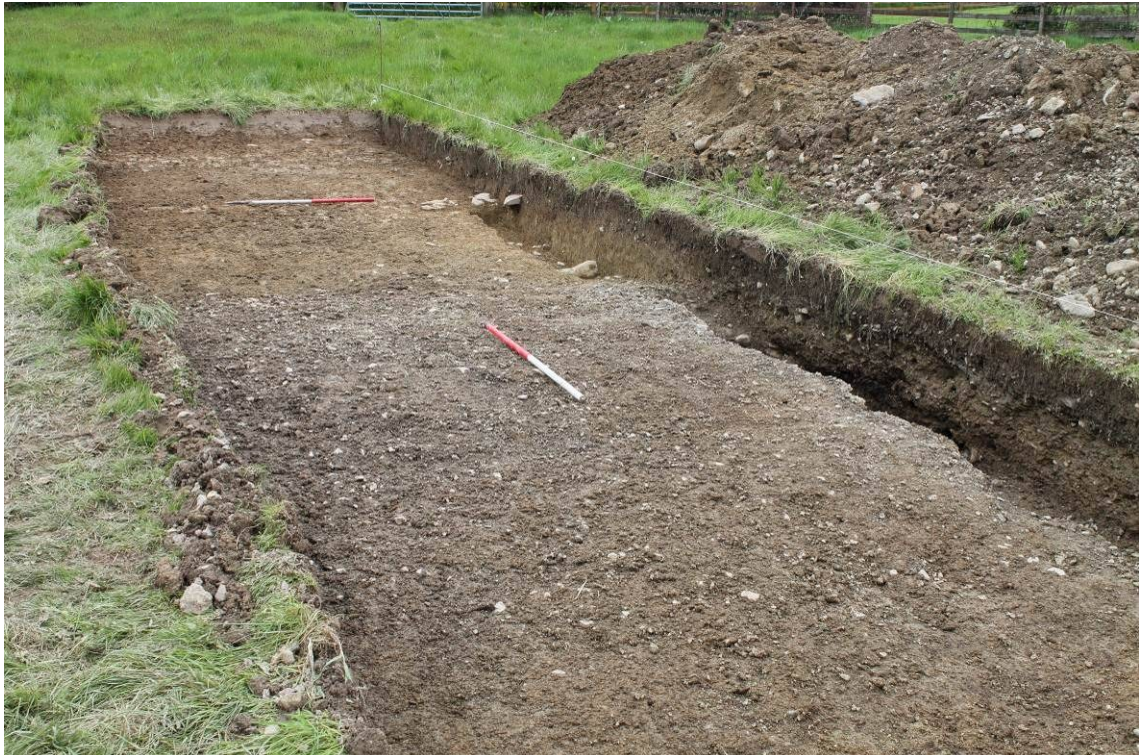
- 4.9 To the west of the Roman road an area of undisturbed silty clay (007) was recorded. It is possible that (007) is a former land surface, through which the Roman road was constructed (Photo 4). No archaeological features or material could be seen within or cutting through layer (007). The layer was not further excavated as it was presumed to be natural undisturbed ground.

Photo 4: Oblique angle (northwest facing) showing road surface in the foreground (008) and natural in the background (007). South facing excavated section visible.

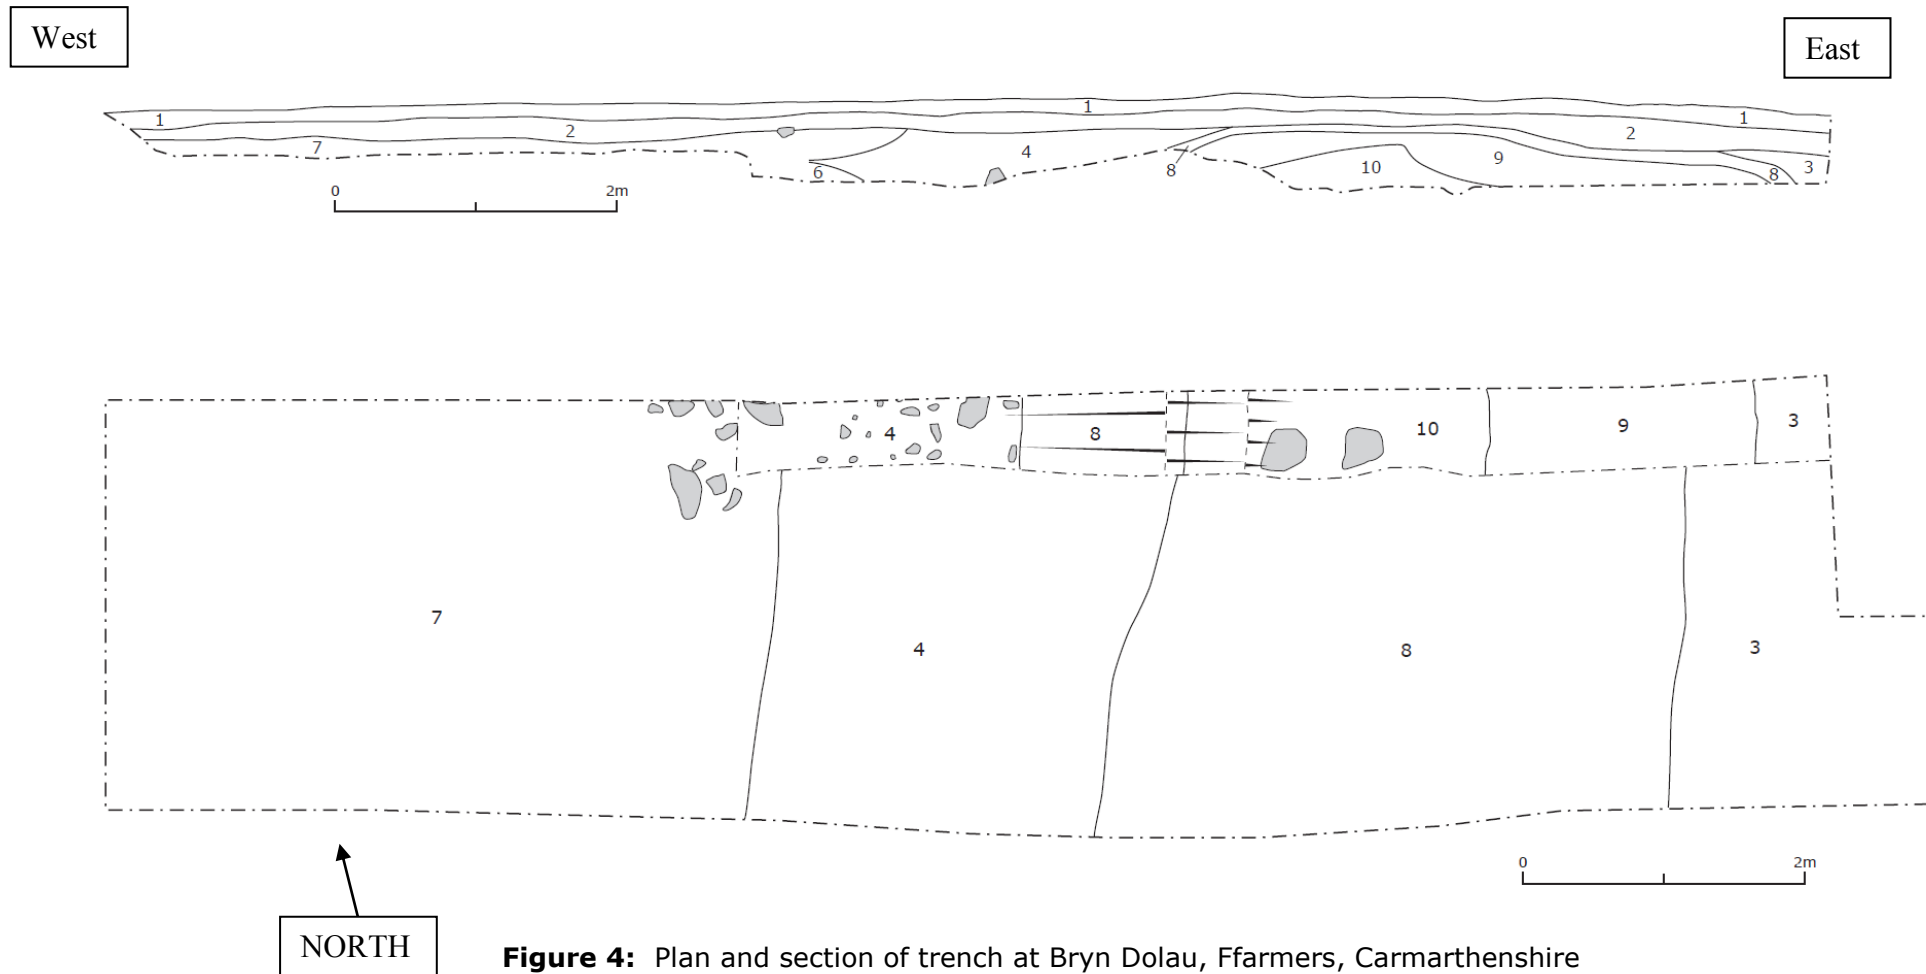
Figure 4: Plan and section of trench at Bryn Dolau, Ffarmers, Carmarthenshire

- 4.1 Descriptions of contexts recorded in the trench can be found in Table 3 and illustrated in Figure 4.
- 4.2 A 12m x 3m trench was laid out aligned east to west bisecting the footprint of the proposed dwelling and overlying the predicted route of the Roman road.
