HENLLAN WASTE WATER TREATMENT WORKS, CEREDIGION: ARCHAEOLOGICAL WATCHING BRIEF

(NGR SN 35459 40238)

Prepared by Dyfed Archaeological Trust
For: Asbri Planning

RHIF YR ADRODDIAD / REPORT NO. 2014/27
RHIF Y PROSIECT / PROJECT RECORD NO. 106716

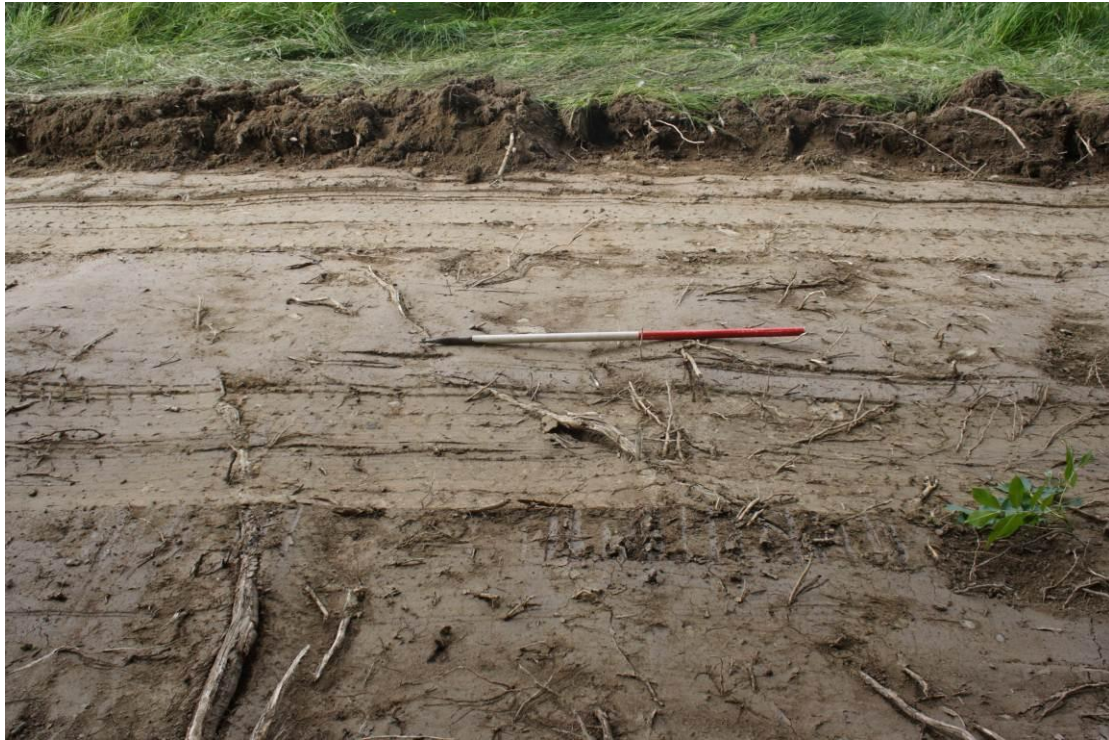
- 4.1 The excavation of the topsoil across the extent of the new access track (phase 1) was conducted immediately prior to the arrival of the archaeologist. The topsoil was approximately 0.10 – 0.15m in depth and consisted of a friable light brown silt loam. The area was covered with a large number of roots (Photo 1). The level removed for the topsoil strip did not expose any underlying archaeological remains as the full depth of topsoil was not removed.

Photo 1: Excavation of topsoil for new access track (Phase 1).

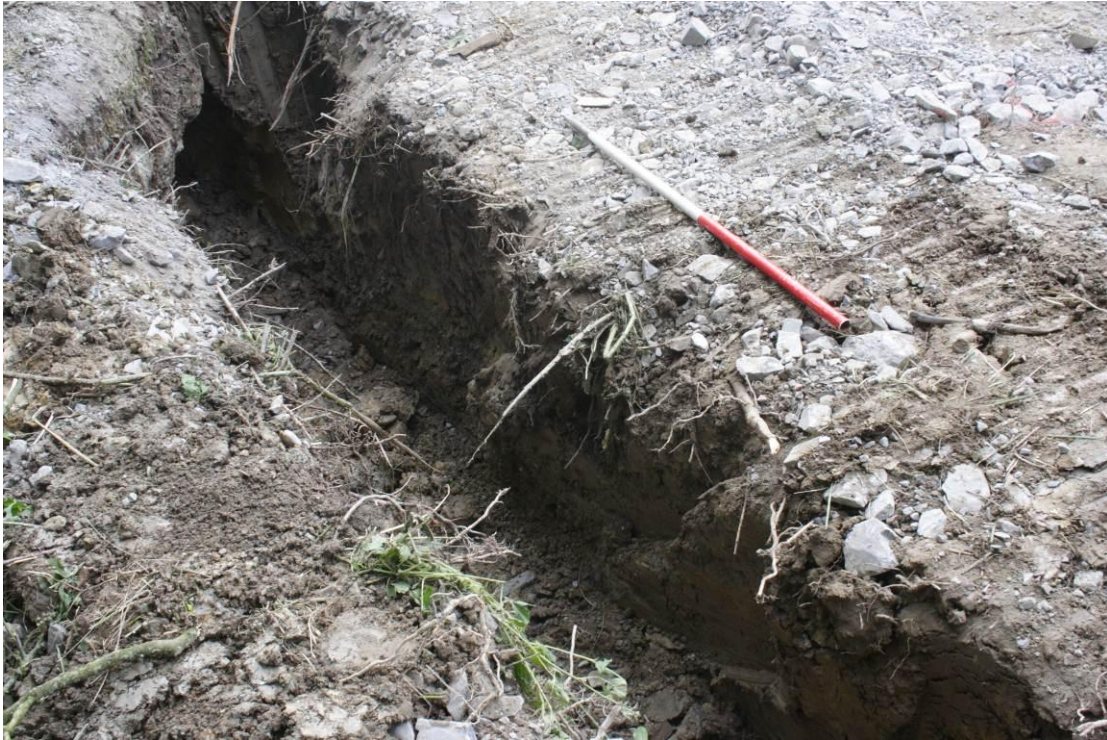
- 4.2 The Phase 2 works involved the excavation of a linear trench for drainage purposes. This trench was approximately 1m wide, running parallel down the midsection of the new access track, aligned east/west. The trench was excavated to a depth of approximately 0.75m (Photo 2). At fixed points along the drainage trench larger trenches of approximately 2m x 2m and to a depth of approximately 1.5m were also excavated for inspection chambers (Photo 3).

Photo 2: Excavation of drainage trench (Phase 2).

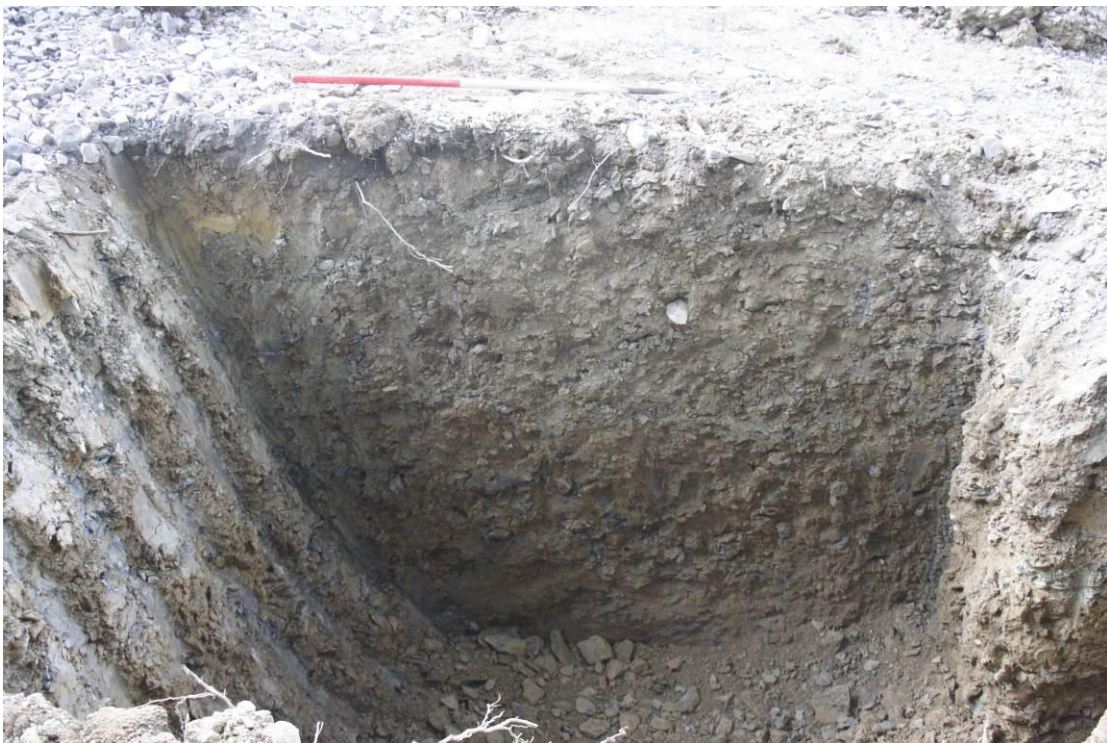
Photo 3: Example of trench excavated for manhole openings. North facing section. Note the remnant topsoil at the top of the section and shale at the base

- 4.4 Moving west along the trench it becomes obvious that the clay loam subsoil increased in depth to over 1m deep. The shale layer was only just visible at the base of the most westerly manhole opening.

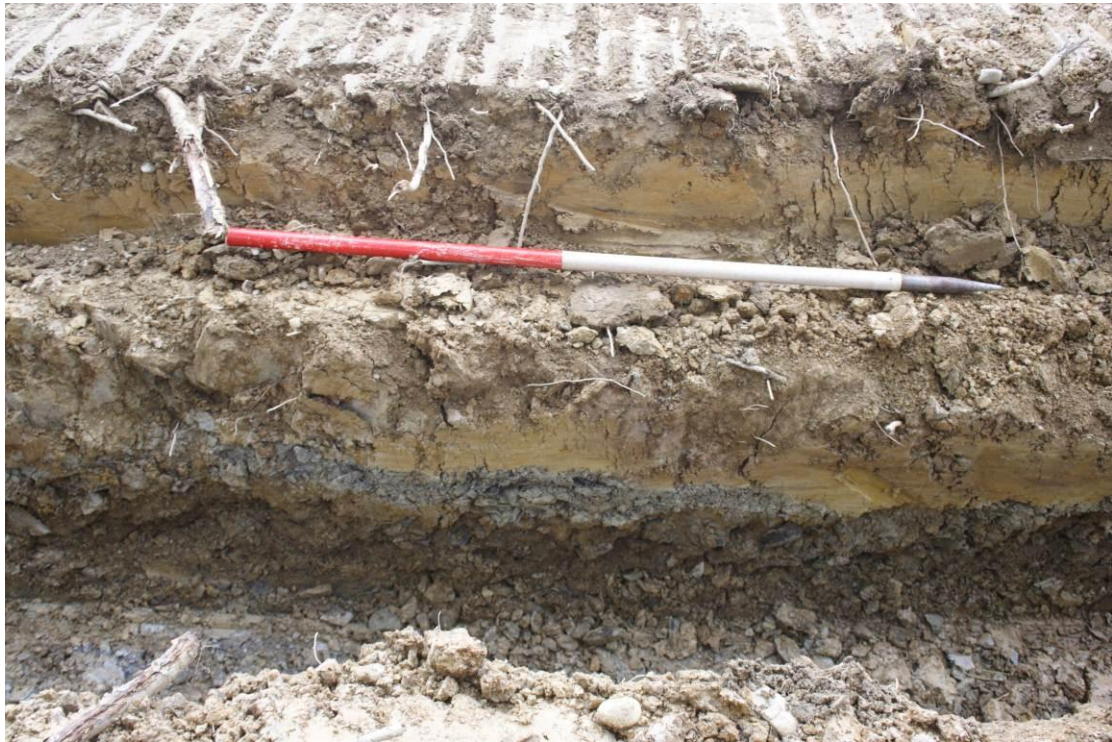
- 4.3 Excavation of the drainage trench revealed that the subsoil consisted of a light brown, undisturbed clay silt that varied in depth across the site. At the most eastern end of the trench the subsoil was approximately 0.5 – 0.70m in depth, with the first 0.15 – 0.20m containing a high volume of small stone inclusions. It was noted that the clay silt subsoil was overlying the natural grey shale bedrock occurring at a depth of approximately 0.70cm (Photo 4).

Photo 4: North facing section at eastern end of drainage trench, note the grey shale layer clearly visible beneath the clay loam subsoil and remnant topsoil at the top of the section
