# **EXTENSION & ALTERATIONS TO EXISTING BUILDING & OUTBUILDINGS AT GWAUNFA, WEST STREET, NEWPORT, PEMBROKESHIRE: ARCHAEOLOGICAL WATCHING BRIEF**

RHIF YR ADRODDIAD / REPORT NO 2014/32  
RHIF Y DIGWILLIAD / EVENT RECORD NO 107364

Ionawr 2015  
January 2015

Gan / By  
Fran Murphy

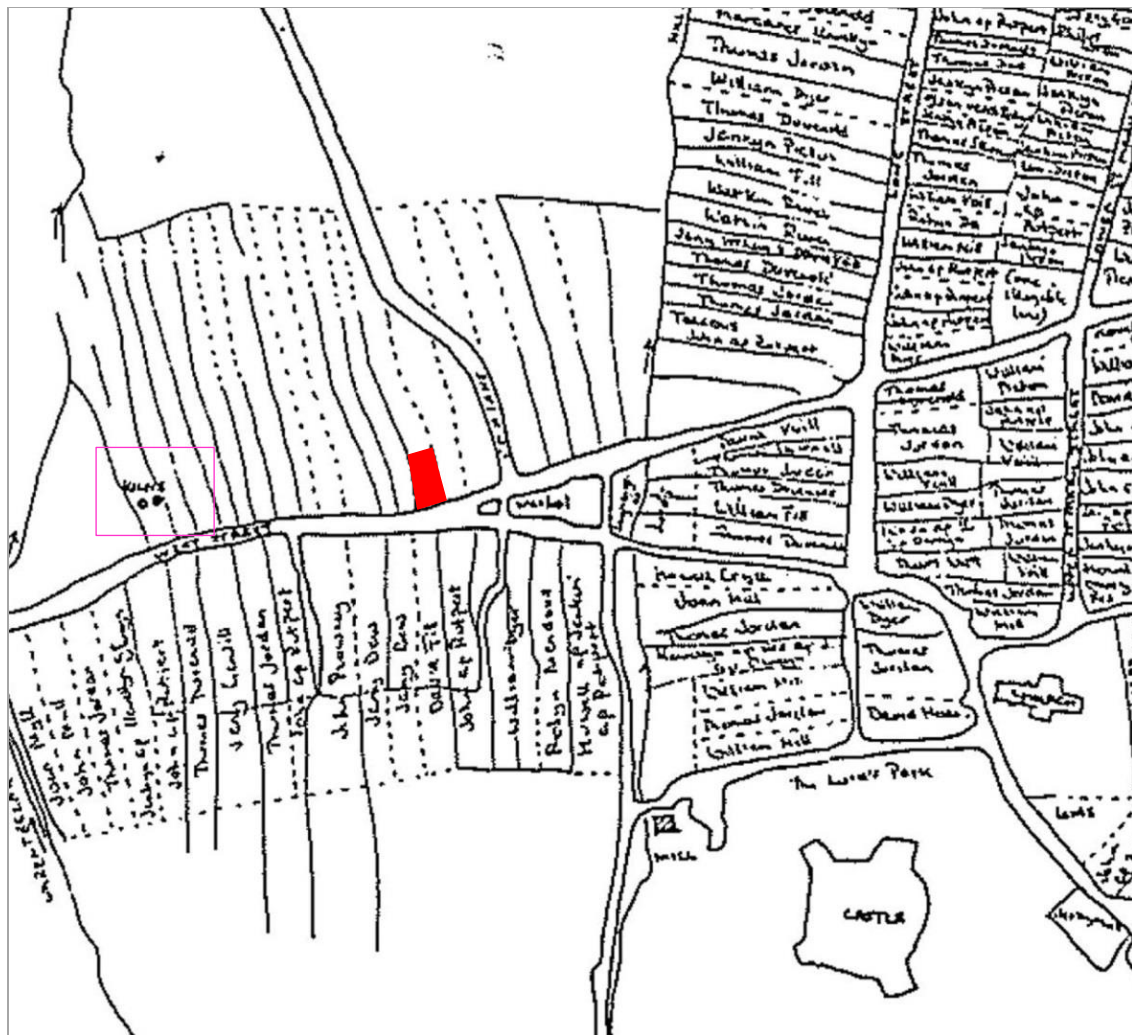
**Figure 4:** Annotated plan of the burgage plots in Newport and the tenants identified from the 1434 rental (from V. M. Bignall, 1991). The location of Gwaunfa (PRN 60565) is shown in red, with its associated burgage plot extending to the north above. The location of the two medieval pottery kilns (PRN 1498) discovered in 1921, and now a scheduled ancient monument (PE437), is outlined in pink.

- 2.2.3 Excavation work carried out by Dyfed Archaeological Trust in 1985 (Stenger 1985) and 1991 (Murphy 1994) recorded medieval buildings within the burgage plots that made up the medieval borough of Newport. A 'burgage plot' is a tract of land within a medieval town which was allocated to burgesses or freemen; those who were eligible to practice a trade in the town and elect the members of the town council. The tracts could be between 12-18m in width and averaged 60m in length and formed the basis of medieval towns. The position of the proposed new house lies at the northern extent of one of these medieval burgage plots. This is visible on the extant town rental map of 1434 (Figure 4) that shows the layout of the plots in Newport.

- 2.2.7 One of many listed buildings in this area as presented in Table 2, Gwaunfa is listed as being amongst the earliest vernacular town houses in Newport which retains good traditional character. Map evidence shows that the present street pattern was established by 1434 (Figure 4) and that extending back from the street frontages were the long narrow properties or 'burgage plots' that characterise a medieval town. Burgage plots are the tracts of land within a medieval town which were allocated to the burgesses, who were freemen; those who were entitled to practise a trade and to elect members of the town's ruling council. These plots were from 12-18m in width, averaged 60m in length and occupied the entire area represented by the present-day town. Medieval buildings have been recorded within the plots in Newport during excavation by Dyfed Archaeological Trust in 1985 and 1991. The property Gwaunfa fronts a former burgage plot that extended to the north behind it. This is visible on the extant town rental map of 1434 (Figure 4).

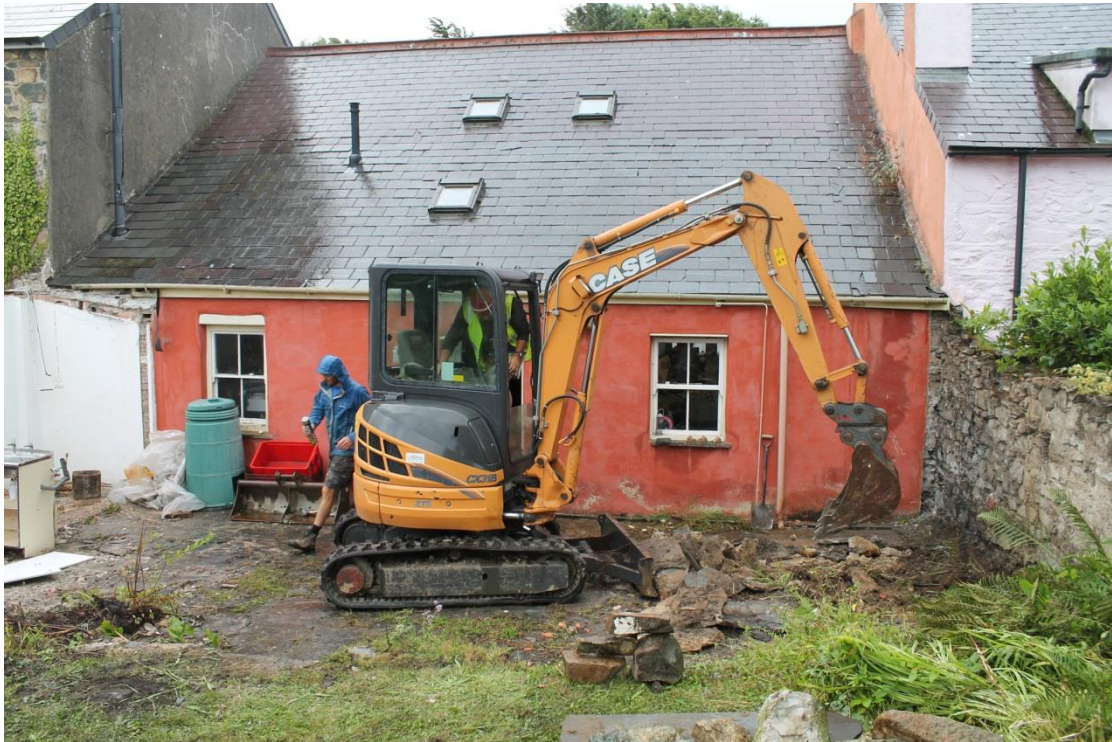
**Photo 1:** Photograph taken looking south showing the machining of the stone paving.

- 3.1.2 The brick outbuildings had been demolished before beginning the watching brief. During the watching brief the concrete bases and the stone paved area were removed using a small mechanical excavator with a grading bucket (Photo 1).

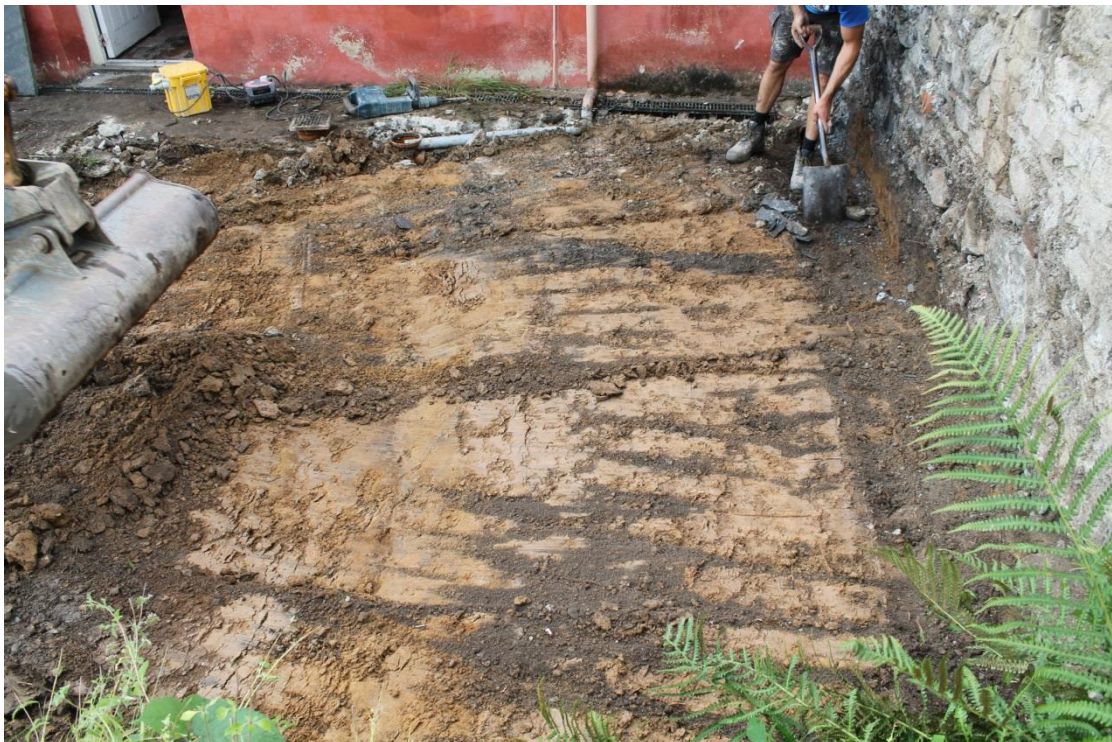
**Photo 2:** Photograph taken looking south showing the natural yellow/brown clay subsoil revealed after the removal of the stone paving. A modern drainage trench runs parallel with the west wall.

- 4.1.3 The removal of the stone paving exposed clean yellow/light brown sandy clay visible across the whole of the stripped area (Photo 2), representative of the area's natural fluvio-glacial sandy clays.

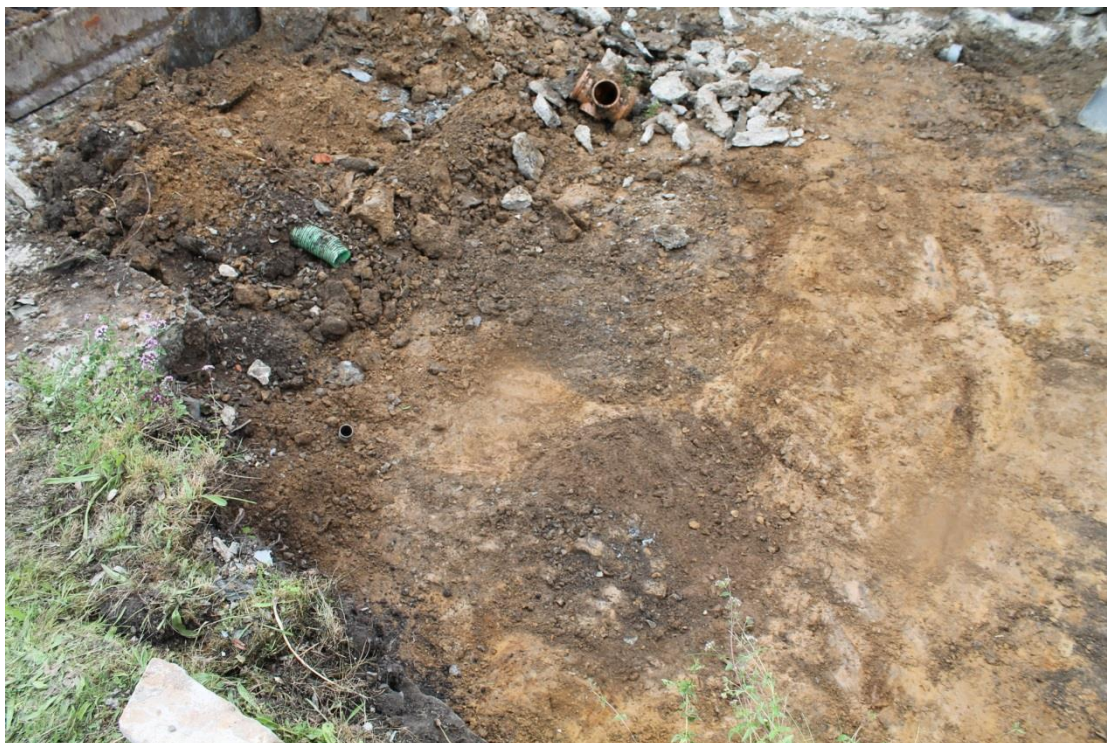
**Photo 3:** Photograph taken looking southeast showing evidence of the dark filled features emerging from under the stone paving

- 4.1.4 Cutting into this clay were a group of irregularly shaped, discrete features, visible as areas of darker, looser soil, in contrast to the surrounding lighter coloured clay, (Photos 3-6) that lay some 2.5m north of the north wall of the property. As the scheme of works did not necessitate removing the natural clay to greater depth there was no requirement to excavate any of the features as they would not be disturbed. Therefore the depths of the features were not determined.

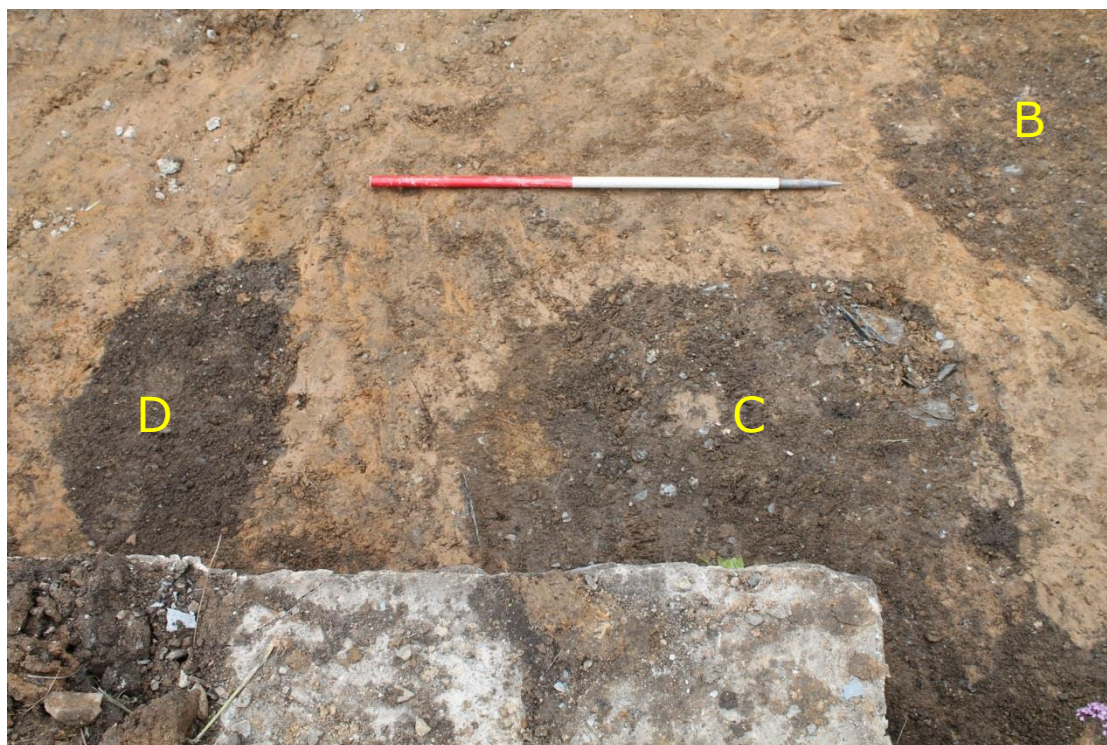
**Photo 5:** Photograph taken looking south showing features B, C & D.  
1m scale

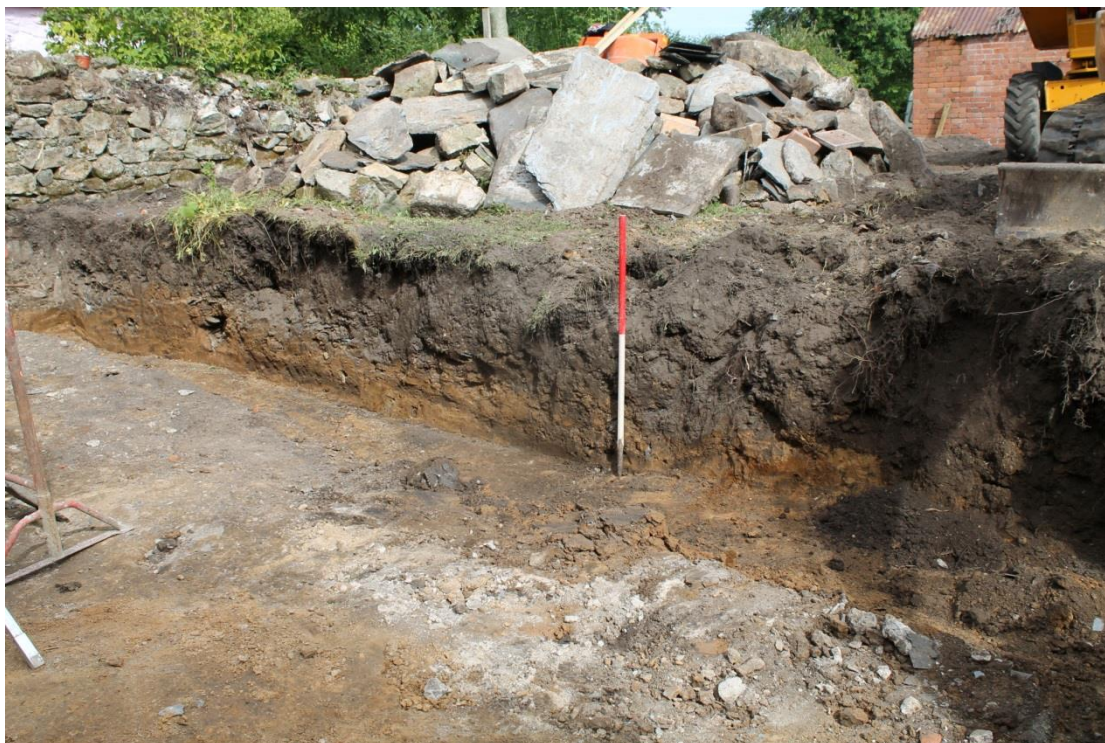
**Photo 7:** Photograph taken looking northwest showing the section left after the removal of the stone dwarf wall and steps. Note the small depressions cut into the natural yellow clay subsoil recorded in Figure 3. 1m scale

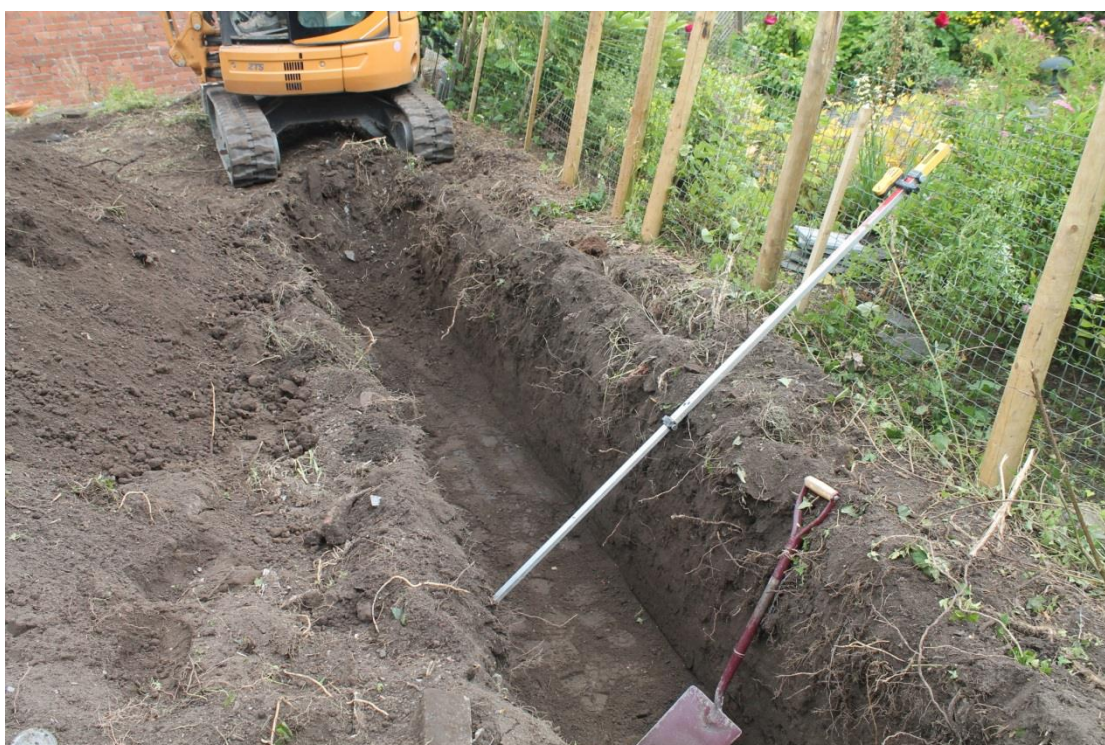
**Photo 8:** Photograph taken looking northeast showing the machine excavation of the eastern wall foundation trench.

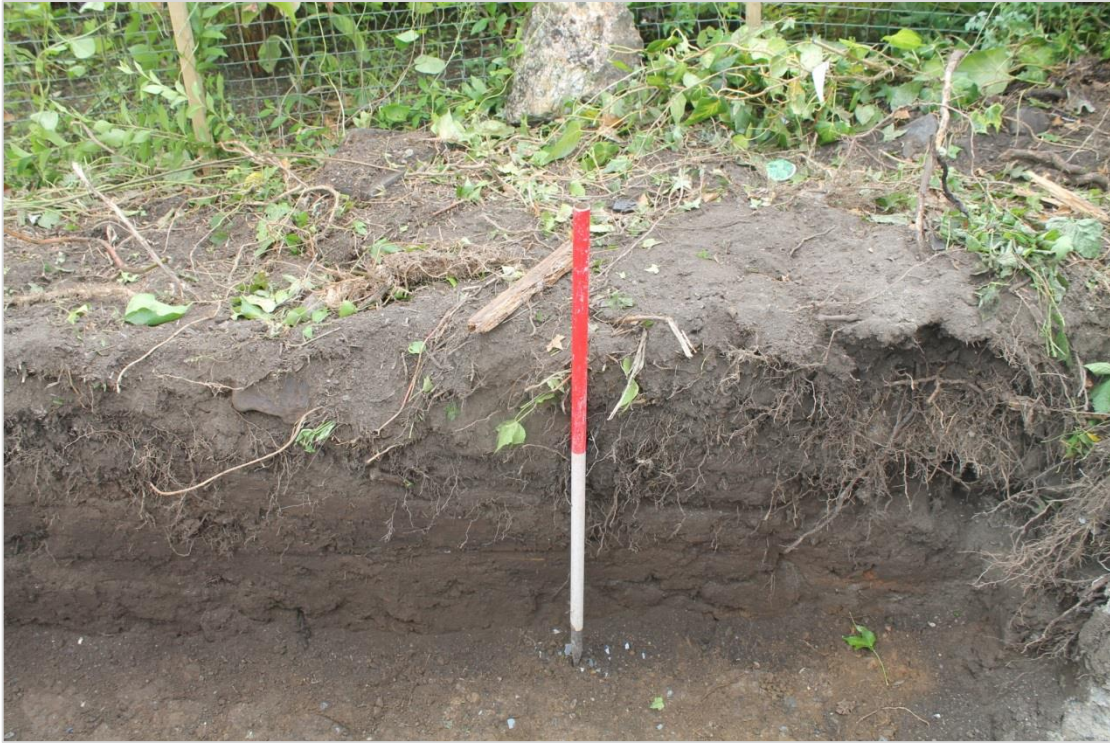
**Photo 9:** Photograph taken looking east showing the machine excavated wall foundation trench. Note the homogenous loamy garden soil above the natural yellow clay subsoil seen at the bottom of the trench. 1m scale

- 4.1.13 The topsoil visible in the eastern trench was a consistent loose dark brown loam/garden soil, measuring 0.80-0.90m in depth (Photo 9). This garden soil/topsoil was very clean and contained little in the way of inclusions, but at the interface with the clay subsoil was found a large sherd of 18<sup>th</sup> century pottery (D. Williams 2014, pers comm., 14 Sept).

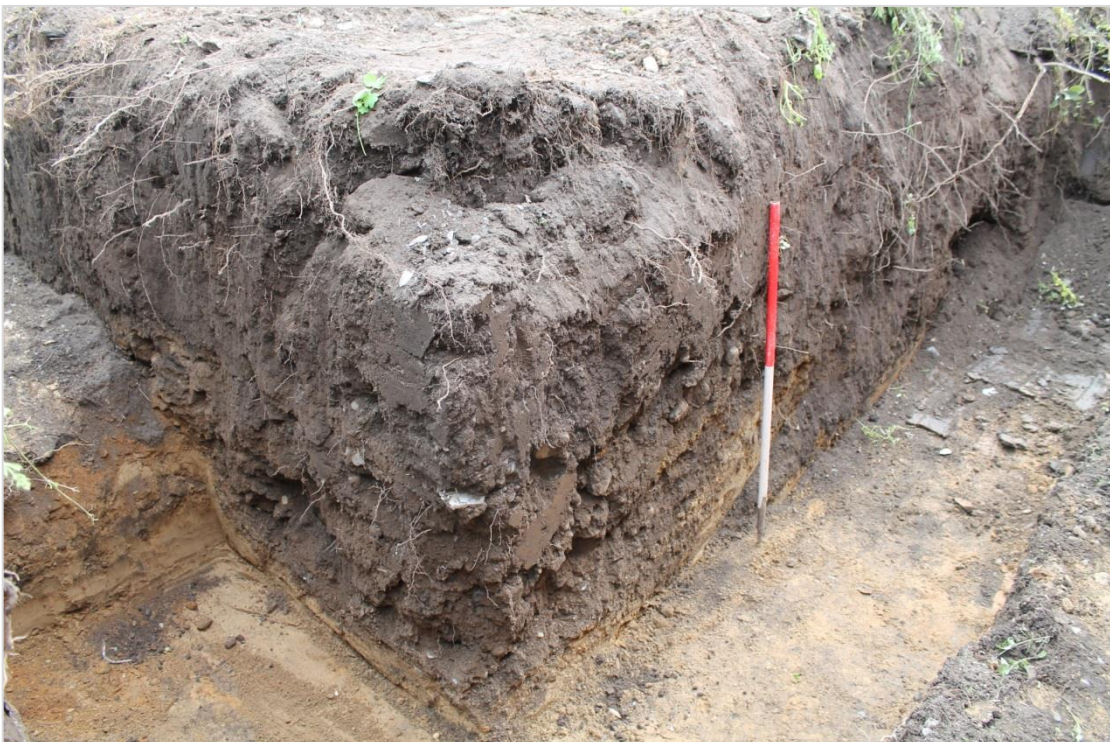
**Photo 10:** Photograph taken looking roughly southwest showing the corner of the eastern wall foundation trench and the trench parallel to the brick building. Note the drop in the natural clay subsoil at this position. 1m scale

- 4.1.14 Towards the northern end of the trench the clay subsoil dropped steeply downwards; to a depth of 1.60m below the surrounding ground level. However, this was at the location of a former retaining wall between the raised garden area and the brick building to the north that had been removed prior to the watching brief, so it was difficult to ascertain whether it was a foundation cut for an earlier retaining wall or possible evidence of a boundary ditch (Photos 10 & 11).

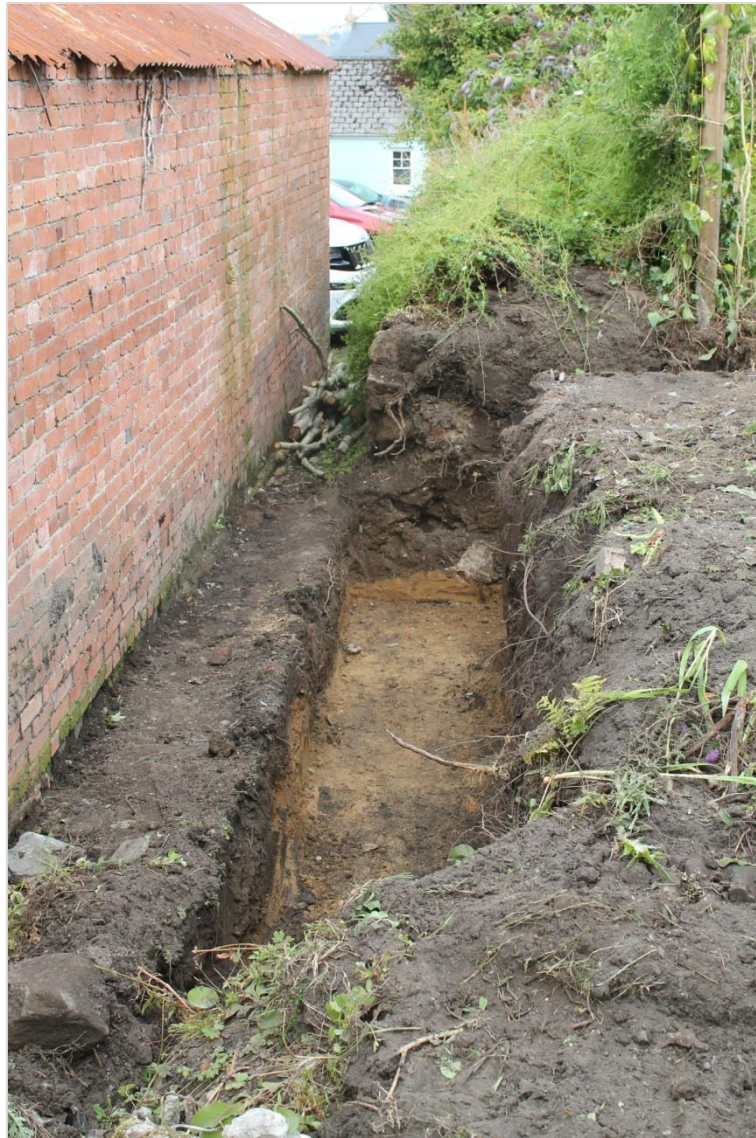
**Photo 11:** Photograph taken looking roughly east showing the trench parallel to the brick building.

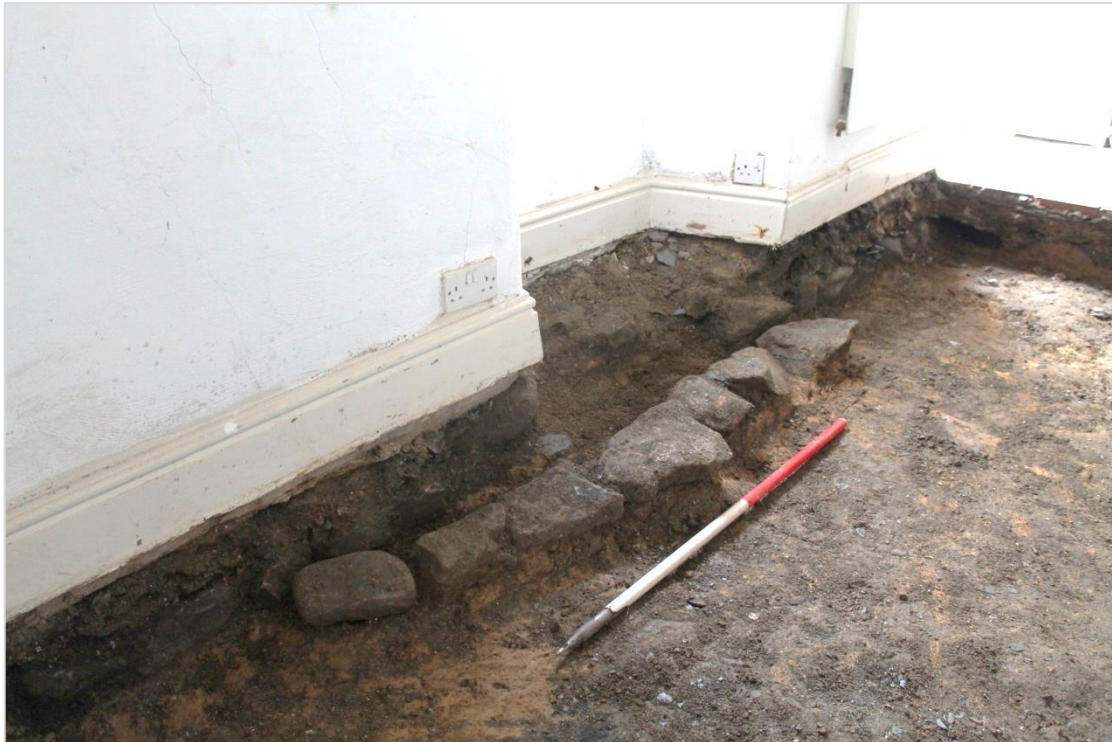
**Photo 12:** Photograph taken facing roughly northeast showing the line of stones revealed after the removal of a modern concrete floor and some underlying natural clay subsoil in the dining room. 1m scale

- 4.2.8 The stones were all faced to the north and in the area of the window embrasure there was evidence of a remnant of an opposing parallel line of faced stones. It is possible the stones formed a possible stone edged drainage gully, the stones having been packed tightly within a cut into the clay subsoil.

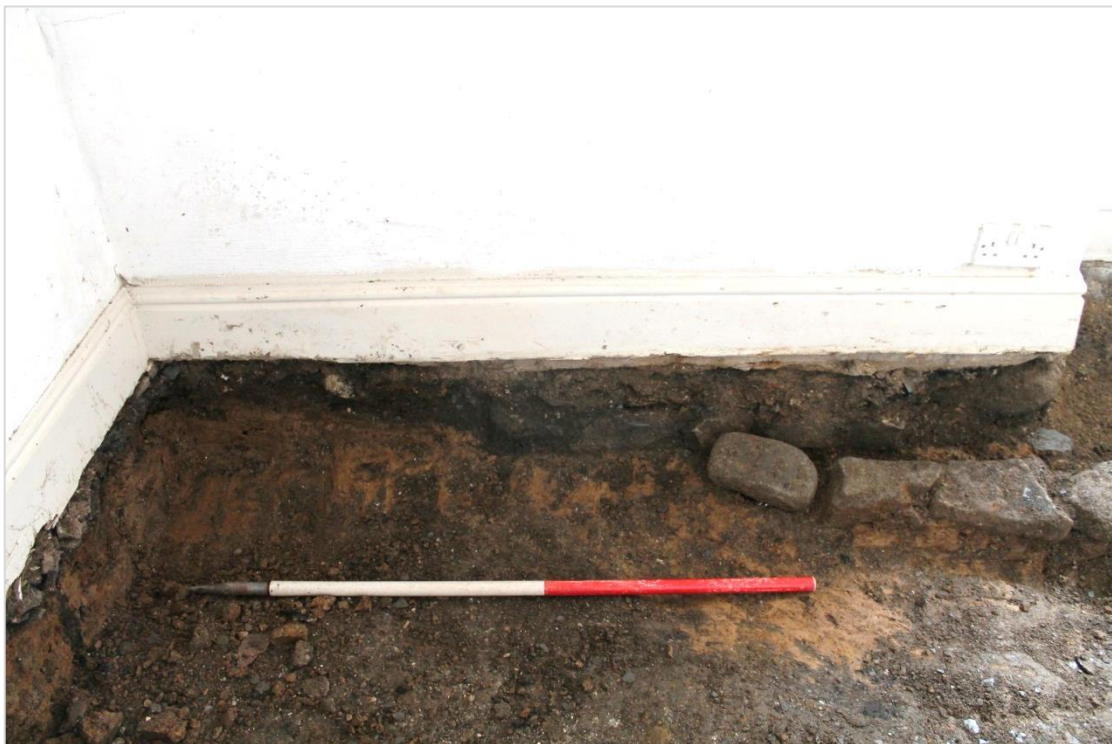
**Photo 13:** Photograph taken facing north showing the line of stones curving under the present north wall of Gwaunfa's dining room. 1m scale

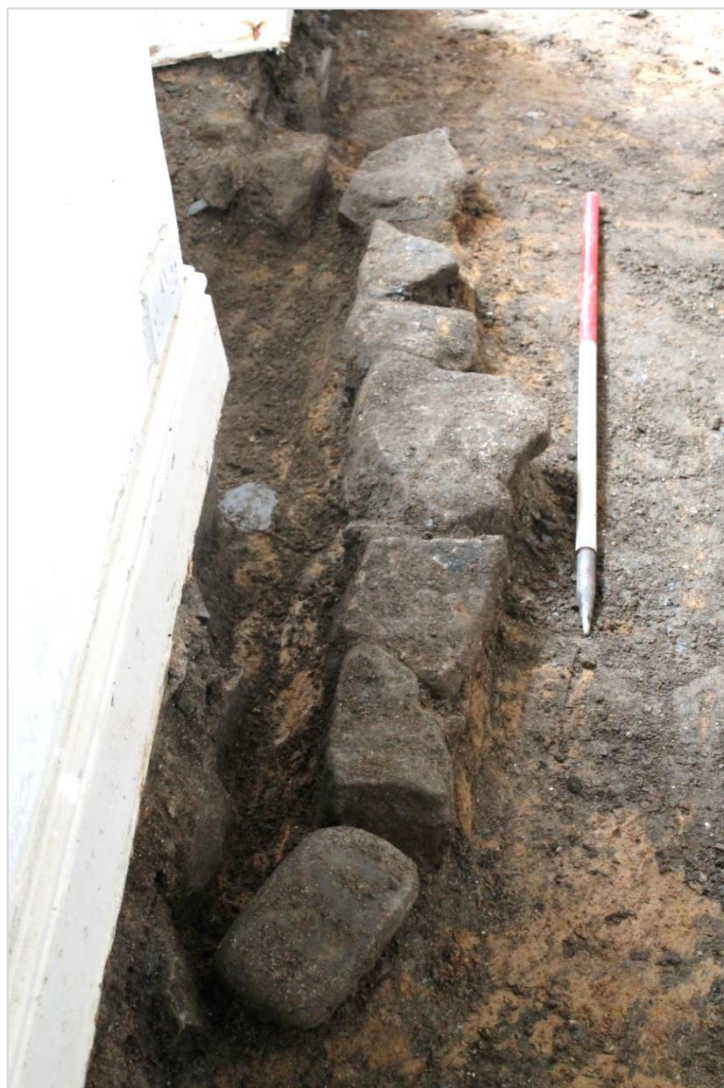
**Photo 14:**

Photograph taken facing east showing the line of stones revealed after the removal of a modern concrete floor and some underlying natural clay subsoil in the dining room. 1m scale

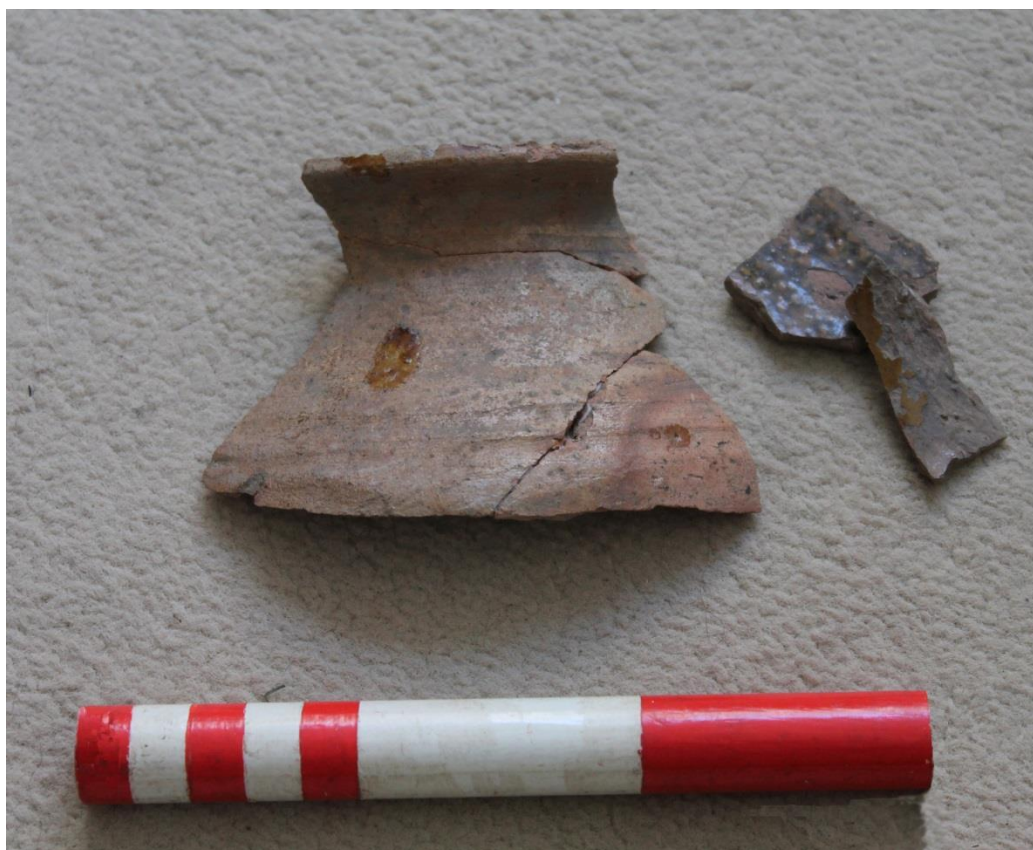
**Photo 15 & 16:** Two views of the pottery sherds from the top of features B & C – identified as possible 16<sup>th</sup> century Newport ware. 0.15m scale

- 4.1.7 Four sherds of pottery were recovered from the top fills of features B & C. Three sherds were of probable 16<sup>th</sup> date and could possibly come from a local Newport pottery production site; (Photos 15 & 16) the remaining sherd of local Dyfed Gravel Tempered ware is possibly 17<sup>th</sup>/18<sup>th</sup> century date (D. Williams 2014, pers comm., 14 Sept).
