INSTALLATION OF ELECTRICAL CABLE AT MANORBIER CASTLE, MANORBIER, PEMBROKESHIRE: ARCHAEOLOGICAL WATCHING BRIEF (NGR SS 0638 9779)

Prepared by Dyfed Archaeological Trust
For: Manorbier Castle

RHIF YR ADRODDIAD / REPORT NO 2014/37
RHIF Y PROSIECT / PROJECT RECORD NO. 107507

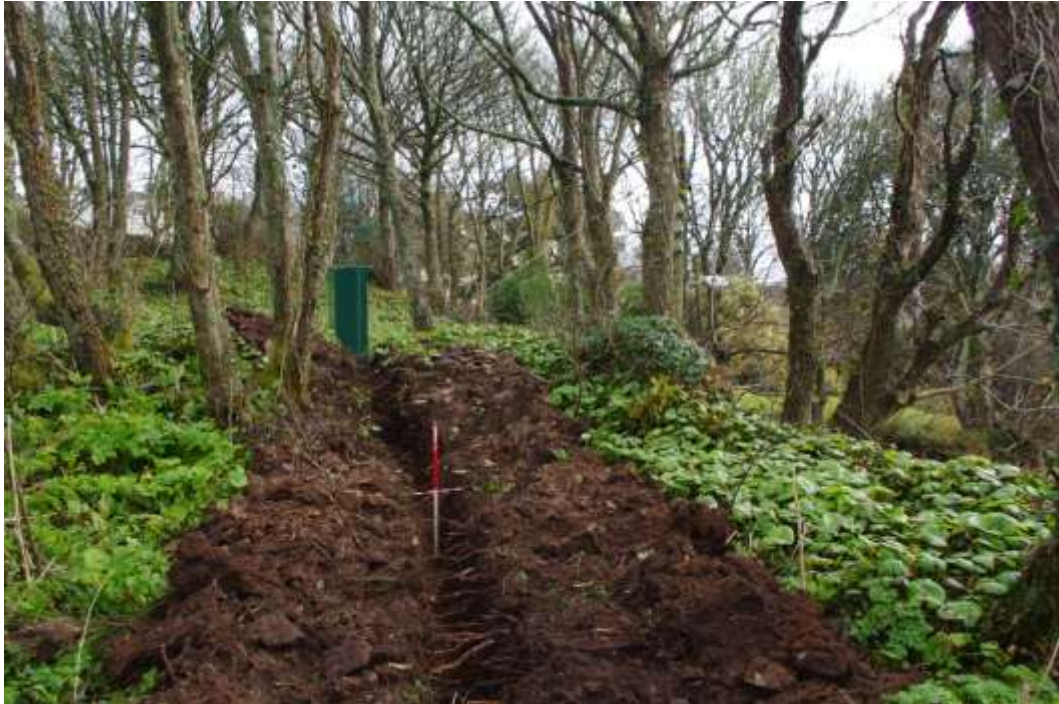
Photo 1: View roughly east along Section 1 of cable trench towards substation transformer (green box) through woodland

- 4.1.1 This part of the route started at an existing substation transformer box in the eastern part of the castle grounds (Photos 1 & 2) running roughly west through an area of rough woodland on the southeastern side of the castle for a length of around 40m.

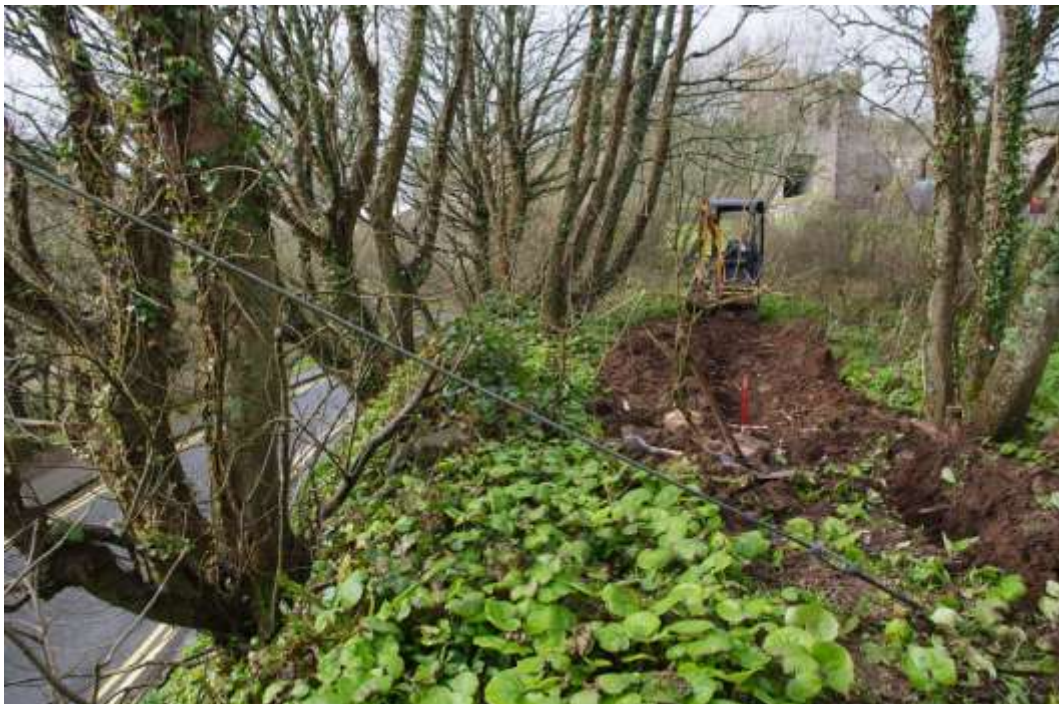
Photo 2: View roughly west along Section 1 of cable trench through woodland towards castle, with drop to road on south side

- 4.1.3 The trench was excavated through relatively deep topsoil, heavily disturbed by root action, around 0.60m in depth at the eastern end of the trench. The topsoil was dark, reddish brown and quite friable with a large amount of stone rubble within it. Occasional patches of mortar were also noted at the eastern end of the route where it lay closest to the revetment wall alongside the road to the south (Photo 2).

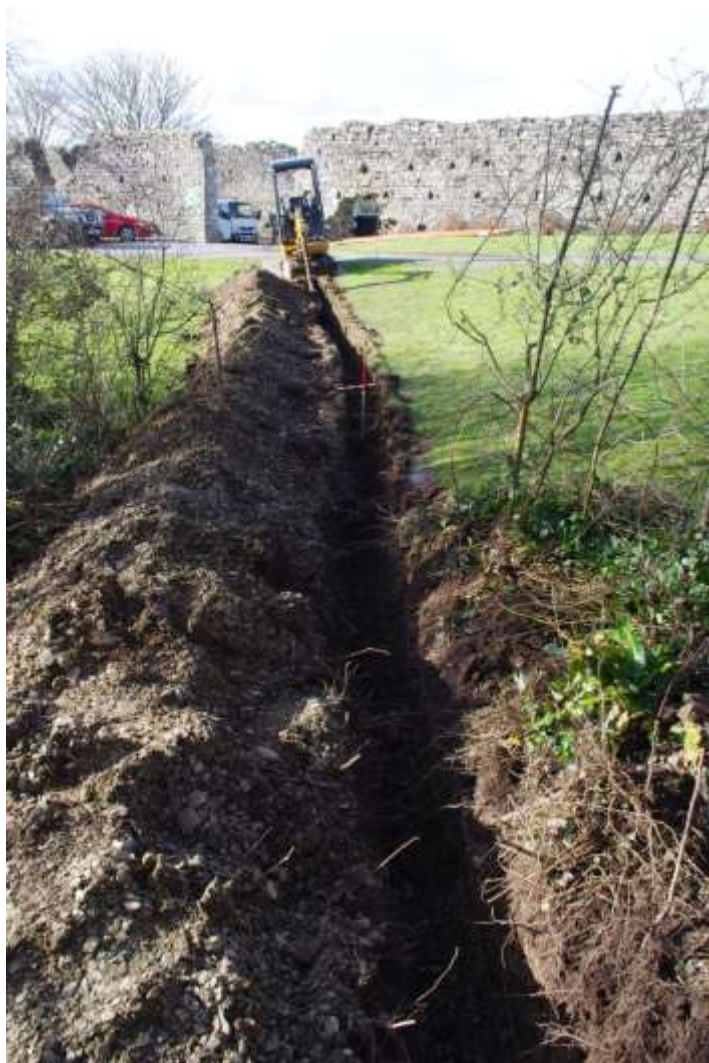
Photo 3: View northwards along Section 2 of the cable trench across grassed area from woodland towards barn

- 4.2.1 This part of the cable trench ran in a northerly direction from the woodland across the grassed area and driveway into the castle, towards the barn. It ran for some 25m (Photos 3, 4 & 5).
- 4.2.2 The excavation of the southern end of this part of the cable was carried out, but the northern stretch and that beneath the castle driveway was observed following excavation.
- 4.2.3 The trench was around 0.60m deep, excavated through topsoil with the underlying natural subsoils beneath. The natural ground was somewhat stonier than seen in Section 1.
- 4.2.4 No archaeological features or finds were observed within this stretch of the cable run.

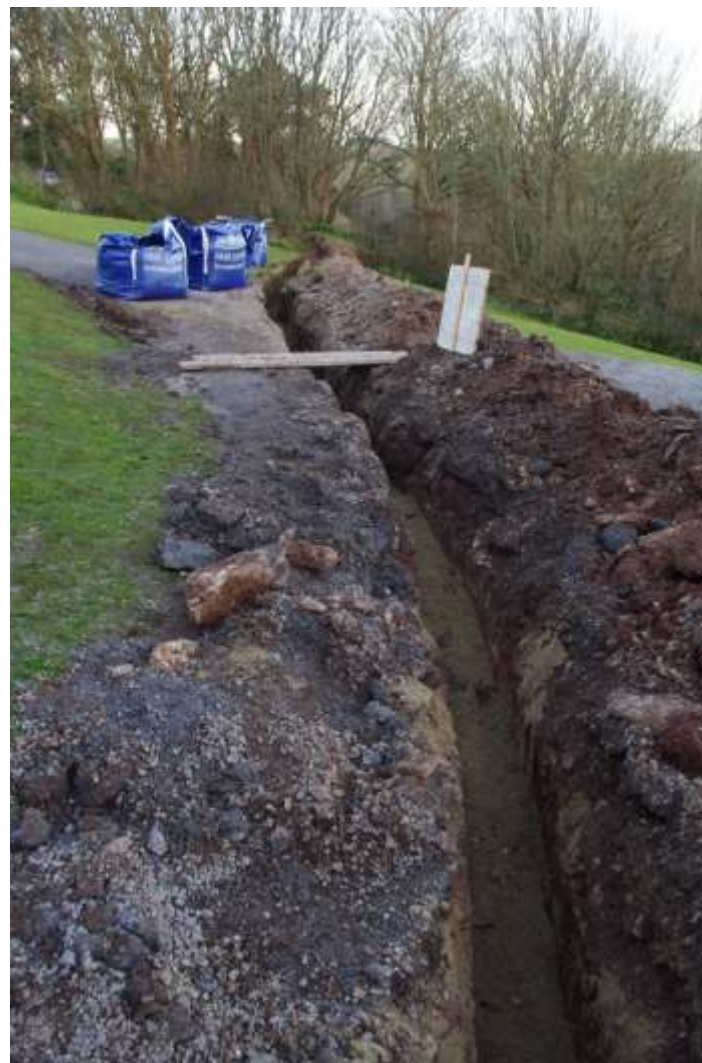
Photo 4: View southwards along Section 2 of cable trench across grassed area and driveway to castle towards woodland (following sand infill in readiness for cable)

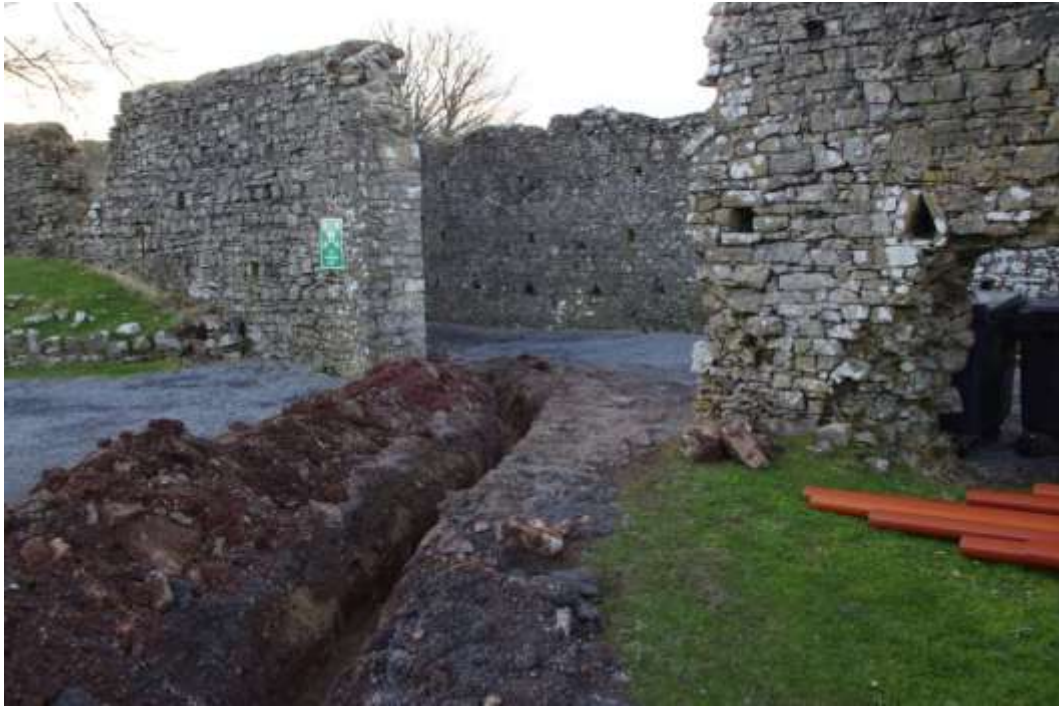
Photo 5: End of Section 2 of cable run, where it turns to the west through the former barn

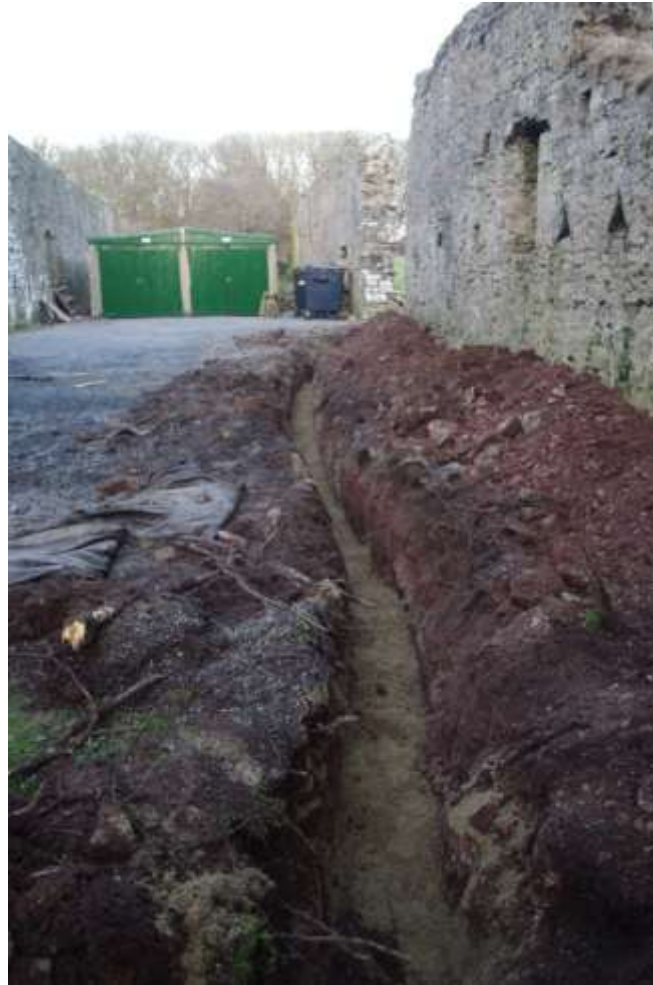
Photo 6: View east along Section 3 of the cable trench through the former barn

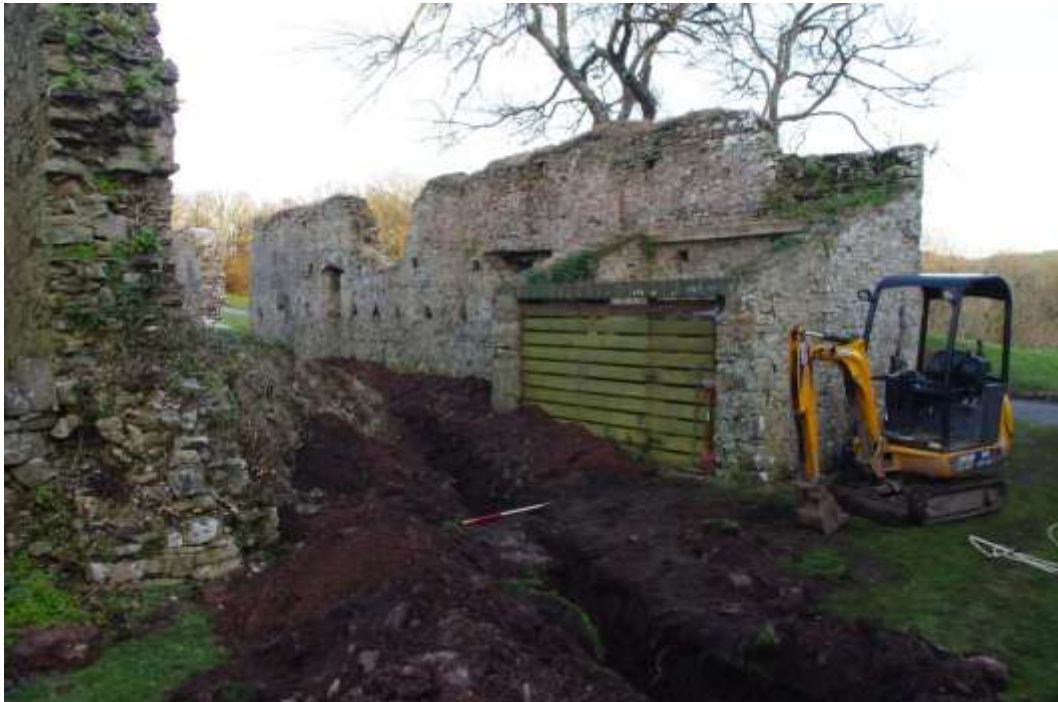
- 4.3.5 On the northern side of the cable run at the western end of the barn the ground level rose by over 1m in height where it appeared stone rubble had been piled up (Photos 7 & 8).

Photo 7: View southeast at western end of barn showing cable trench and line of observed wall (marked by the 1m scale)

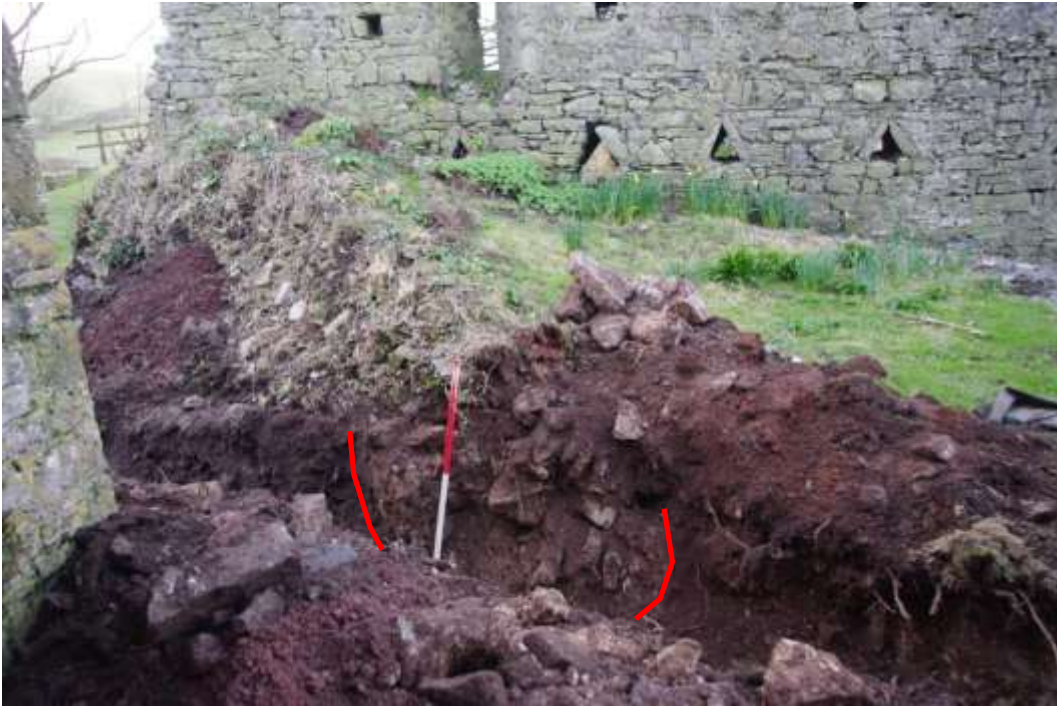
Photo 8: Rubbish pit observed at the western end of the barn (marked by 1m scale and edges highlighted in red)

- 5.4 Section 3 of the cable trench ran through the stone barn on the northeastern side of the castle. For the majority of its run no significant remains were identified. A post medieval rubbish pit and other post-medieval debris were noted within the trench. At the western end of Section 3 the former western wall of the barn was identified. The wall was of a fairly substantial width, although the footings were relatively shallow. It appeared that when the wall had been demolished it was levelled off to a depth below ground level and buried. It was possible to pass the cable beneath the wall due to the shallow depth of the footings and thus the works caused minimal damage to the structure.

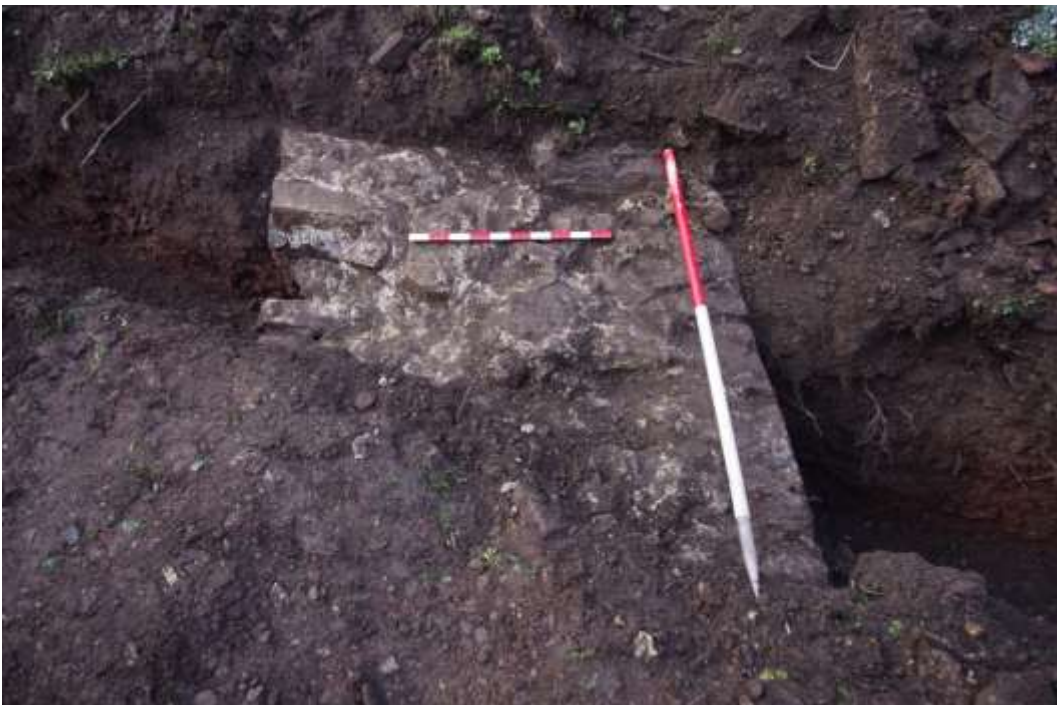
- 4.3.6 Excavation of the cable trench uncovered the wall footing of the former western wall of the barn (Photos 7, 9, 10, 11 & 12)

Photo 9: View south along exposed western wall of barn
in Section 3 of cable trench

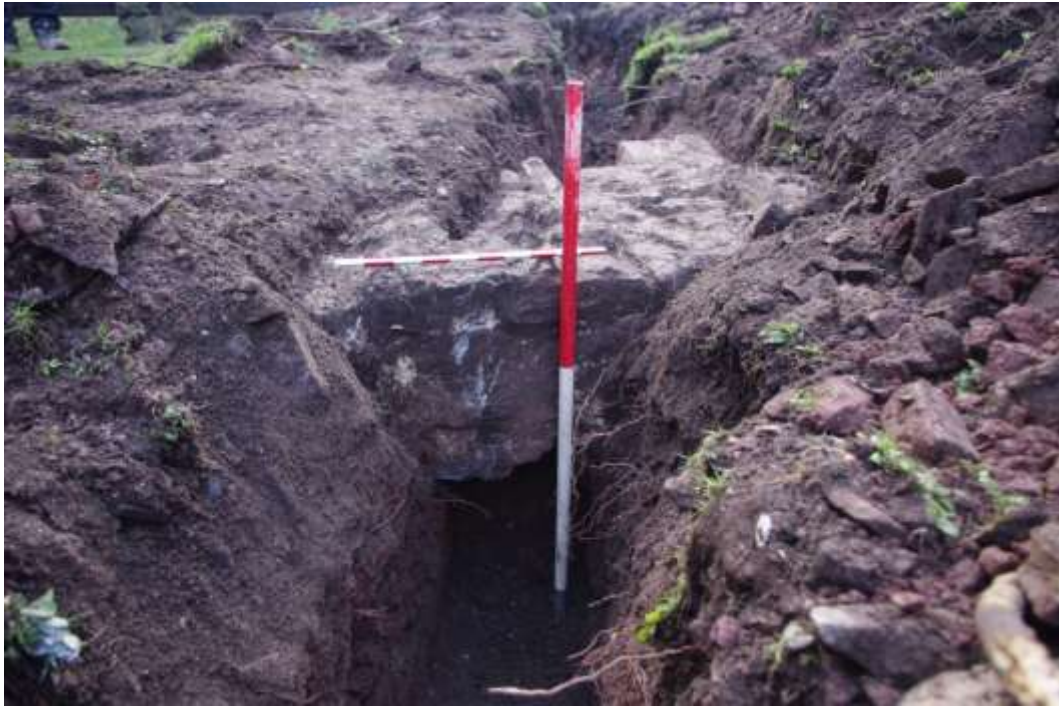
Photo 10: View east of exposed western wall of barn in Section 3 of cable trench showing shallow depth of wall and the void for the cable excavated beneath

- 4.3.8 The wall had evidently been taken down and levelled sometime in the past. It survived to a depth of 0.40m, comprising two courses of stone lying on top of a thin mortar and rubble stone lower base (0.14m maximum depth) (Photo 10). It was presumably the former southwestern end of the former barn buildings (Figure 6).
- 4.3.9 It was agreed with the site contractors that the wall footing would be retained and that the cable would be passed beneath the wall, which was possible due to the shallow depth of the surviving wall footing.

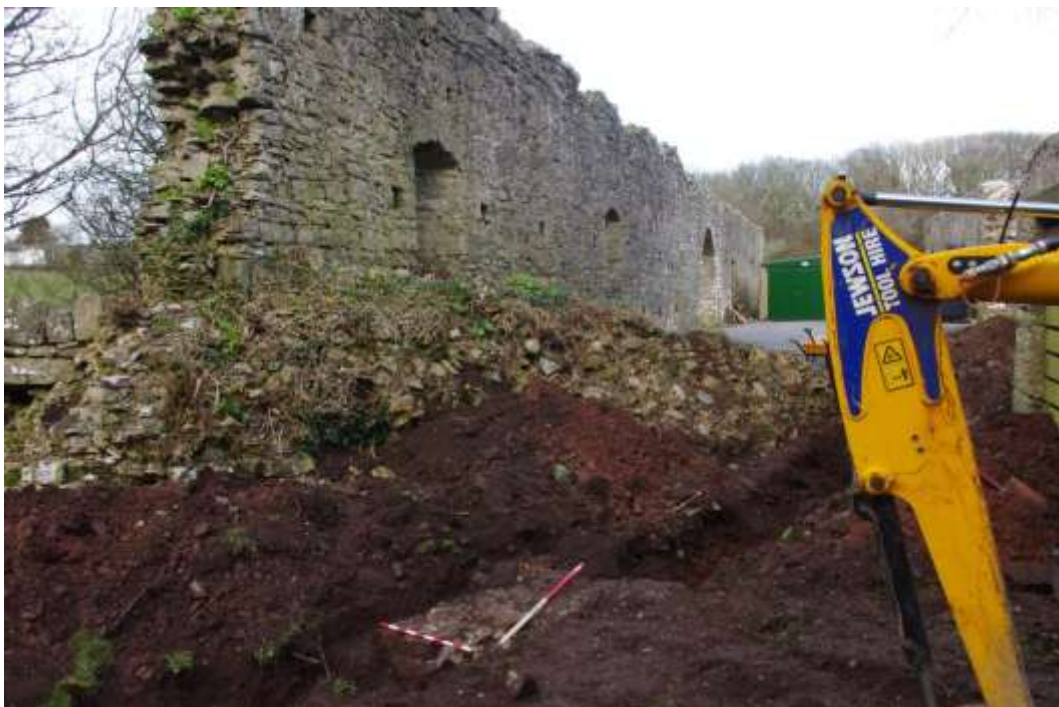
Photo 11: View northeast showing footing for western wall of barn in relation to north wall

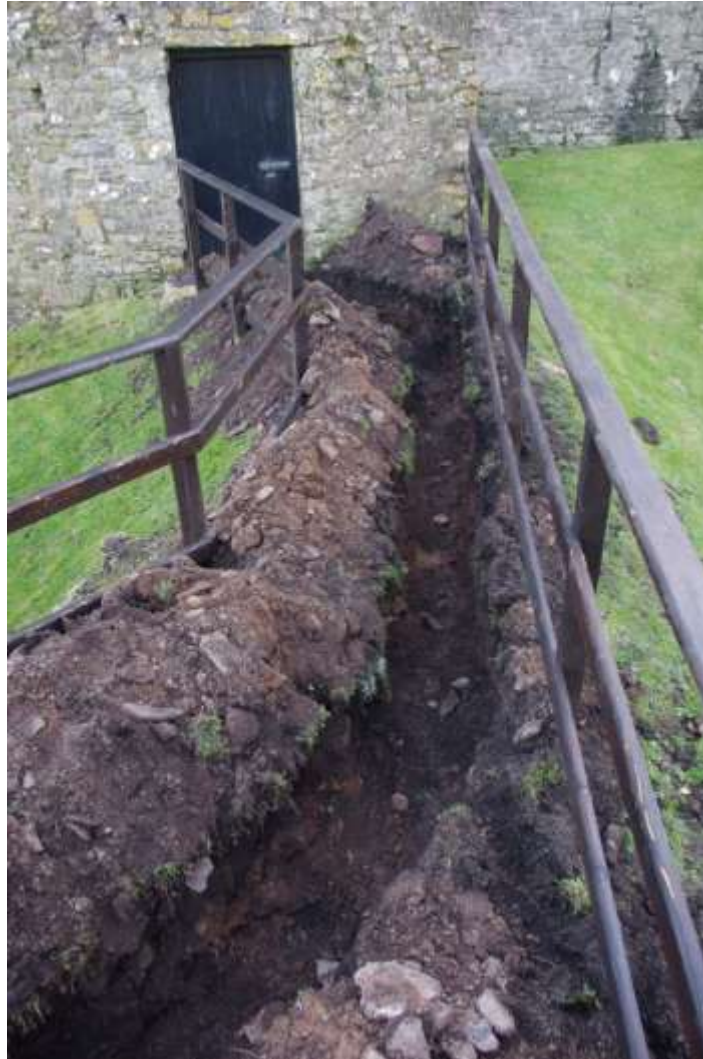
- 4.4.1 This section of the cable trench crossed the castle moat ditch via a modern causeway across the ditch for a length of approximately 5m (Photo 12). The trench was around 0.50m deep and cut through a mixed re-deposited topsoil and rubble layer (the causeway material).
- 4.4.2 The causeway had evidently been created in more recent years to provide a second access across the castle moat to a doorway through the inner precinct wall into the castle. The moat may date from the Civil War period when the castle defences were improved, although it seems most likely that it would have been a redevelopment of an existing medieval moat.

Photo 12: Line of cable run through raised ground across the former moat, looking southwest

- 5.6 Section 4 of the cable trench ran across the post-medieval causeway that had been constructed across the ditch surrounding the eastern side of the inner ward of the castle. The ditch is said to date from the Civil War period and the causeway from a later period in the castle's history. Existing cables and services cross over this causeway, although they were not seen during the watching brief.

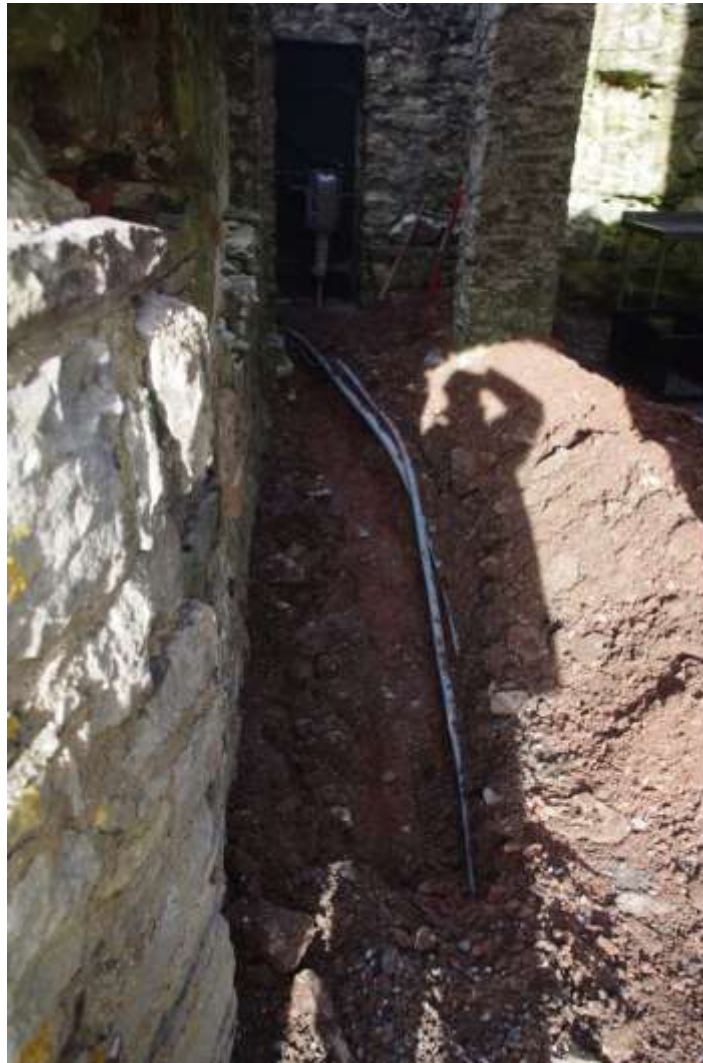
- 4.5.1 The cable run then passed through the doorway in the inner curtain wall and crossed through a former building and out into the courtyard area of the castle. This stretch ran for around 8m (Photo 13).
- 4.5.2 This stretch of the cable run was very shallow (less than 0.30m in depth) and followed the line of existing service runs (Photo 13) through previously disturbed ground. No significant archaeological remains were disturbed in this stretch of trench.

Photo 13: Cable run through buildings on inside of inner curtain wall, following the route of existing services, looking northeast

- 5.7 The cable trench then passed into the inner wall of the castle following the line of existing service runs through buildings on its eastern edge (Section 5). The trench was very shallow in this area (as were previous service runs) and caused no further disturbance to buried archaeological remains. Section 6 of the run followed the same existing service runs across the lawned area of the inner ward and again caused no disturbance to archaeological remains.

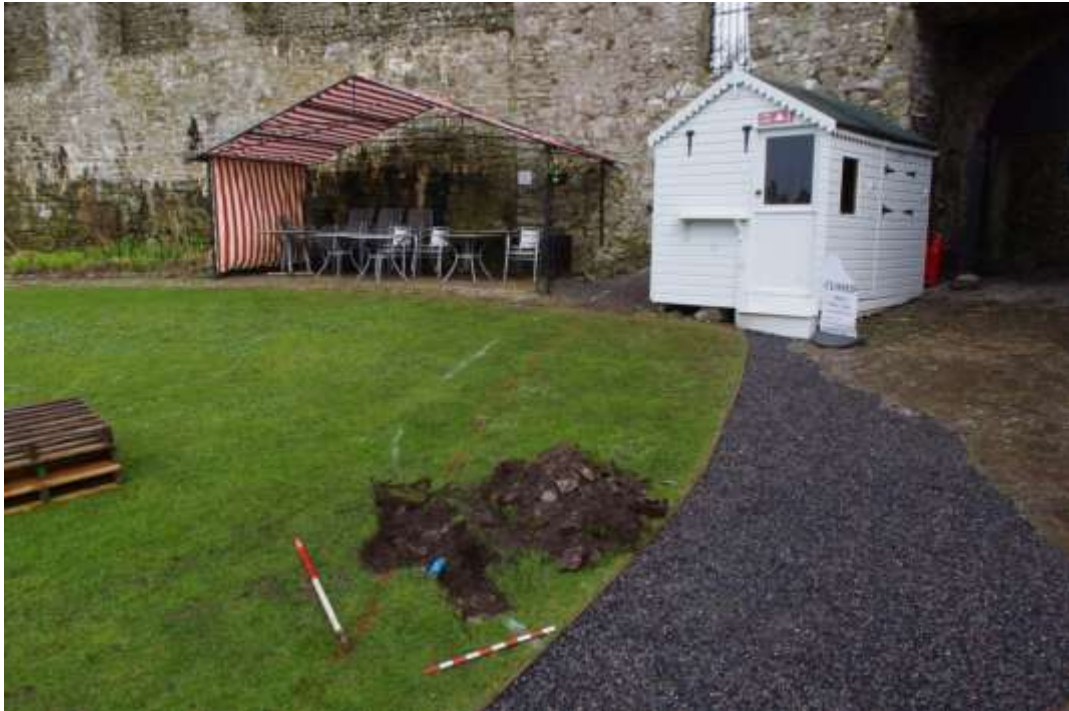
- 4.6.1 The next stretch of the cable run continued to follow the existing service trench from the buildings on the inside of the curtain wall and running across the central grassed area towards flower beds. This stretch of the run was around 12m in length.
- 4.6.2 This part of the cable run was not archaeologically monitored as it was clear that it followed the existing service trench. This was confirmed in a test pit excavated through the lawned area (Photo 14).

Photo 14: Section 6 of the cable run across the lawn within the inner ward of the castle. Note the test pit with visible existing service. Looking northeast.

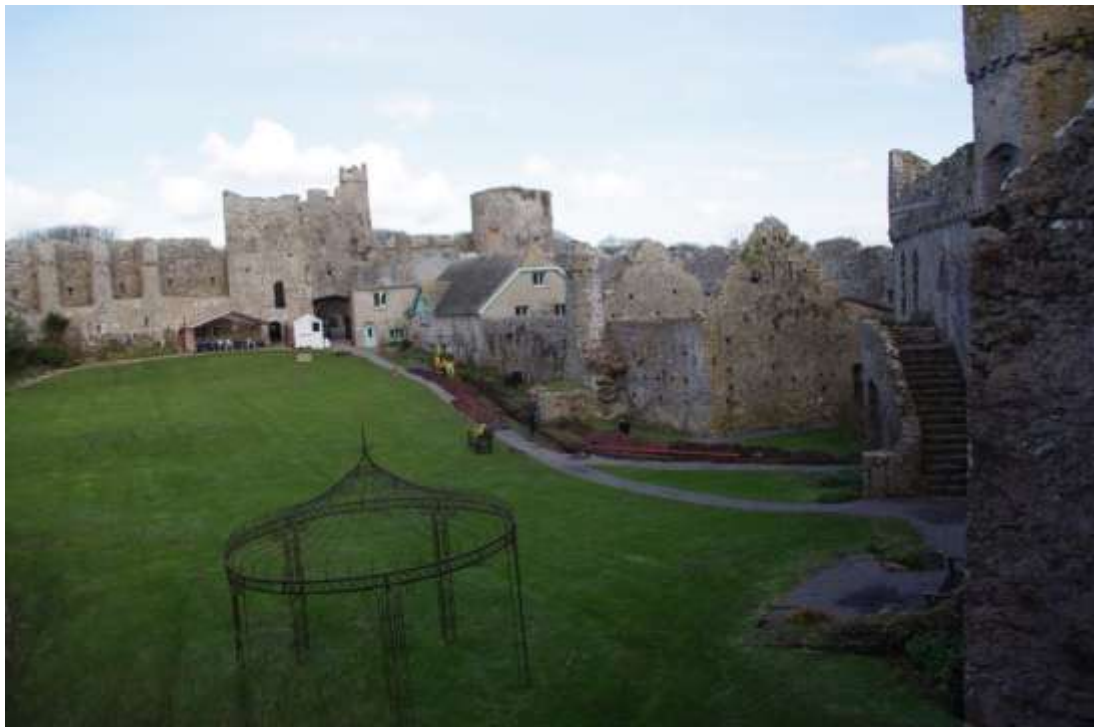
- 4.7.1 The cable trench then crossed through the flower beds on the northern side of the southern range of buildings within the castle for a length of approximately 30m (Photo 15). The cable route was aligned roughly east to west.

Photo 15: View east across inner ward of castle showing Section 7 of the cable run across the northern edge of the flower beds

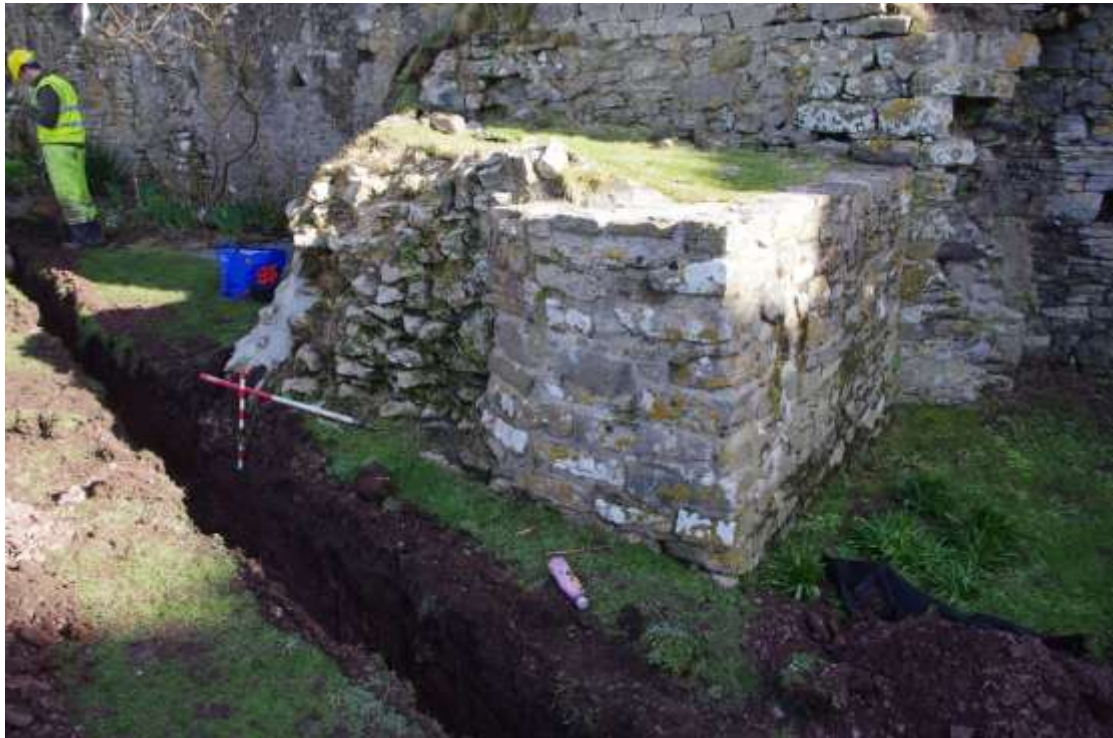
- 4.7.2 At the western end of Section 7 the cable trench passed adjacent to a large masonry block protruding from one of the buildings on the inside of the inner curtain wall (Photos 16 & 17).

Photo 16: View southeast across Section 7 of the cable trench showing substantial masonry block

- 4.7.3 The masonry block appeared to represent a substantial wall projecting into the centre of the inner ward of the castle. The excavated cable trench clearly demonstrated that the masonry did not continue into the trench route. It appeared to be neatly faced at its eastern end (Photo 17), where it was exposed in the edge of the cable trench, possibly suggesting an entranceway through a structure.
- 4.7.4 The trench in the section through the flower beds was excavated to a maximum depth 0.5m through very dark topsoil which had been subject to cultivation. The trench was deeper at the masonry block at its western end, where undisturbed natural subsoils were present beneath the stonework and across the base of the trench (being around 0.7m to 0.8m deep in this part).

- 5.9 At the western end of Section 7 the cable run passed adjacent to a large stub of masonry projecting from the building range along the southern side of the inner ward of the castle. The cable trench uncovered a small part of the face of this wall stub which indicated a neatly faced wall below ground level, implying that the wall stopped in this location, possibly for a doorway into a former building. No indication of a threshold into the building was noted, nor any sign that the wall continued in any form across the cable trench (unless present at a level below the base of the trench), although this is unlikely due to the presence of an outcrop of bedrock immediately west of the wall.

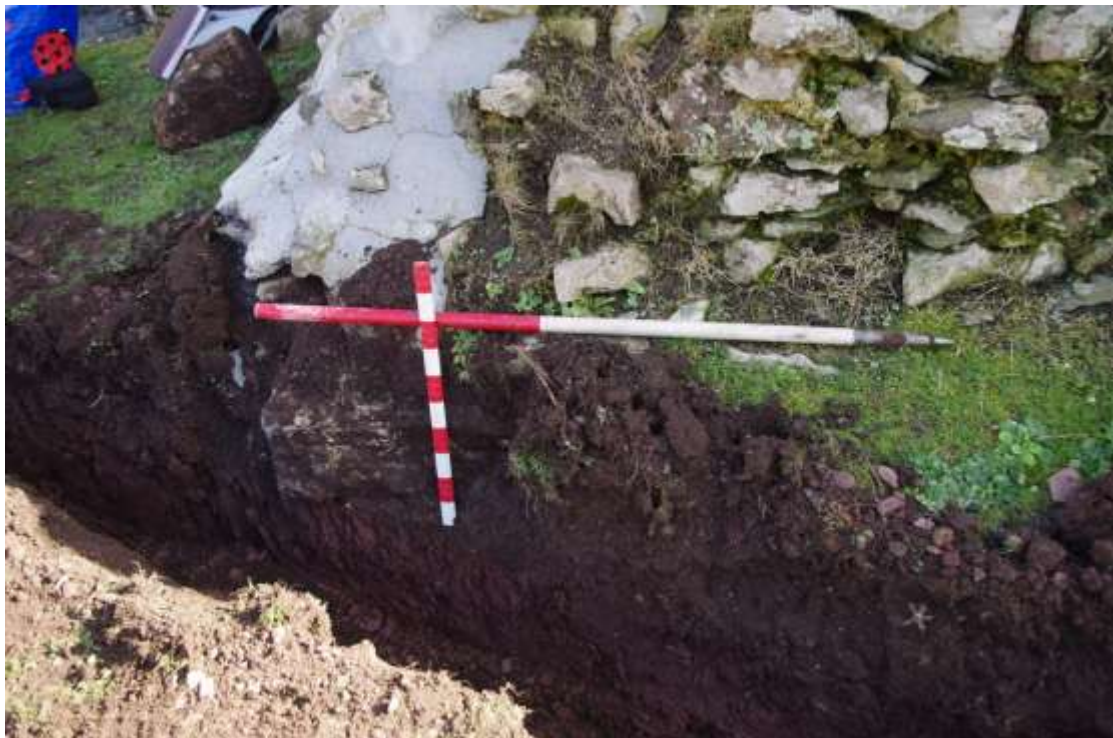
Photo 17: View southeast across Section 7 of the cable trench showing detail of the exposed part of the masonry block in the side of the trench

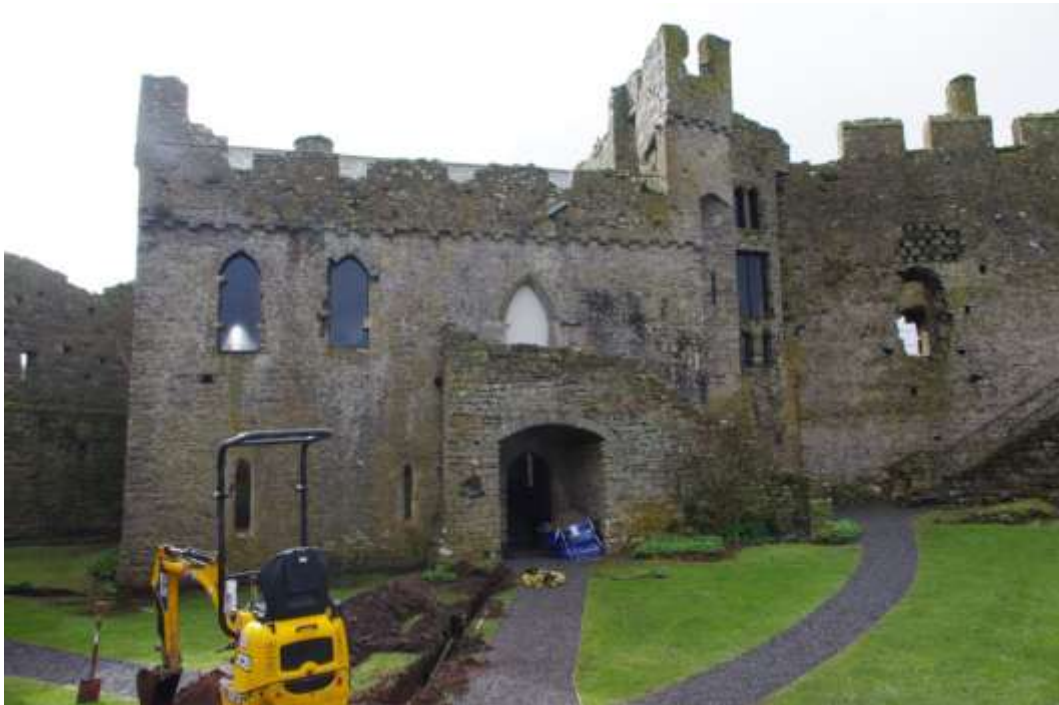
- 4.8.1 The final stretch of the cable run led down from the masonry block, directly to the doorway into the Crypt, a length of approximately 14m (Photo 18).

Photo 18: Section 8 of the cable run looking southwest towards 'The Crypt'

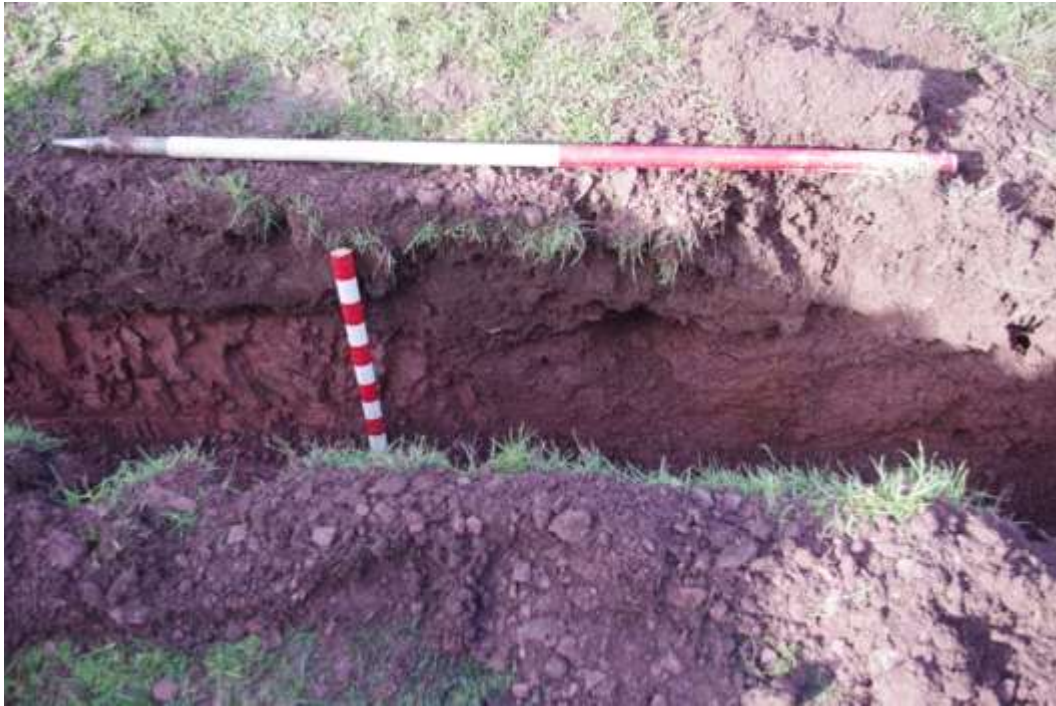
- 4.8.2 At the northeastern end of Section 8 a natural outcrop of the natural red sandstone bedrock was exposed around 0.2m below the ground surface (Photo 19). The bedrock outcrop was only visible for around 1.5m length before it dropped down quite sharply to the southwest.
- 4.8.3 Beyond this bedrock outcrop the material removed from the cable trench was very loose reddish brown topsoil containing numerous fragments of small stones, pieces of pottery (dating from the post-medieval to modern period) and occasional pieces of animal bone. The natural ground surface was not exposed within the remainder of the trench. No significant archaeological remains were noted within the trench.

Photo 19: Red sandstone bedrock exposed in the northeastern end of Section 8

- 5.10 Section 8 ran from adjacent to the stub of wall down to the Crypt. As mentioned above, red sandstone bedrock was revealed at a shallow depth below the ground surface at the eastern end of this section. Southwest of this the ground level appeared to dip substantially. The material excavated for the remainder of the trench comprised loose topsoil suggesting the area may have been backfilled or levelled in the post-medieval period. Other than finds of post-medieval ceramics and animal bone, no significant archaeological remains were identified, such as former wall lines. The base of the trench beyond the bedrock outcrop did not reach the natural ground surface so it is very possible that significant archaeological remains could lie below the base of the excavated trench.

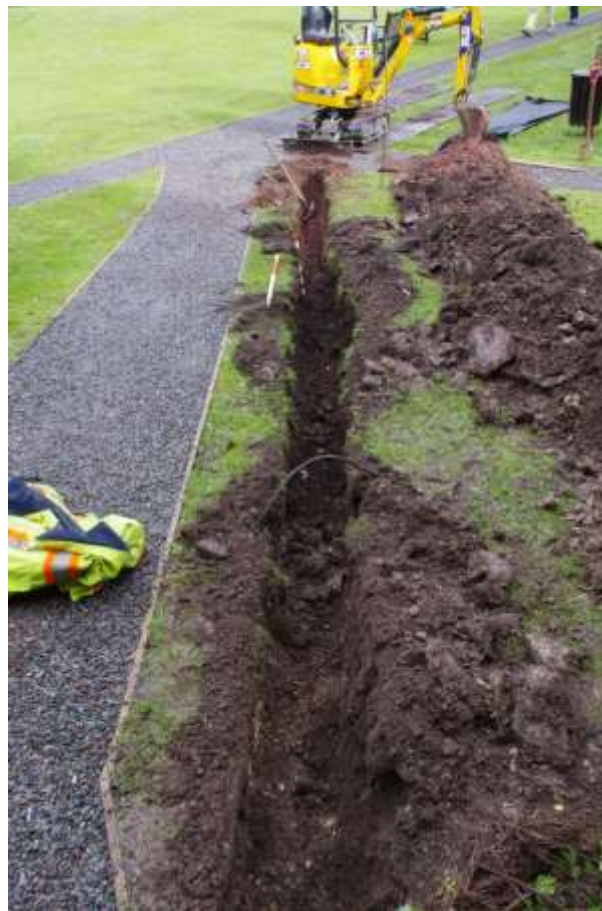
Photo 20: Northeast view along Section 8 showing loose brown soil across most of the trench, with the red sandstone bedrock at the northeastern end
