# **DELTA LAKES, LLANELLI, CARMARTHENSHIRE: ARCHAEOLOGICAL WATCHING BRIEF (NGR SS 5083 9851)**

Prepared by Dyfed Archaeological Trust  
For: Carmarthenshire County Council /  
Arup

RHIF YR ADRODDIAD / REPORT NUMBER. 2014/43  
RHIF Y PROSIECT / PROJECT RECORD NO. 107513

Hydref 2014  
October 2014

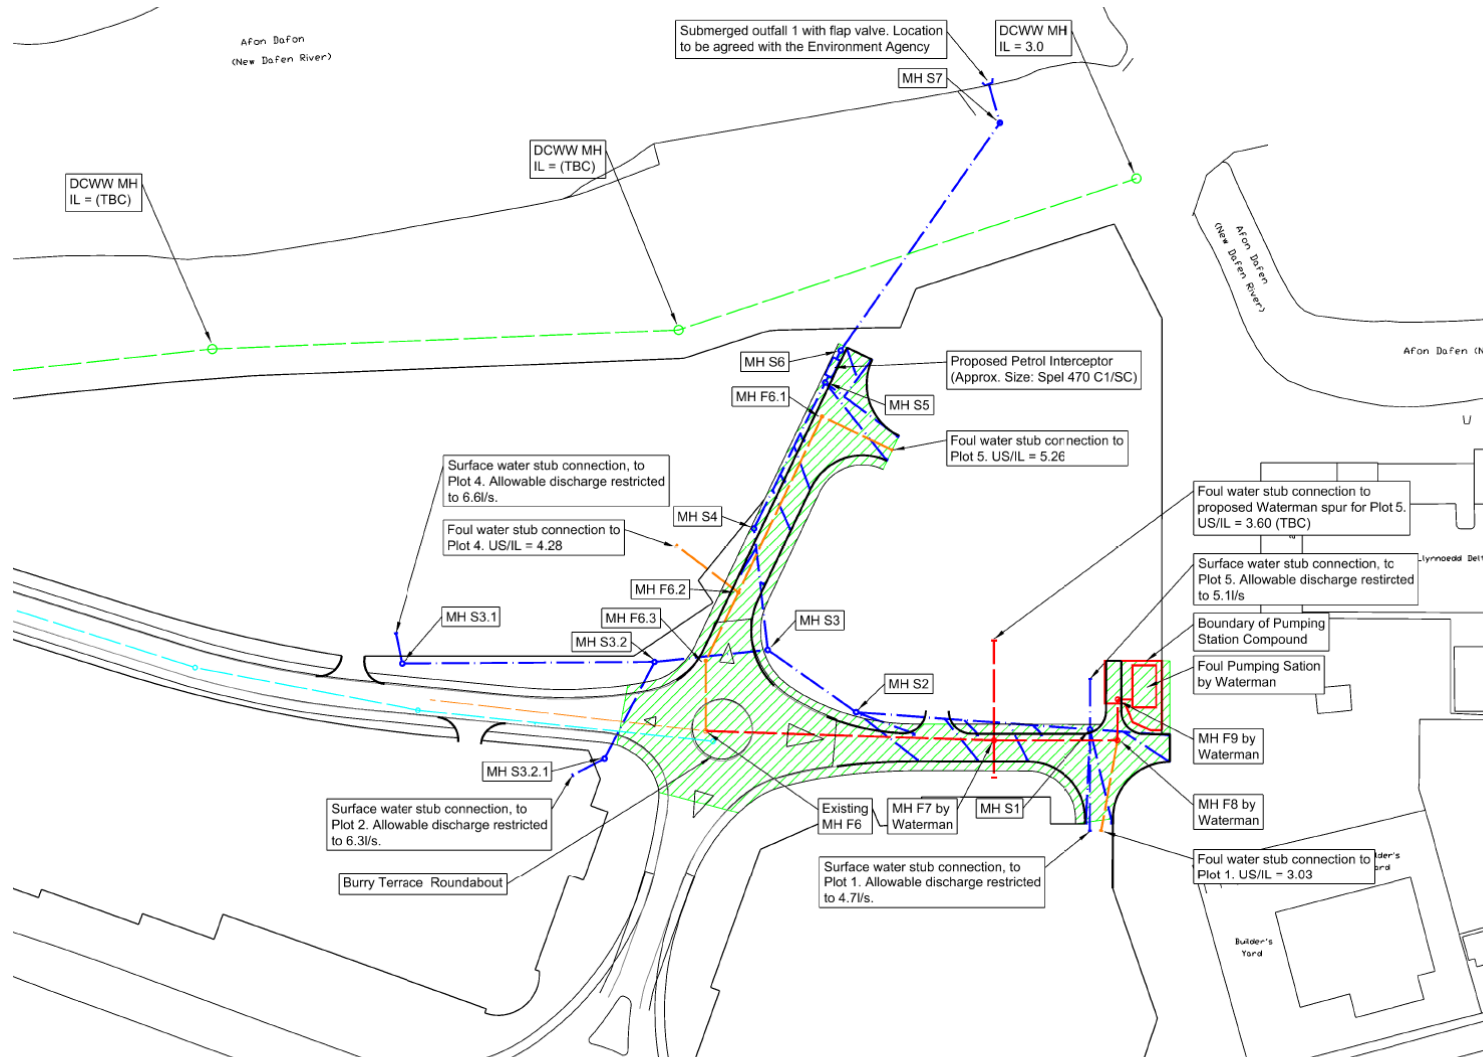
**Figure 2:** Plan showing development proposals at the Delta Lakes site, Llanelli development (as supplied by Arup – detail of plan SK001-10)

1.1.6 The proposed development works at Delta Lakes include (Figure 2):

- A foul sewage pumping station and directly associated utilities;
- Earthworks and access roads associated with the above (hatched in green on Figure 2); and
- Foul and storm drainage associated with the above.

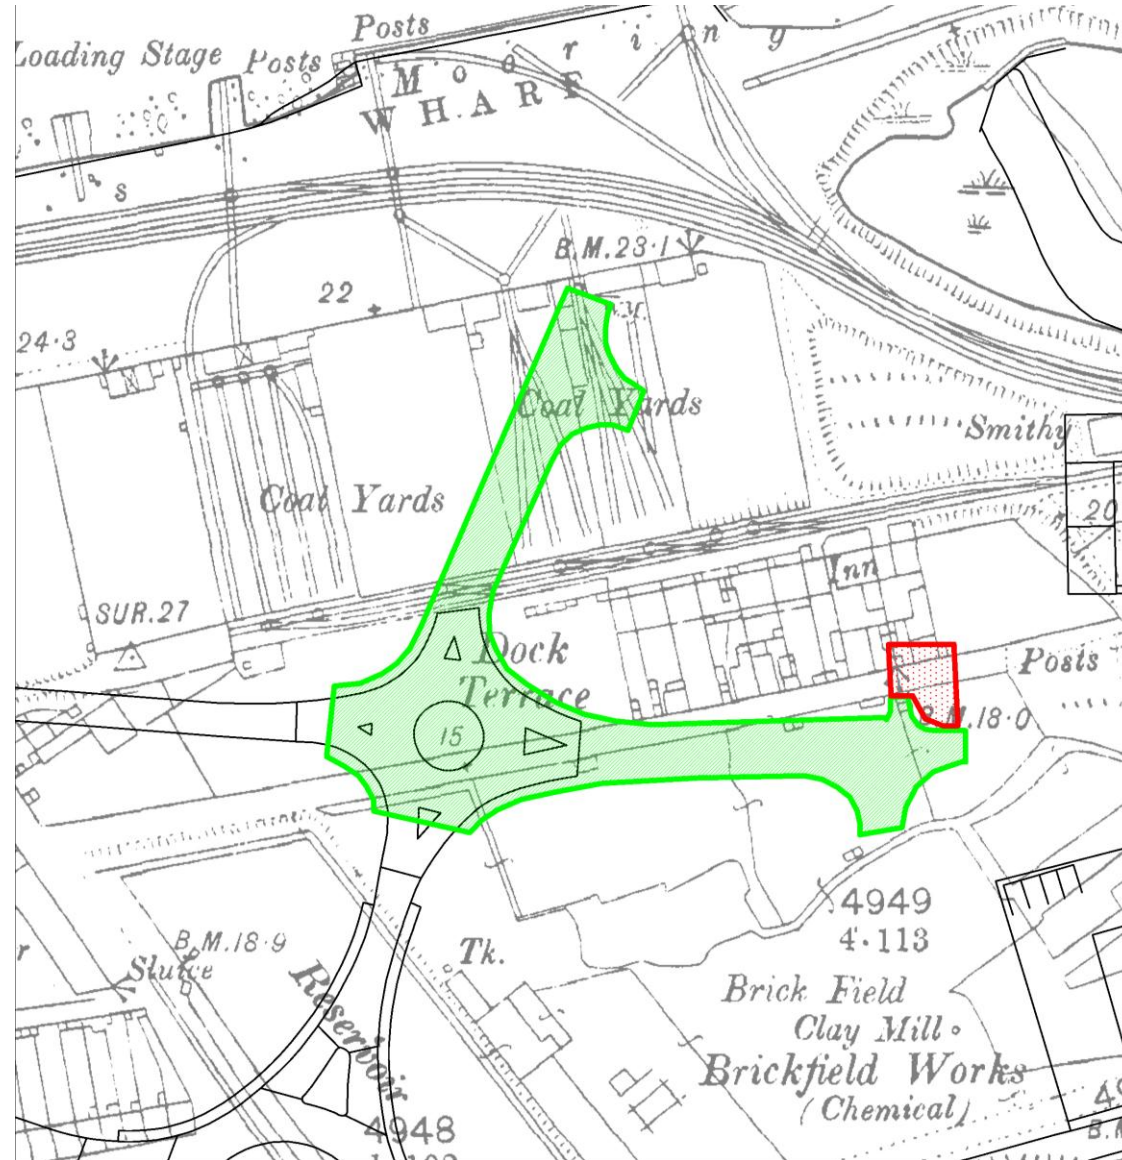
**Figure 3:** Extract of the first edition Ordnance Survey map of c.1880 with outline of modern road layout superimposed and also main areas of Delta Lakes development (red area is pumping station)

2.2.6 Figures 3 and 4 show the First and Second edition OS maps respectively with the modern road layout superimposed. This demonstrates the potential impact the current developments may have upon the underlying archaeology. The majority of the road lines and areas of drainage trenches etc would cut across Dock Terrace and less developed land to the north. The eastern extremity of the development area would reach the former reservoir of the Brickfield Works chemical factory. The pumping station lies across the former Dock Terrace road and buildings on its northern edge.

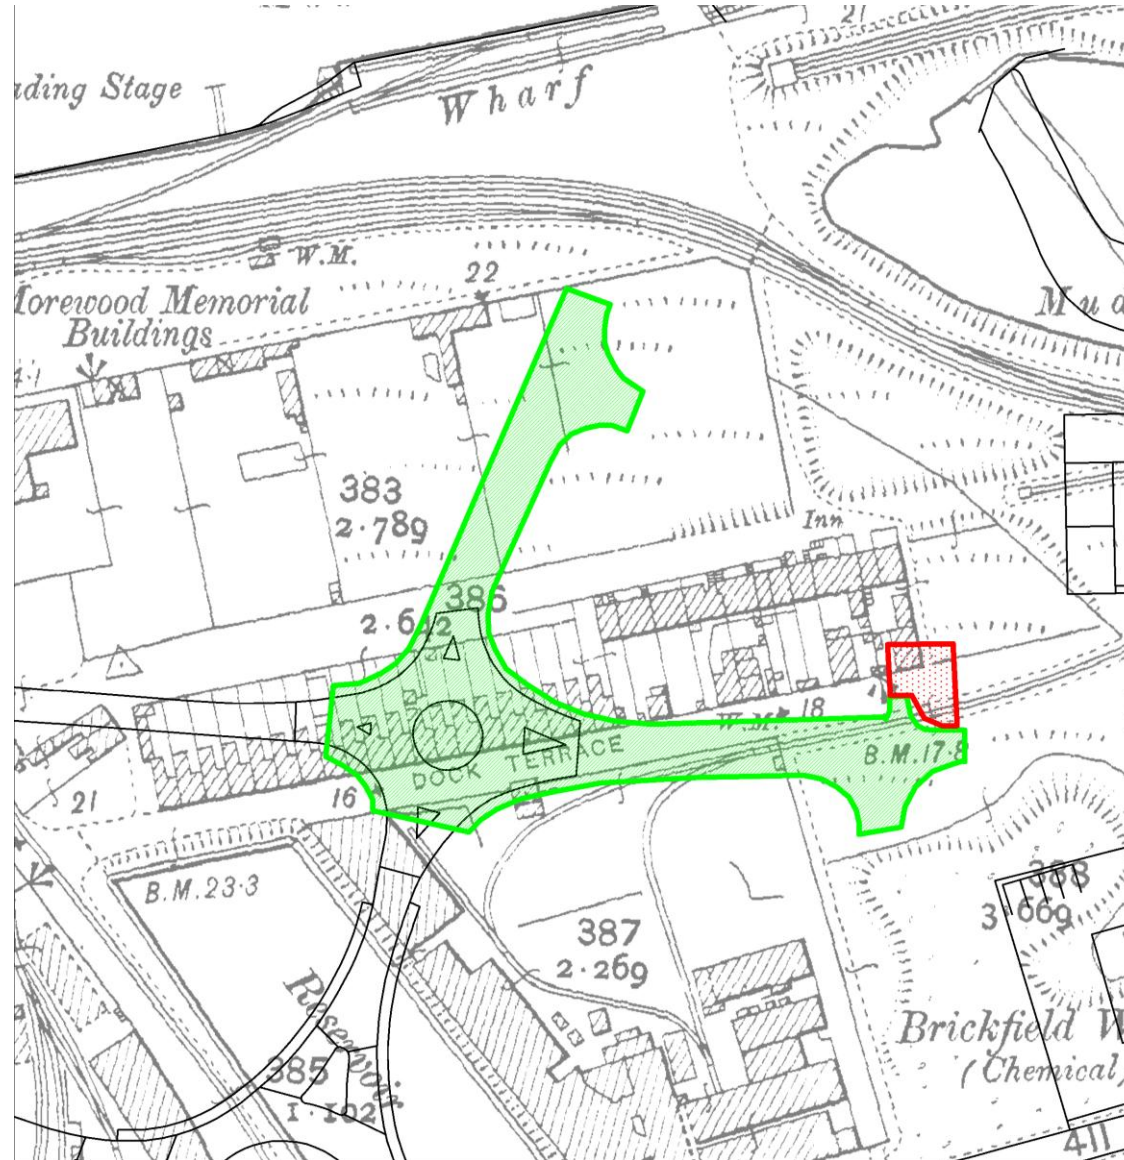
**Figure 4:** Extract of the second edition Ordnance Survey map of 1904 with outline of modern road layout superimposed and also main areas of Delta Lakes development (red area is pumping station)

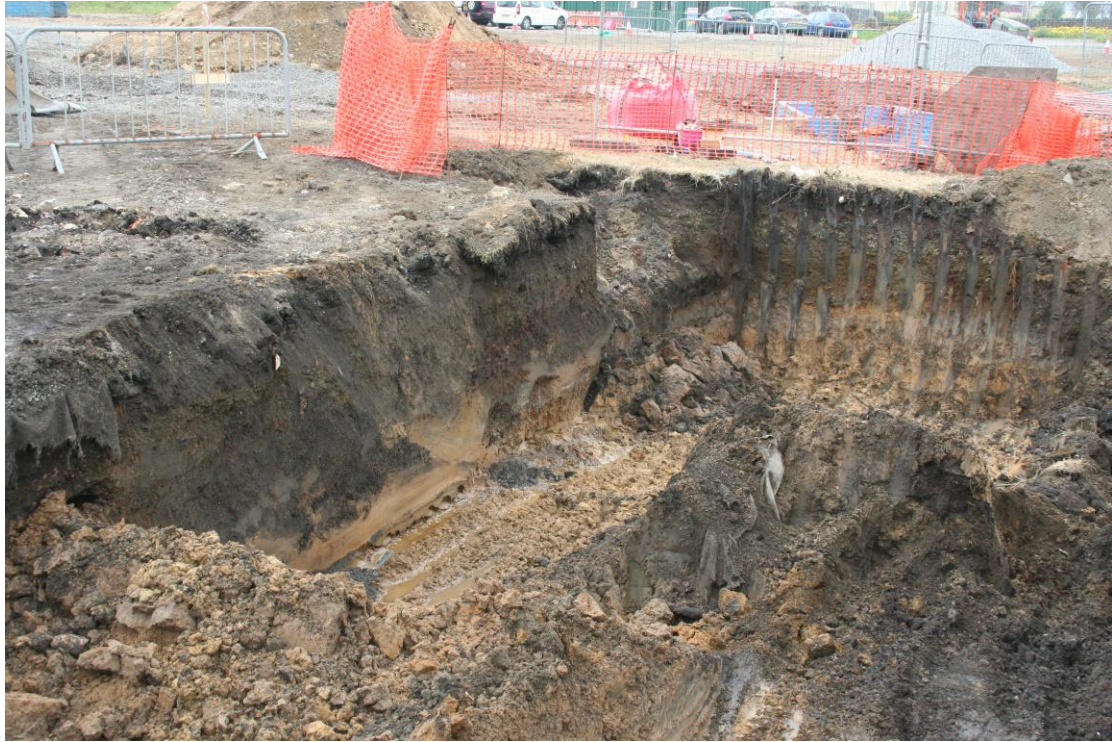
- 4.1 Across the entire excavated area the ground showed signs of being very disturbed. The uppermost layer consisted of a grey, loose, gritty material that is the result of landscaping and levelling of the site. This appears to vary in depth from 1.5m and up to 2m in some places. The material presumably comprises crushed stone and demolition material from the various buildings and structures across the site area.

**Photo 1:** View of excavated area showing disturbed upper layers of 'built material' caused by site levelling.

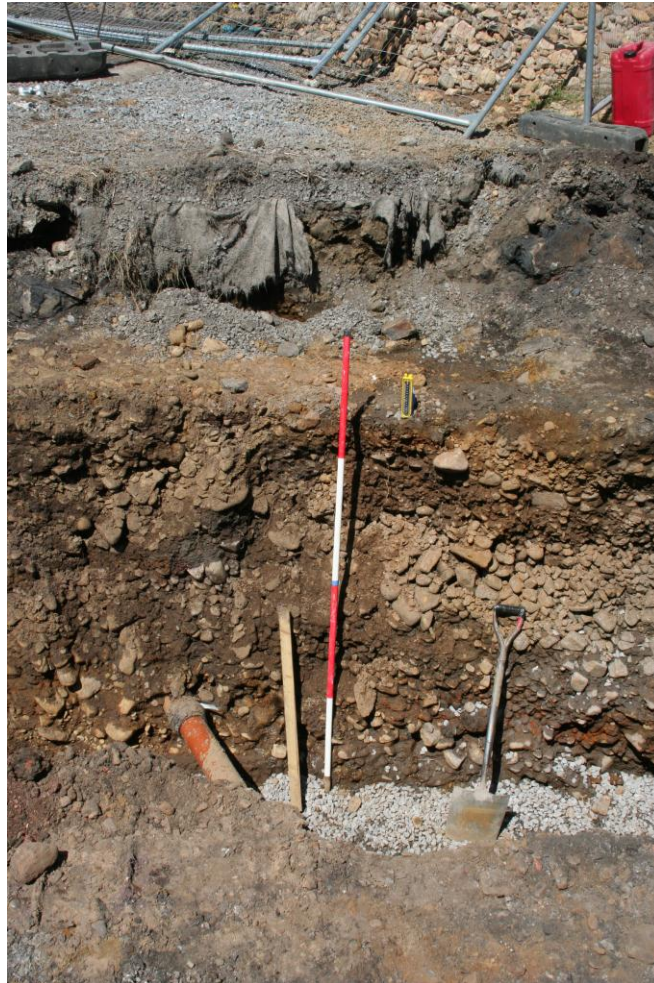
- 4.2 The underlying geology appears to be a natural alluvium, yellow in colour and made up of fine silt and clay, gravel and frequent large stone inclusions. This was most clearly identified in the deeper areas of excavation for the pumping station where numerous gravel layers were encountered. The area of the pumping station was reduced to some 1.5m below the former ground surface. Sheet piles were then inserted around the buildings footprint and the ground level further reduced through natural gravels. Some sheet piles had already been inserted into this area by the time of the last visit to the site, although these were placed through the natural gravels.
- 4.3 No features, finds or deposits of archaeological significance were observed during the watching brief.

**Photo 2:** Natural alluvium underlying disturbed upper layers

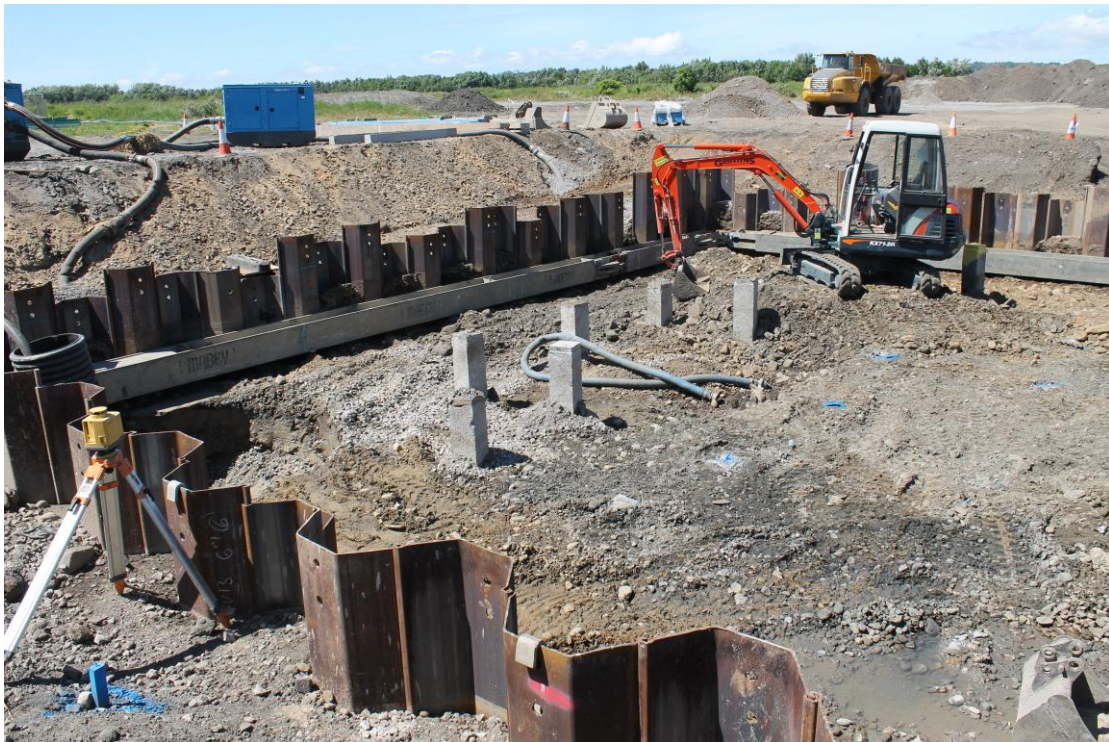
**Photo 3:** Sheet piles around the area of the proposed pumping station
