FOELCWAN FARM, TREVAUGHAN, CARMARTHENSHIRE: ARCHAEOLOGICAL WATCHING BRIEF

RHIF YR ADRODDIAD / REPORT NO. 2014/44
RHIF Y PROSIECT / PROJECT RECORD NO. 107514

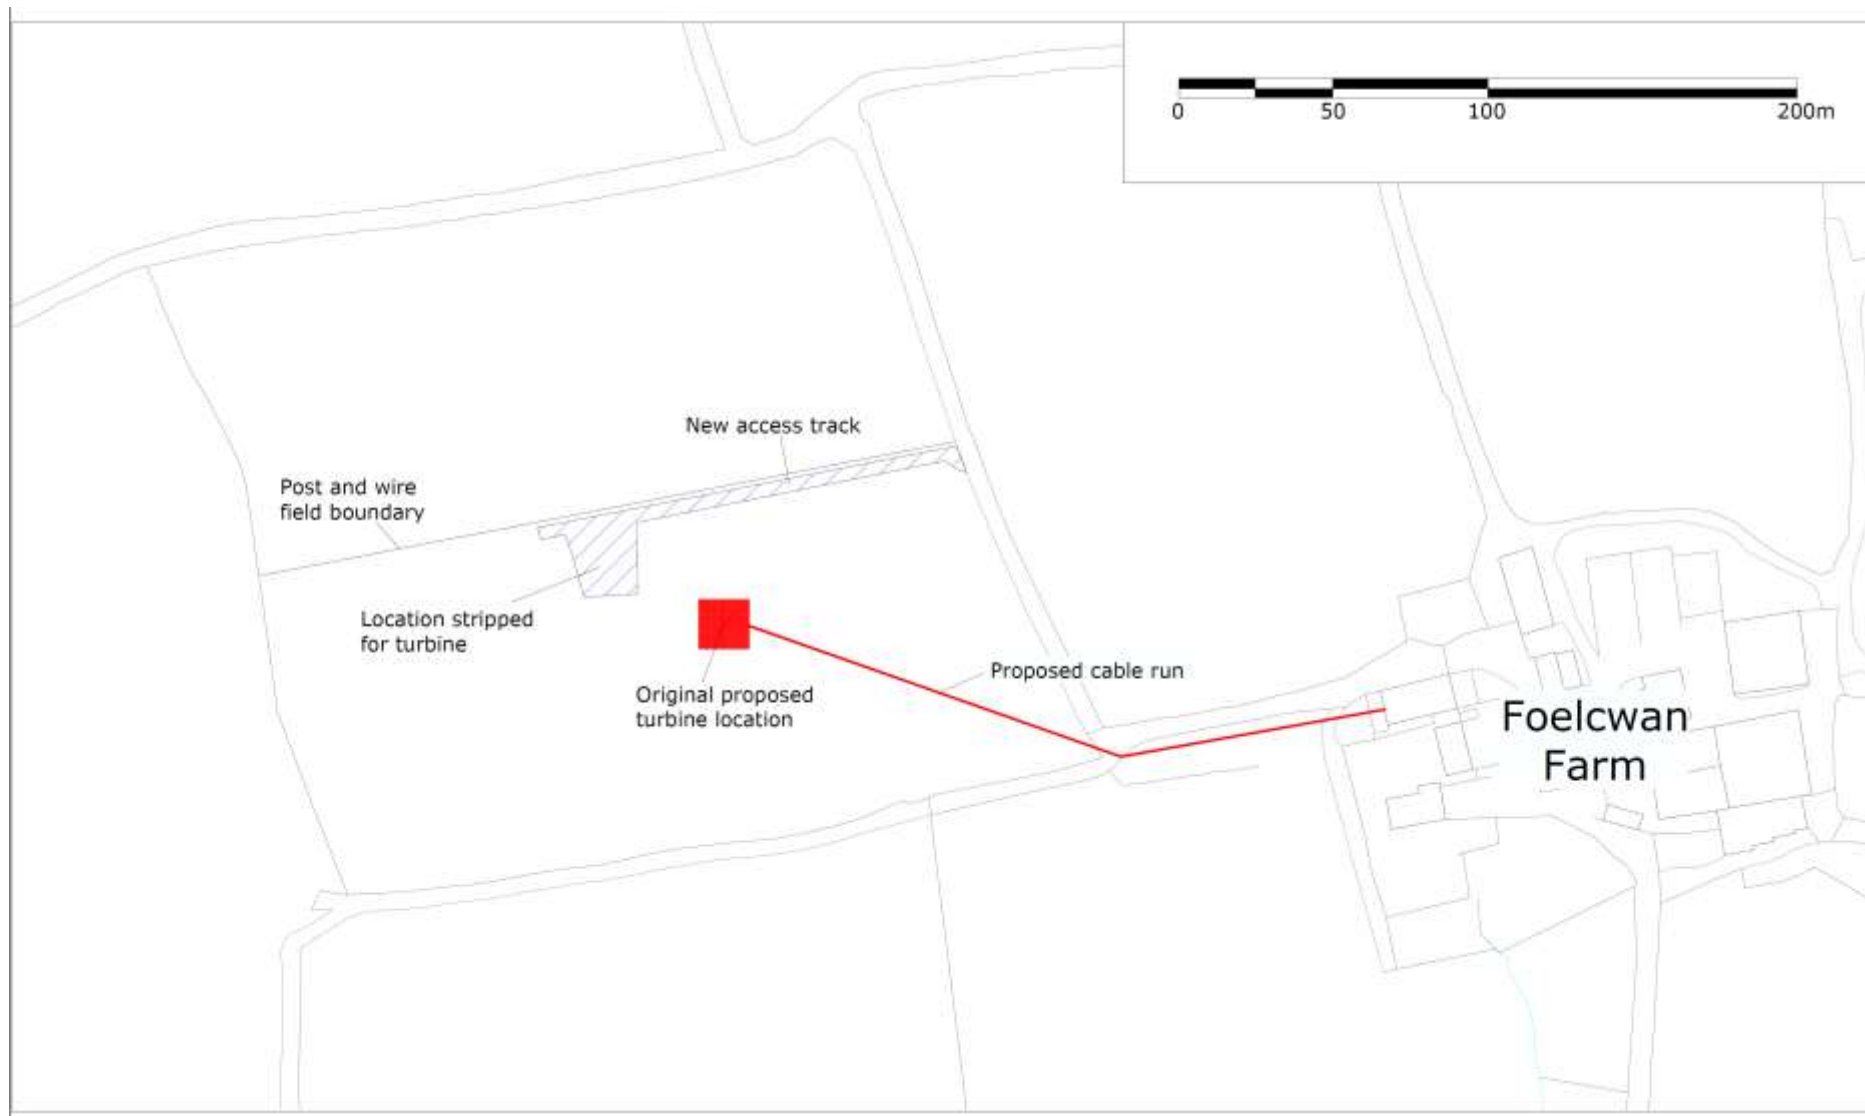
Figure 2: Detailed site location plan, area of watching brief and original proposed turbine location

- 2.1.2 The field in which the turbine is located is shown on maps as being one large area, although a post and wire fence has recently been erected splitting the field into two. This is roughly indicated on Figure 2.

- 2.1.4 The location of the stripped area for the turbine and the original proposed location (NGR SN 238566 222260) did not correspond (Figure 2). It is presumed that the final location of the turbine had been slightly altered, as evidenced by the geotechnical test holes which had been excavated in the same area as the stripped area for the turbine base.

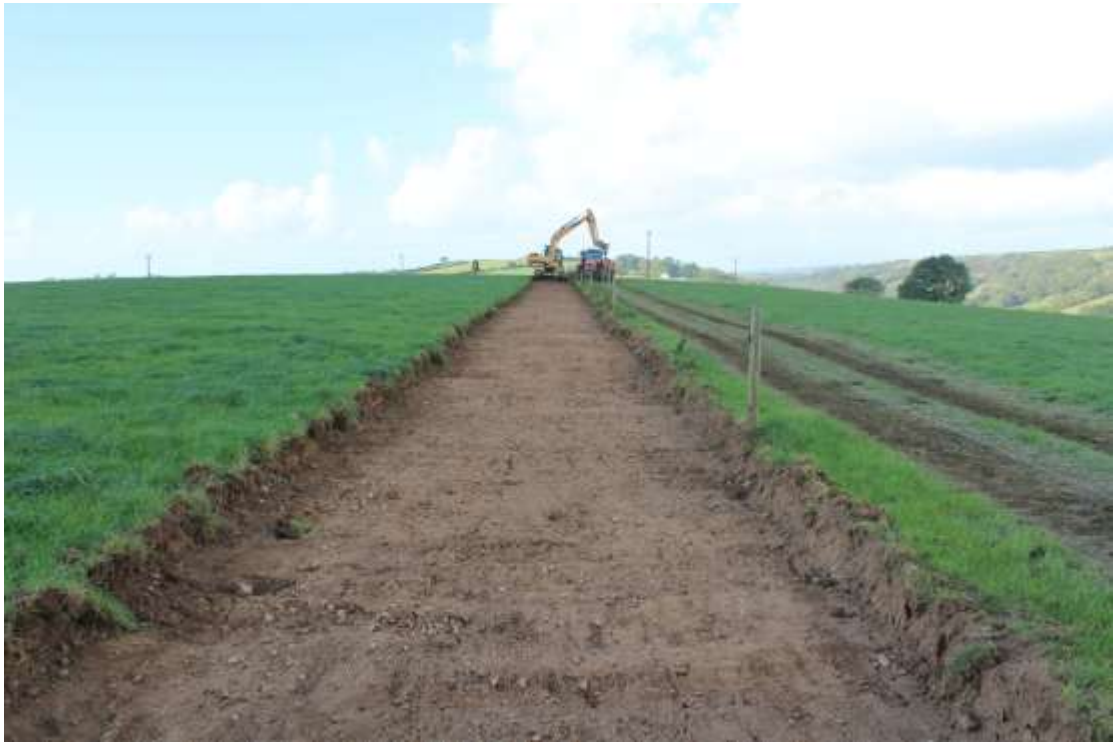
Photo 1: Access route facing west.

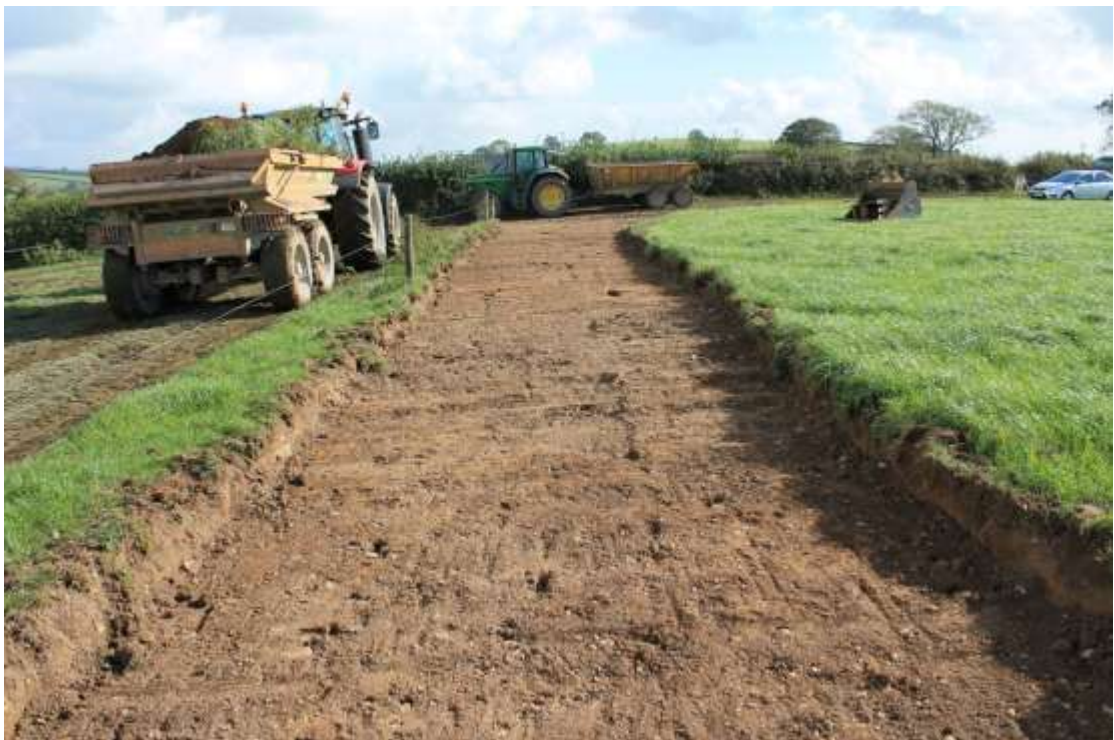
Photo 2: Access route facing east with Crug Par Y Cnwc hill in the background.

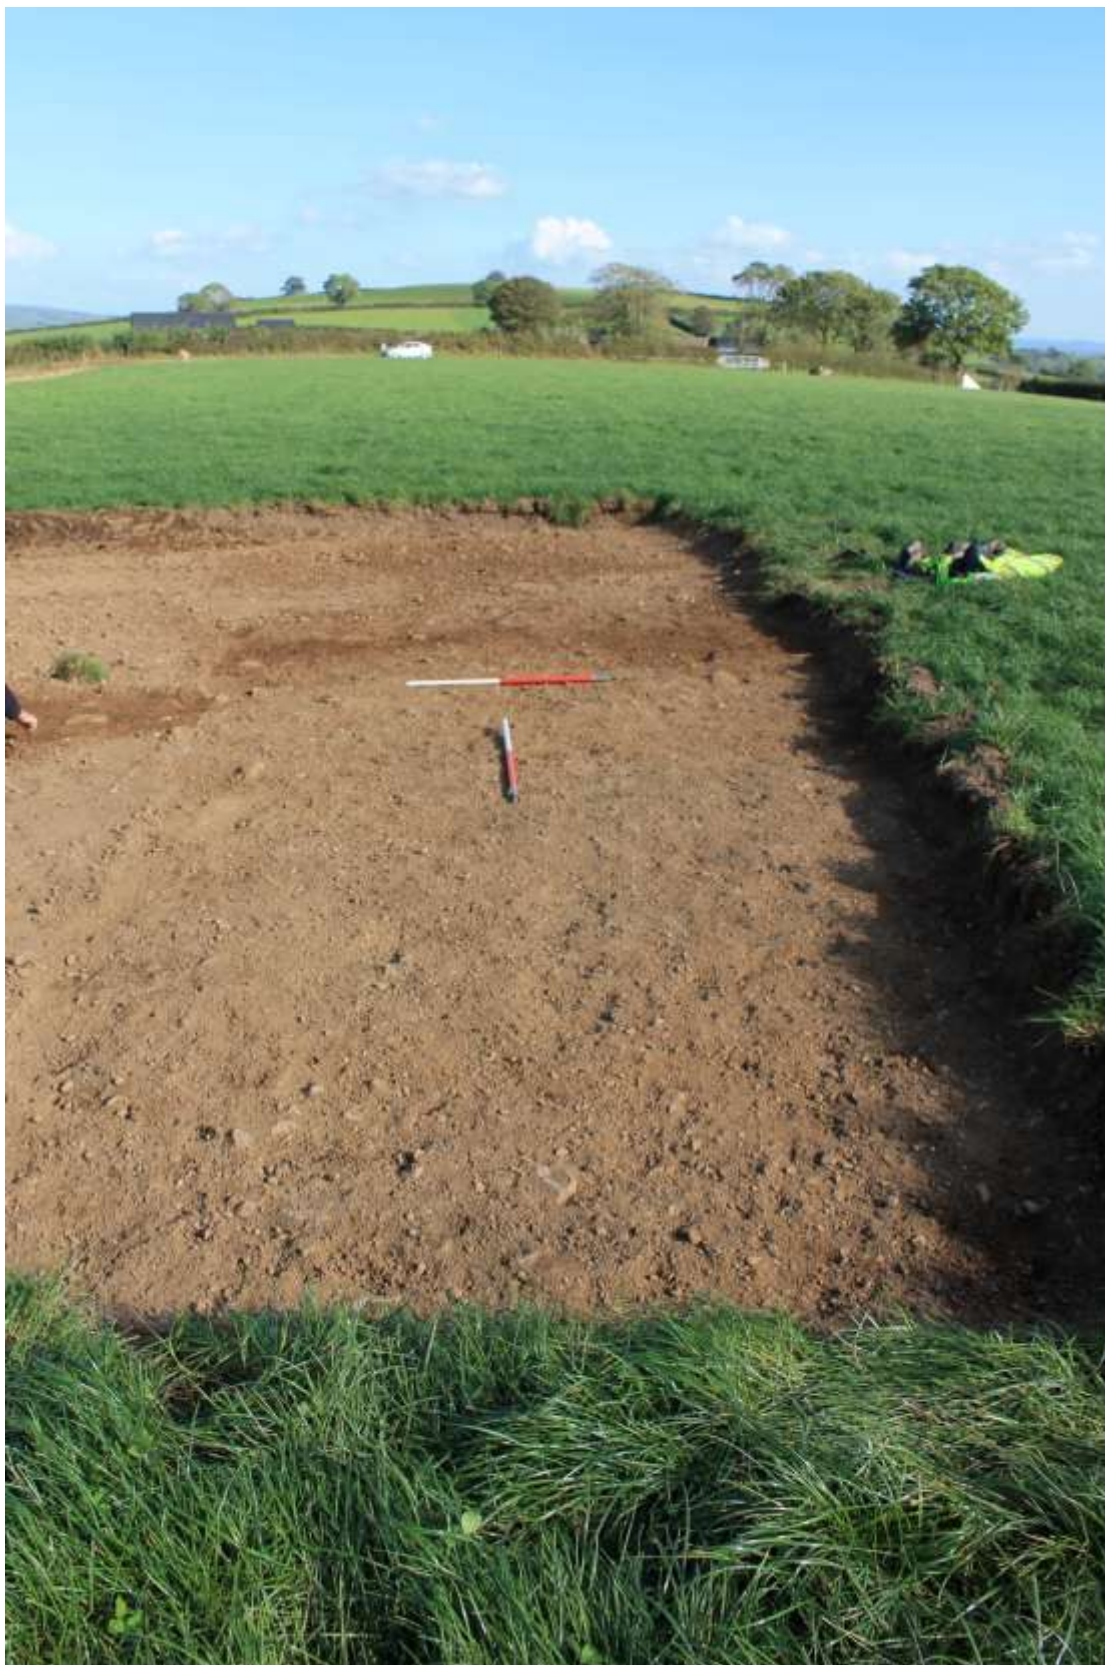
Photo 3: Proposed turbine area fully stripped facing east.

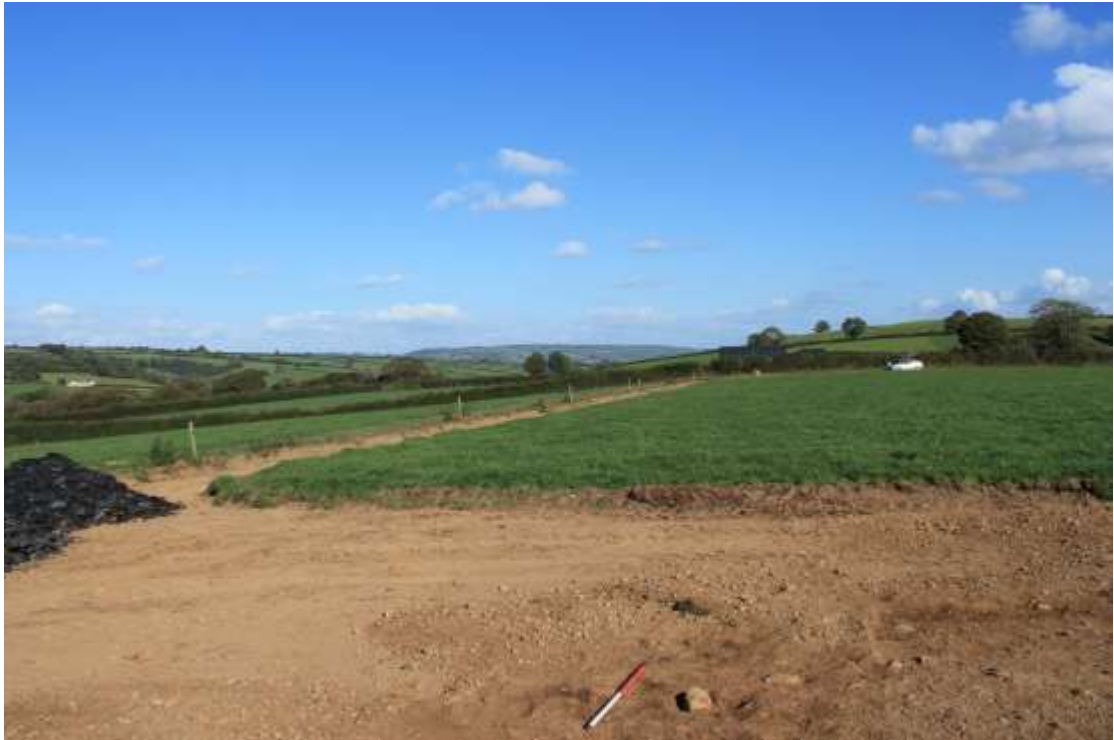
Photo 4: Proposed turbine area facing north-east. Notice the shale being used to fill in the access route to make a road.

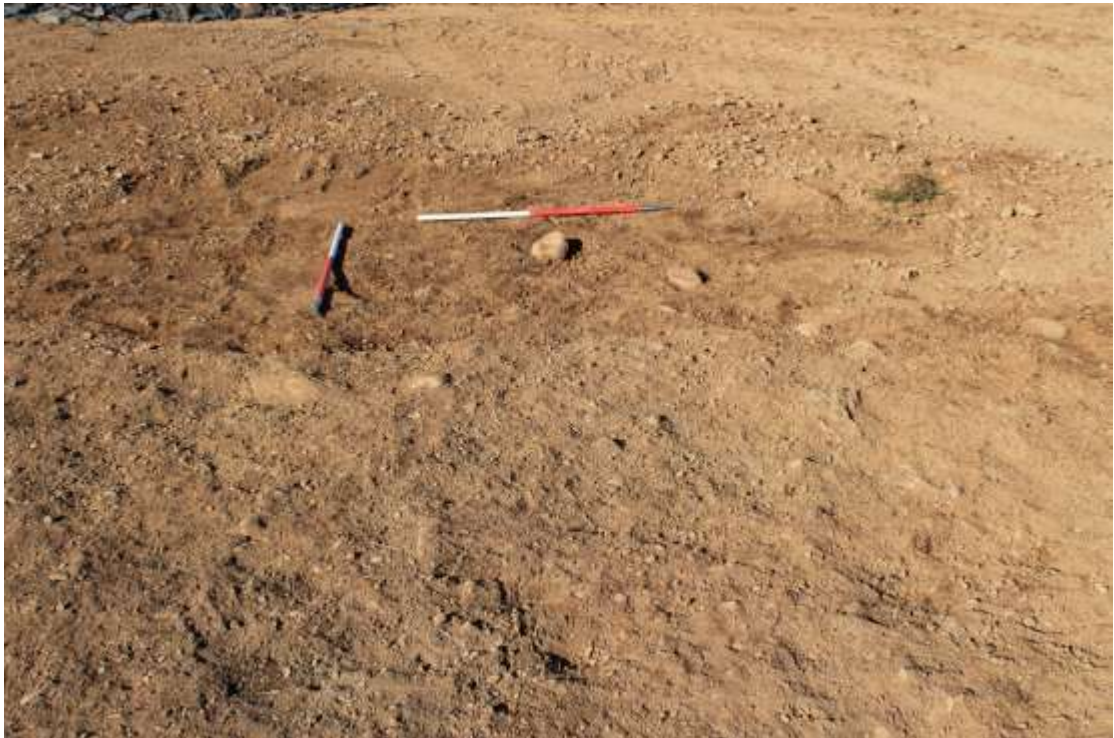
- 4.5. One patch of softer, less stony sediment with a few large stones was noted within the excavated area for the turbine base (Photo 5). Further investigation with a hand trowel did not reveal anything of archaeological value indicating it merely represented a change in the geology.

Photo 5: Ranging rods situated in a patch of slightly softer, less stony sediment which proved not to hold any archaeology upon further investigation.
