GAS MAIN RENEWAL SCHEME 2014 ABERYSTWYTH, CEREDIGION: ARCHAEOLOGICAL WATCHING BRIEF

Prepared by Dyfed Archaeological Trust
For: Wales & West Utilities

RHIF YR ADRODDIAD / REPORT NO. 2014/46
RHIF Y PROSIECT / PROJECT RECORD NO. 107516

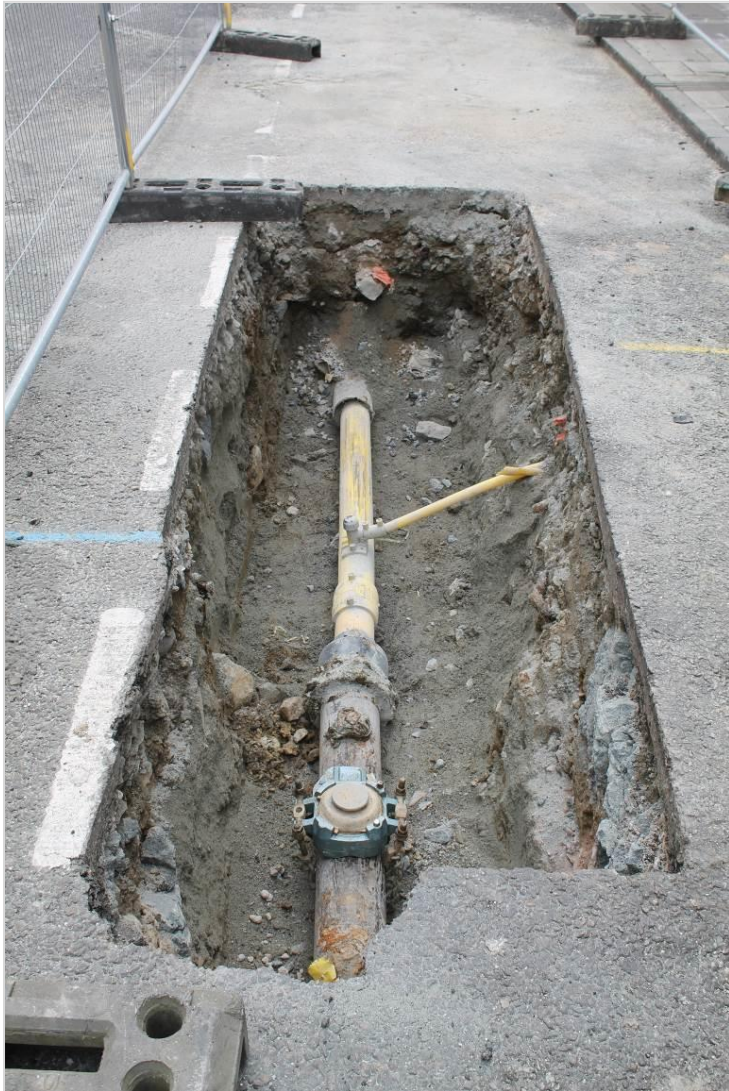
Left - Photo 1: Representative photograph of one of the trenches opened in Bridge Street; facing north.

- 4.2 These trenches were examined and Photo 1 is a representative photograph of the deposits exposed within such a trench. The trenches were no deeper than 0.45m and the stratigraphy clearly shows fragments of concrete situated in a commingled matrix that has resulted from successive episodes of disturbance due to modern services.

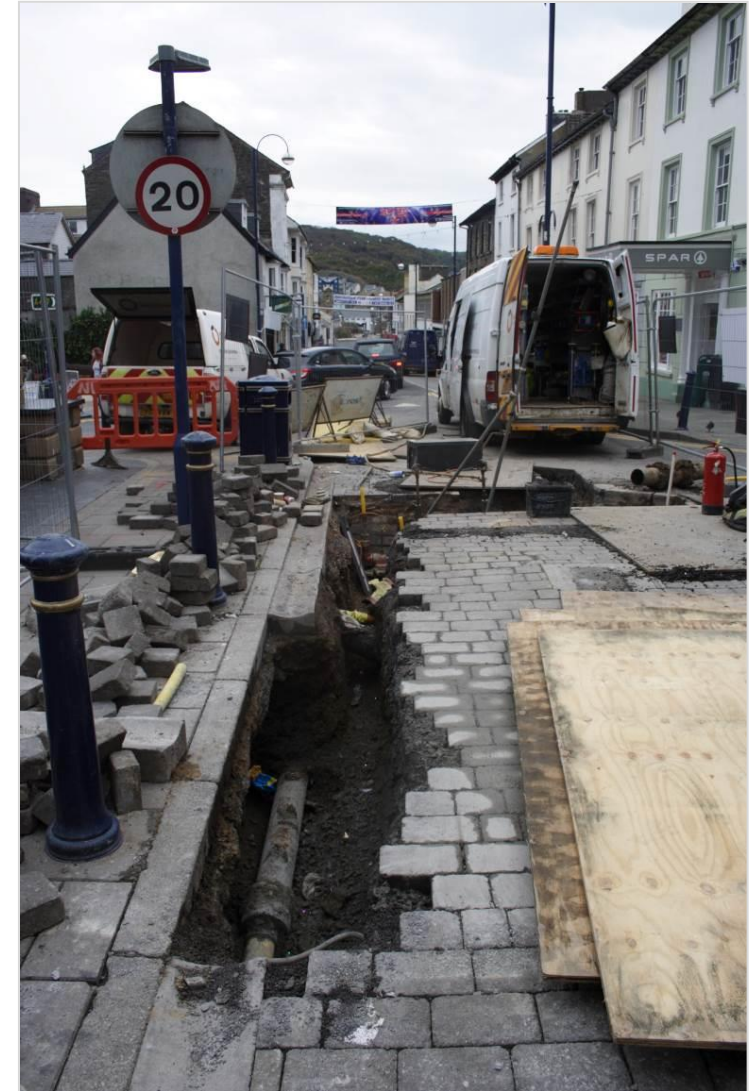
Right – Photo 2: General view of excavated trench at junction of Great Darkgate, Bridge and Pier Street; facing east.

- 4.3 On 14th October the watching brief was carried out during ground works at the junction of Great Darkgate, Bridge and Pier Street (Photos 2 & 3). The works excavated an irregular shaped trench to a maximum depth of nearly 1.00m. Within the sides and the bottom of the trench was clear evidence of how badly the ground had been disturbed by modern services over the years (Photos 4 & 5).

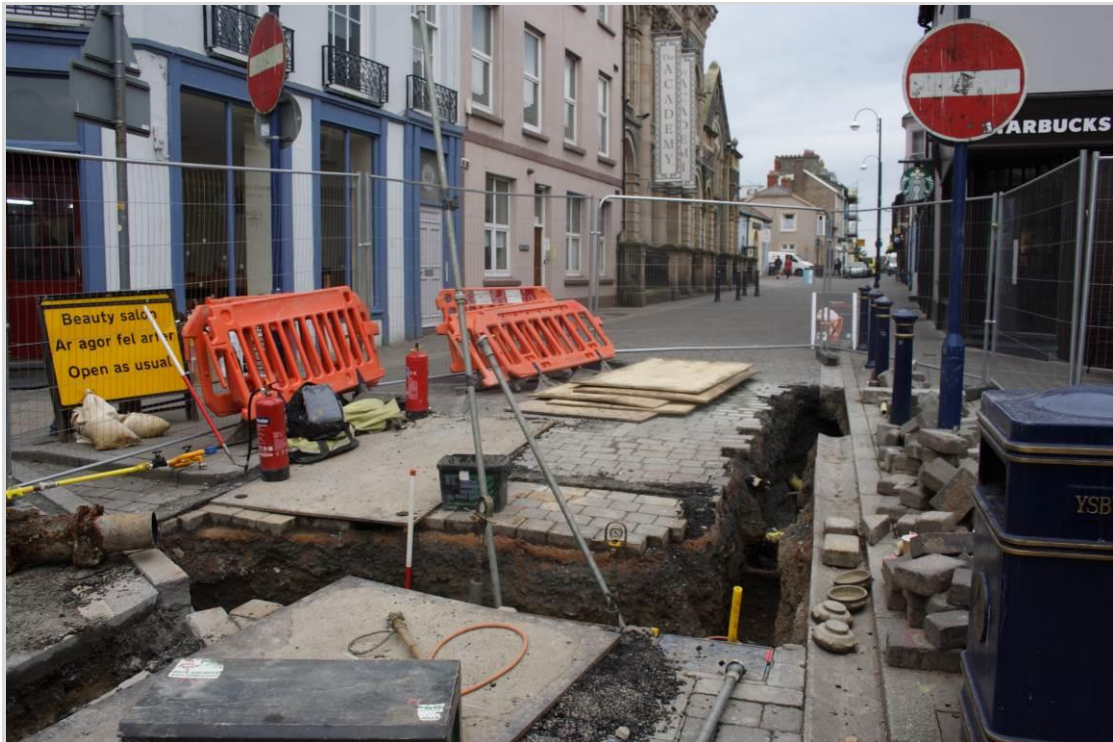
Photo 3: General view of trench at junction of Great Darkgate, Bridge and Pier Street; facing west. 1m scale

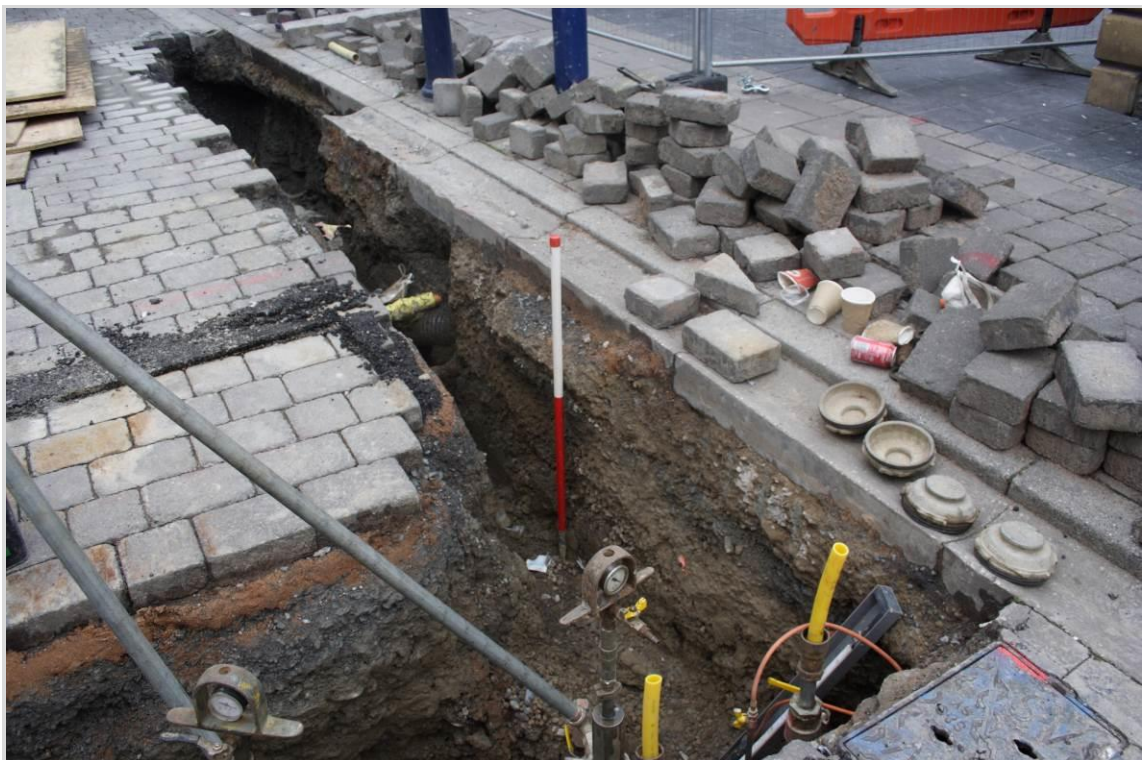
Photo 4: Detail of the south facing section of trench showing the disturbed nature of the below ground deposits. 1m scale

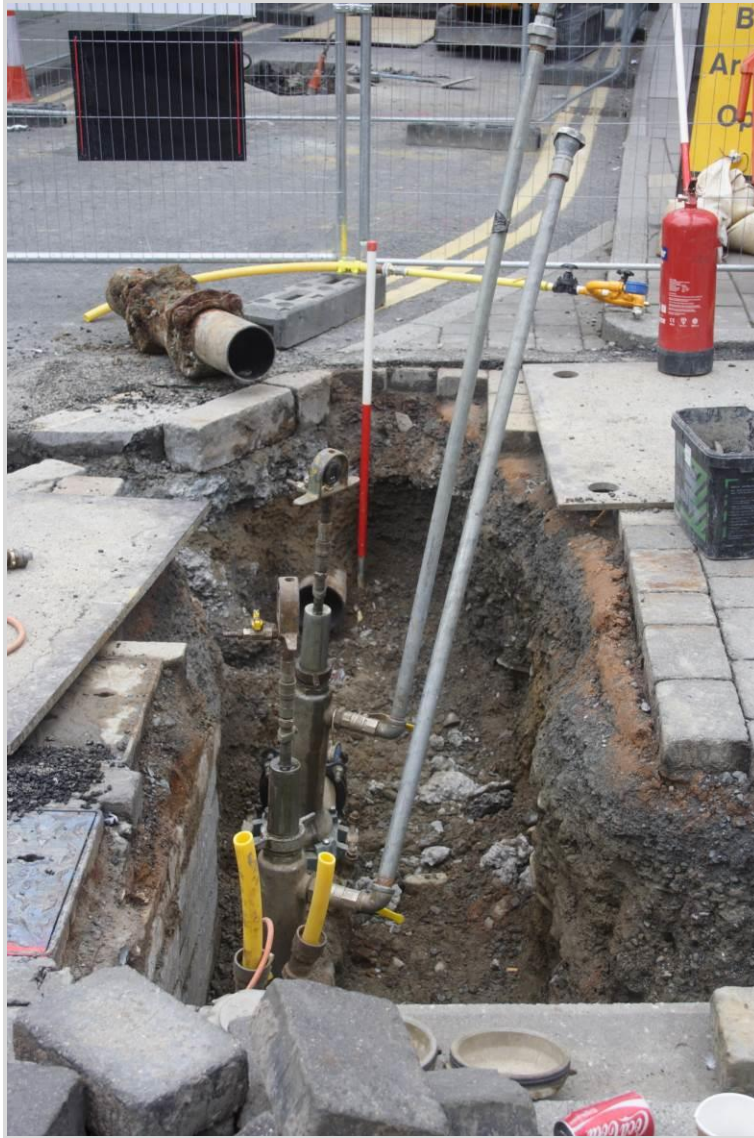
Photo 5: Detail of the south arm of the excavated trench showing the disturbed nature of the below ground deposits; facing south. 1m scale
