**ST INA'S CHURCH, LLANINA,  
CEREDIGION:  
ARCHAEOLOGICAL WATCHING  
BRIEF 2014  
(NGR SN 4049 5982)**

RHIF YR ADRODDIAD / REPORT NO. 2014/53  
RHIF Y PROSIECT / PROJECT RECORD NO. 107530

**ST INA'S CHURCH, LLANINA,  
CEREDIGION:  
ARCHAEOLOGICAL WATCHING BRIEF  
2014**

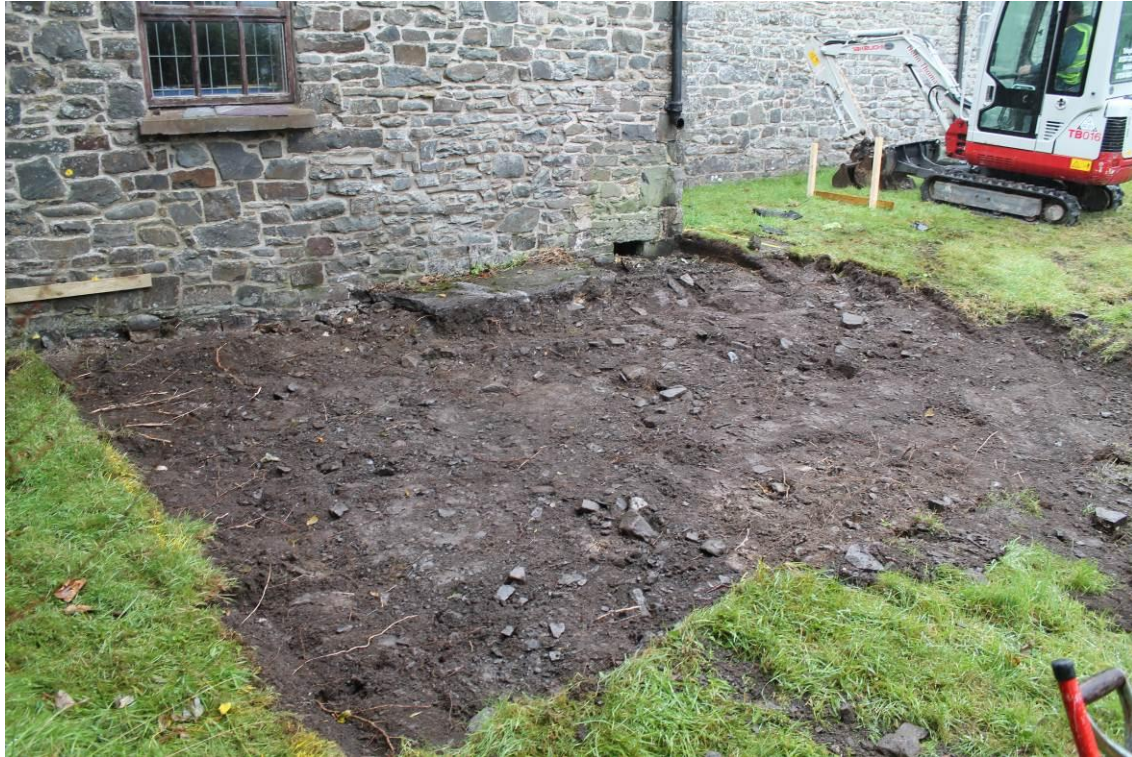
**Photo 1:** The area of the church extension after topsoil had been stripped away by machine. Photograph taken facing southwest.

- 4.1.1 A watching brief was undertaken during the topsoil strip in the area of the church extension (Photo 1) and after that the digging of the foundation trenches for the walls of the extension (Photo 2).

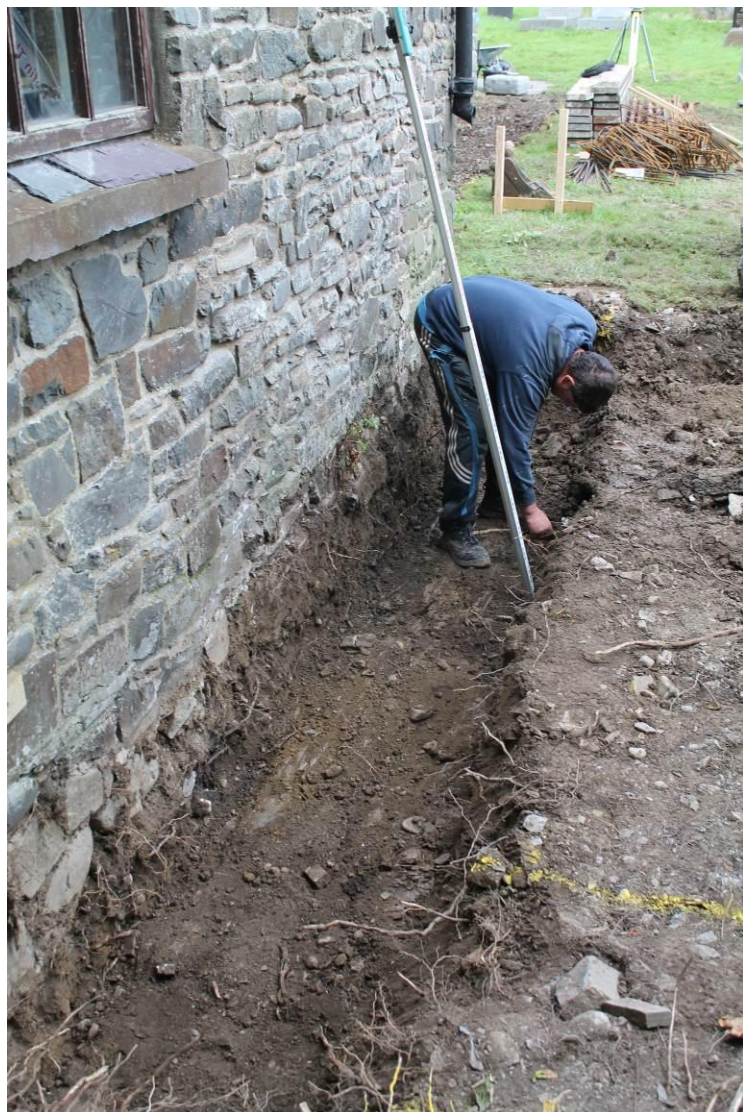
**Left- Photo 2:**  
The excavation of  
the foundation  
trench for the  
walls of the  
church extension.  
Photo taken  
facing west.

- 4.1.2 Below the topsoil a layer of loose dark brown stony silty clay containing pieces of slate, post-medieval pottery and building rubble was exposed. Within this layer a large amount of disarticulated bone was revealed in an area measuring roughly 2.5m by 3.0m. Photo 3 shows the area of disarticulated bone after the removal of the topsoil. Upon investigation, this proved to be human bone, representing a number of individuals that would appear to have been re-interred into a large feature; possibly a pit or shallow depression of some sorts cut into the rubble layer (Photo 2).

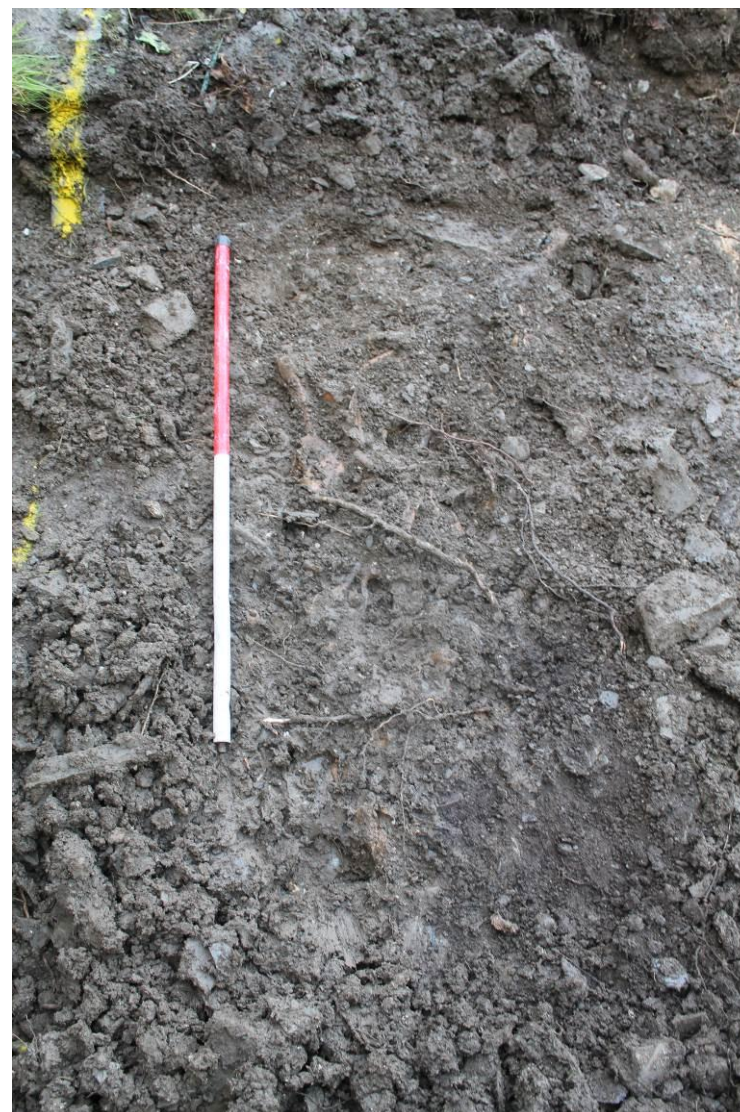
**Right – Photo 3:**  
The spread of  
disarticulated  
human bone as it  
appeared after  
topsoil removal.  
1m scale

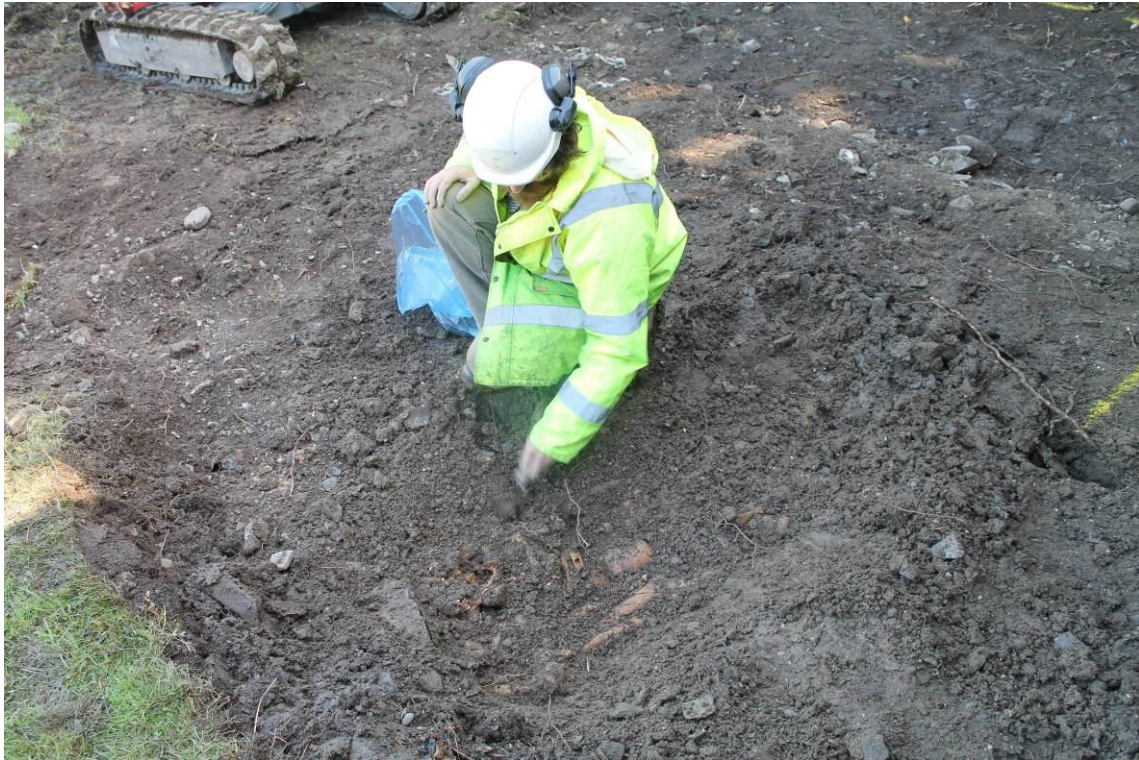
**Photo 4:** The disarticulated human remains being excavated by hand.

- 4.1.3 As the excavation of the foundation trench necessitated some of the removal of the exposed human bones, these were excavated by hand (Photo 4) for re-burial elsewhere in the graveyard. Sufficient human remains were removed to represent at least 20 individuals, but due to their commingled nature, and the partial excavation of the pit, the remains may have represented many more.

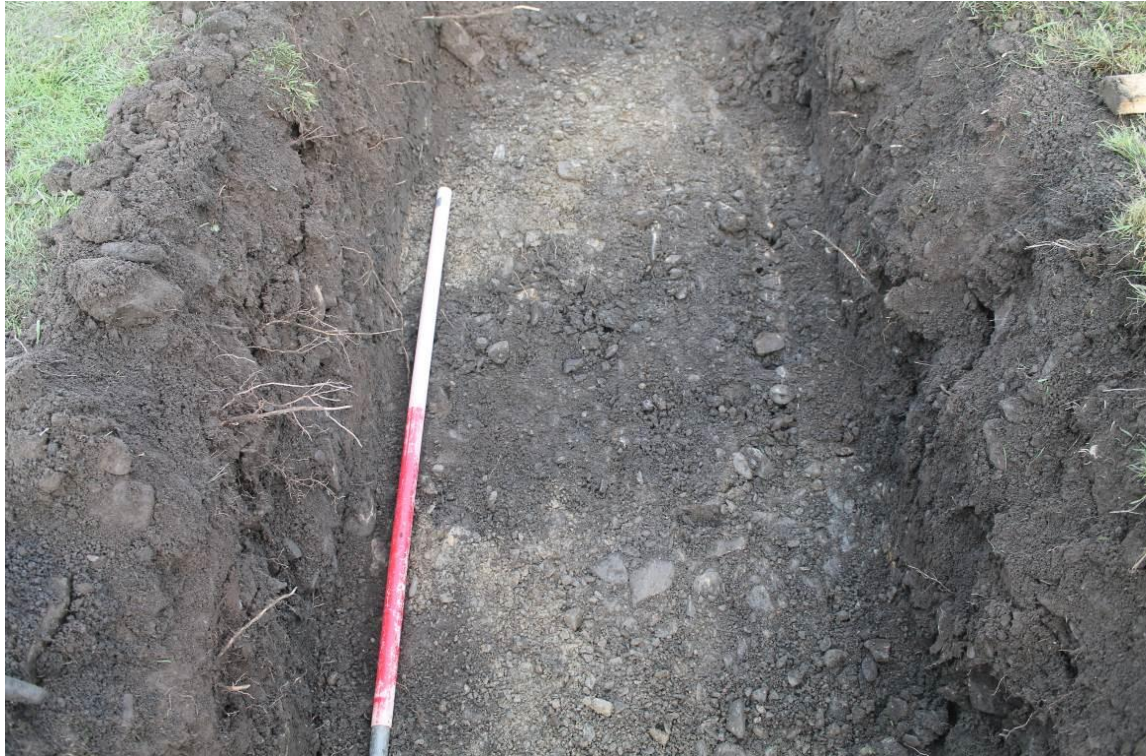
- 4.2.1 Excavation of the trench arch revealed a layer of topsoil very dark in colour, with an almost black appearance. The topsoil layer extended to a depth of c.0.5m where a notable contrast with much lighter subsoil was observed. The trench was excavated to the topsoil/subsoil interface which made it possible to identify a number of cut features. These features were roughly rectilinear in shape and appeared to be orientated east to west. Given these characteristics and their location it is plausible to suggest that they are grave cuts. In total at least six probable grave cuts were observed. Photo 5 shows an example of one of the probable grave cuts.

**Photo 5:** Example of probable grave cut revealed within the excavated trench arch, cutting the subsoil. Photo taken facing north. 1m scale

- 4.2.2 The depth of the trench arch (roughly 0.5m) was not at a sufficient depth to disturb any inhumations contained within the graves but a small number of human bone fragments (rib, distal right humerus and right proximal tibia fragments) were found within the topsoil. Presumably these had been moved around by a natural redistribution e.g. animals.

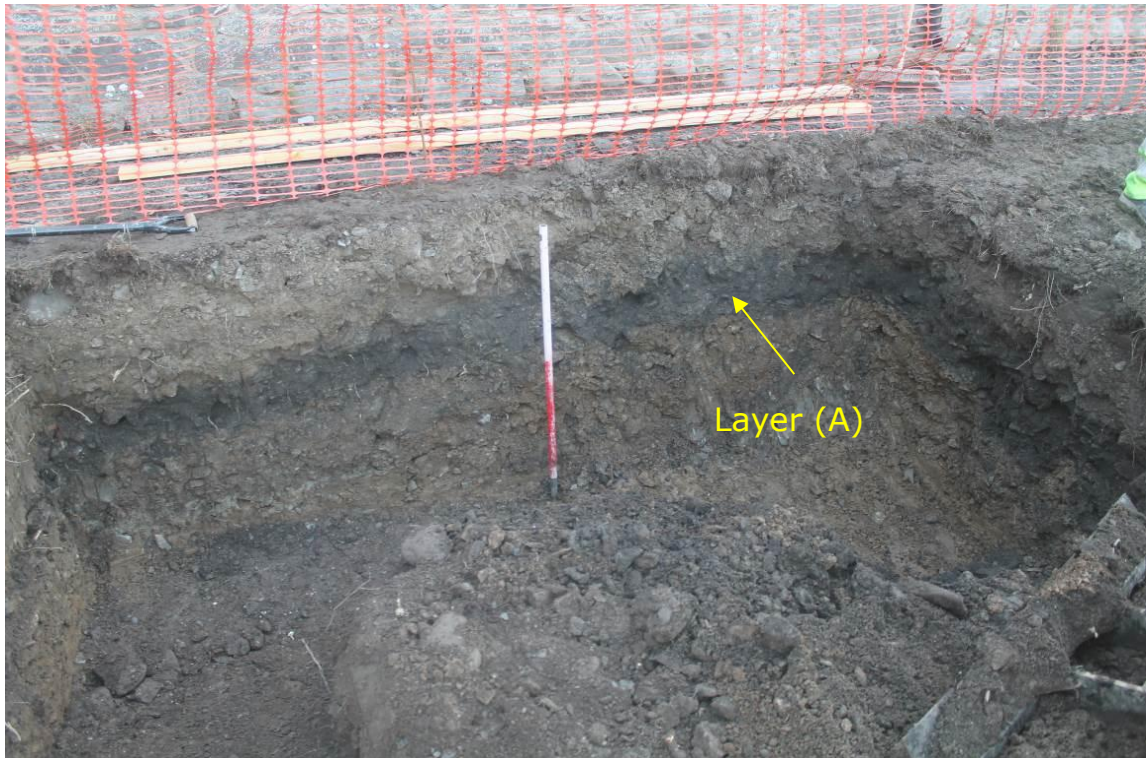
- 4.3.1 The watching brief continued during the machine excavation of the rainwater harvesting tank that involved excavating a trench approximately 2.5m square and 1.0m deep. During the excavation of the trench, below the topsoil, a notable loose dark brown silty clay layer (A) was observed at a depth of approximately 0.50m below the current ground surface at the southern end of the trench, rising to c.0.25m in the north (Photo 6). This layer was situated below the topsoil and shared similar characteristics with that of the fill of the probable grave cuts observed in the trench arch. There was no evidence to suggest that this deposit was within a cut feature but is probably more likely to be a spread of material, possibly filling a shallow depression.

**Photo 6:** North facing section of water tank trench showing the dark soil layer (A) that contained disarticulated human bone. Scale 1m

- 4.3.2 The spread of dark soil (A) was c.0.25m deep and was found to contain within it two large isolated deposits of disarticulated and commingled skeletal remains as well as smaller deposits of disarticulated bone fragments throughout.
- 4.3.3 The first deposit of human remains was found against the eastern edge of the trench and at a shallow depth of 0.25m. It consisted of mainly skulls and other upper body parts including arm bones and ribs. These appeared to be rather haphazardly placed, with one of the skulls upside down. Three relatively intact skulls were found and additional bone fragments from the frontal bone would suggest a minimum number of five individuals. Photo 7 shows one of the skulls prior to lifting; behind the skull are the disarticulated fragments of arm bones.

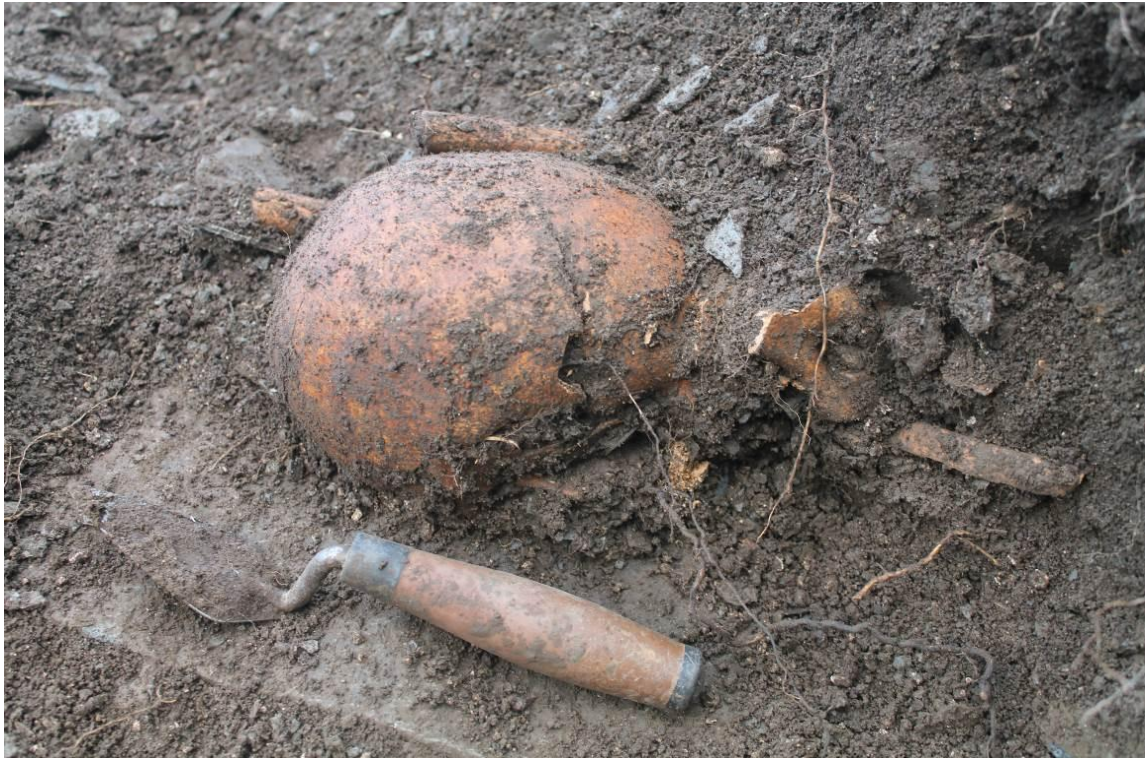
**Photo 7:** Skull surrounded by disarticulated and commingled bone fragments found within the dark soil layer (A).
