**FELIN WNDA, CEREDIGION, WATER MAIN
REPLACEMENT SCHEME:
ARCHAEOLOGICAL WATCHING BRIEF 2014
(NGR SN 32376 47002)**

RHIF YR ADRODDIAD / REPORT NO. 2014/54
RHIF Y PROSIECT / PROJECT RECORD NO. 107531

FELIN WNDA, CEREDIGION, WATER MAIN REPLACEMENT SCHEME: ARCHAEOLOGICAL WATCHING BRIEF 2014

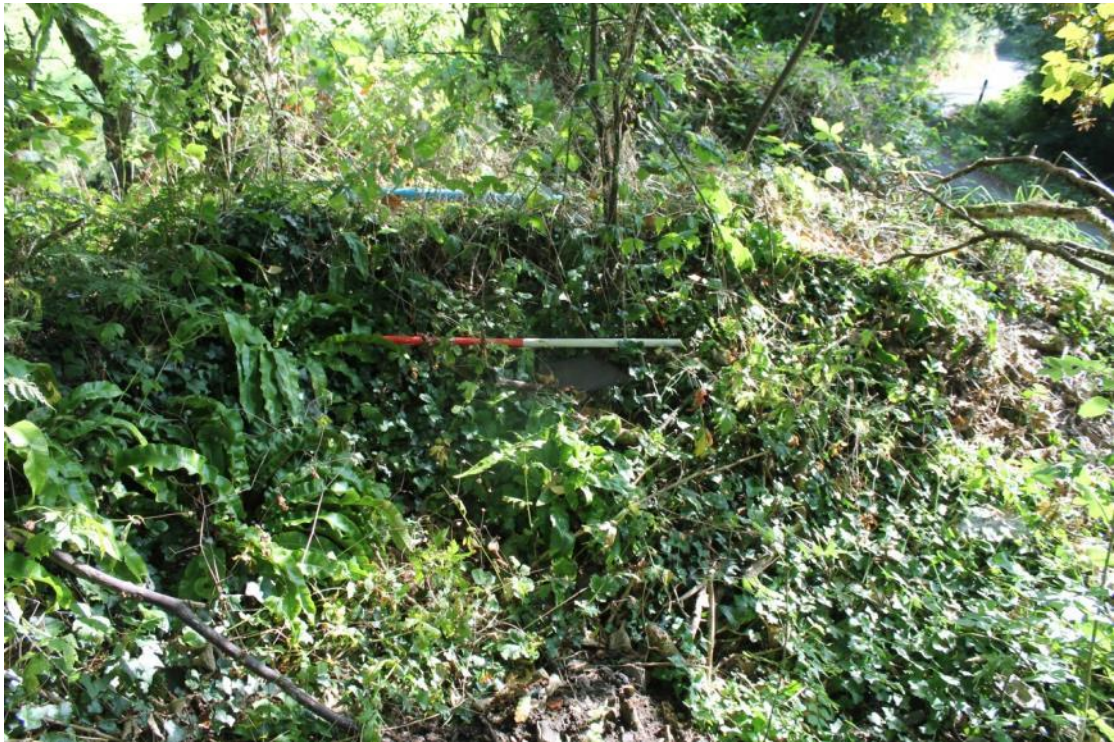
Photo 1: The length of wall that came to the notice of the site contractor in July 2014. Photograph taken facing south. 1m scale

- 1.1.2 The proposed works included the excavation of a trench, to provide access to the old water main ready for replacement. The pipe route passed close to the area of the former chapel of ease of Capel Gwnda (PRN 5737) and it was in close vicinity to this site that during initial ground works in July 2014 a length of walling some 25 to 30m in length came to the notice of the contractor in July 2014 (Photo 1). It is believed that the remains represent a farm building or cottage.

- 4.1 During the watching brief and prior to recommencing ground works with the excavator, an area to the northwest of the length of wall (Photo 1) was cleaned of the surrounding vegetation and loose soil (Photo 2). This allowed for a fuller assessment of the ground through which the trench for replacing the water main would pass.

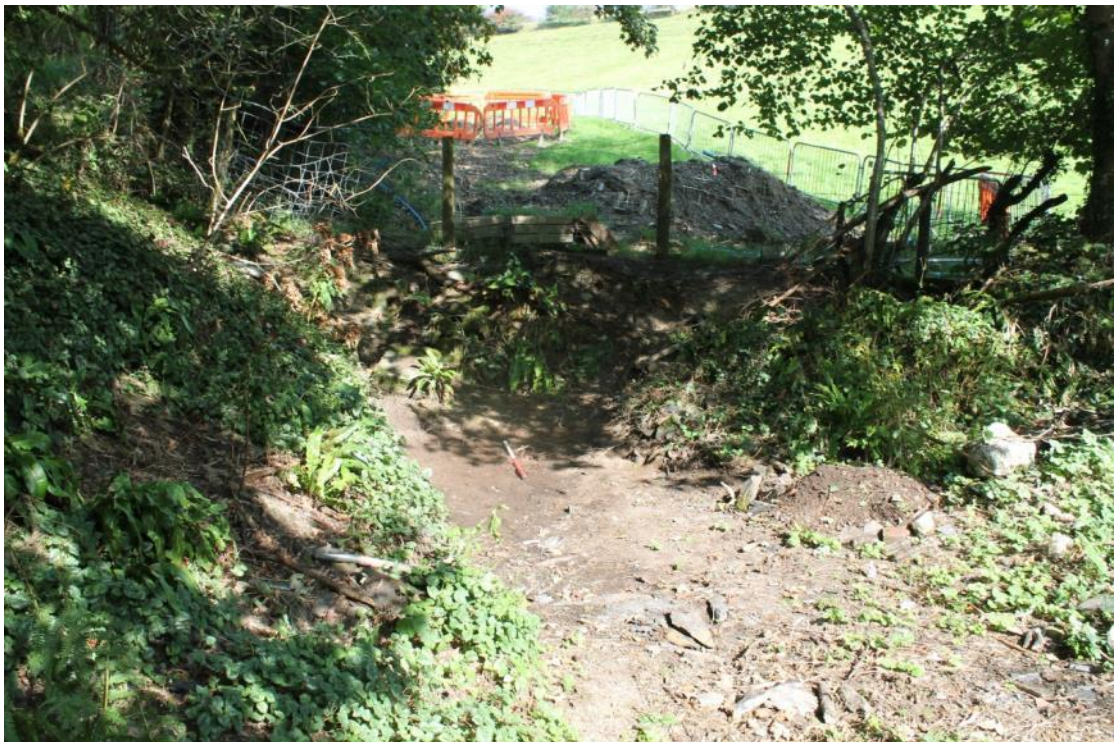
Photo 2: The area to the northwest of the length of wall cleaned of the surrounding vegetation and loose soil. Photograph taken facing northeast. 1m scale

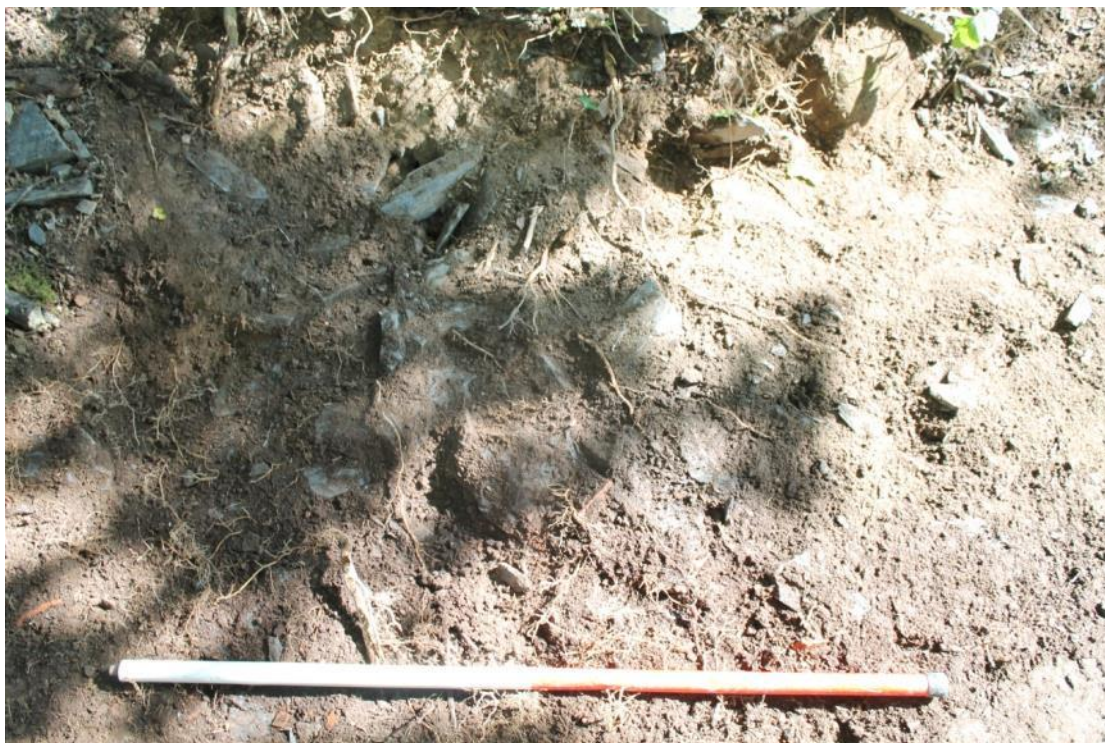
- 4.2 The cleanup showed that the material in this area was a mixture of debris including building stone that had collected from the gradual decay of the nearby walled structure (represented by the length of wall) and accumulated rubbish (Photo 3). The finds observed in this material consisted of plastic wrappers, broken glass, old metalwork, rubber and a glass syringe.

Photo 3: Cleaned area prior to excavation of trench, showing loose root filled, material including rubbish and small stones. Photograph taken facing roughly northeast. 1m scale

- 4.3 As the standing wall proved to be outside of the proposed line of the water main trench and the ground surface showed signs of recent disturbance, the machine excavation of the water main trench was allowed to continue.

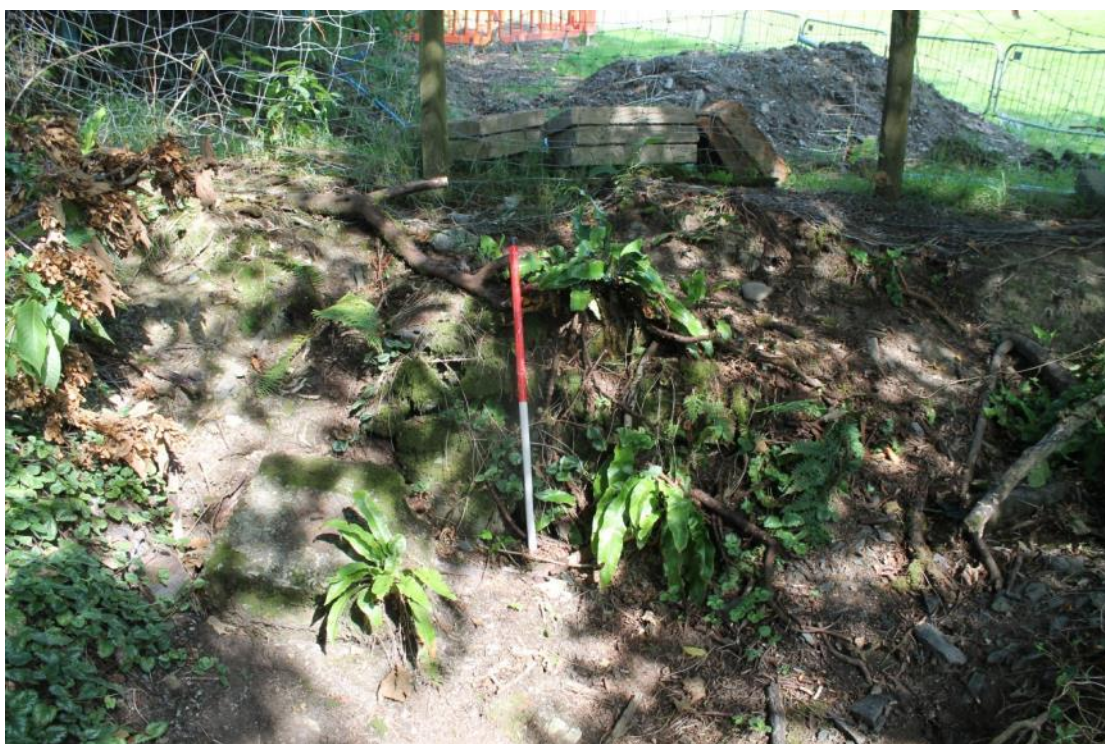
- 4.4 A short section of stone built revetment (Photo 4) to the north of the wall is thought to indicate the line of the previous water main. It is thought likely that after the earlier excavation someone built up the gap created by the route of the pipe trench to maintain the integrity of the hedge line.

Photo 4: Dry-stone revetment wall to northwest of the length of wall. Photograph taken facing roughly northeast. 1m scale

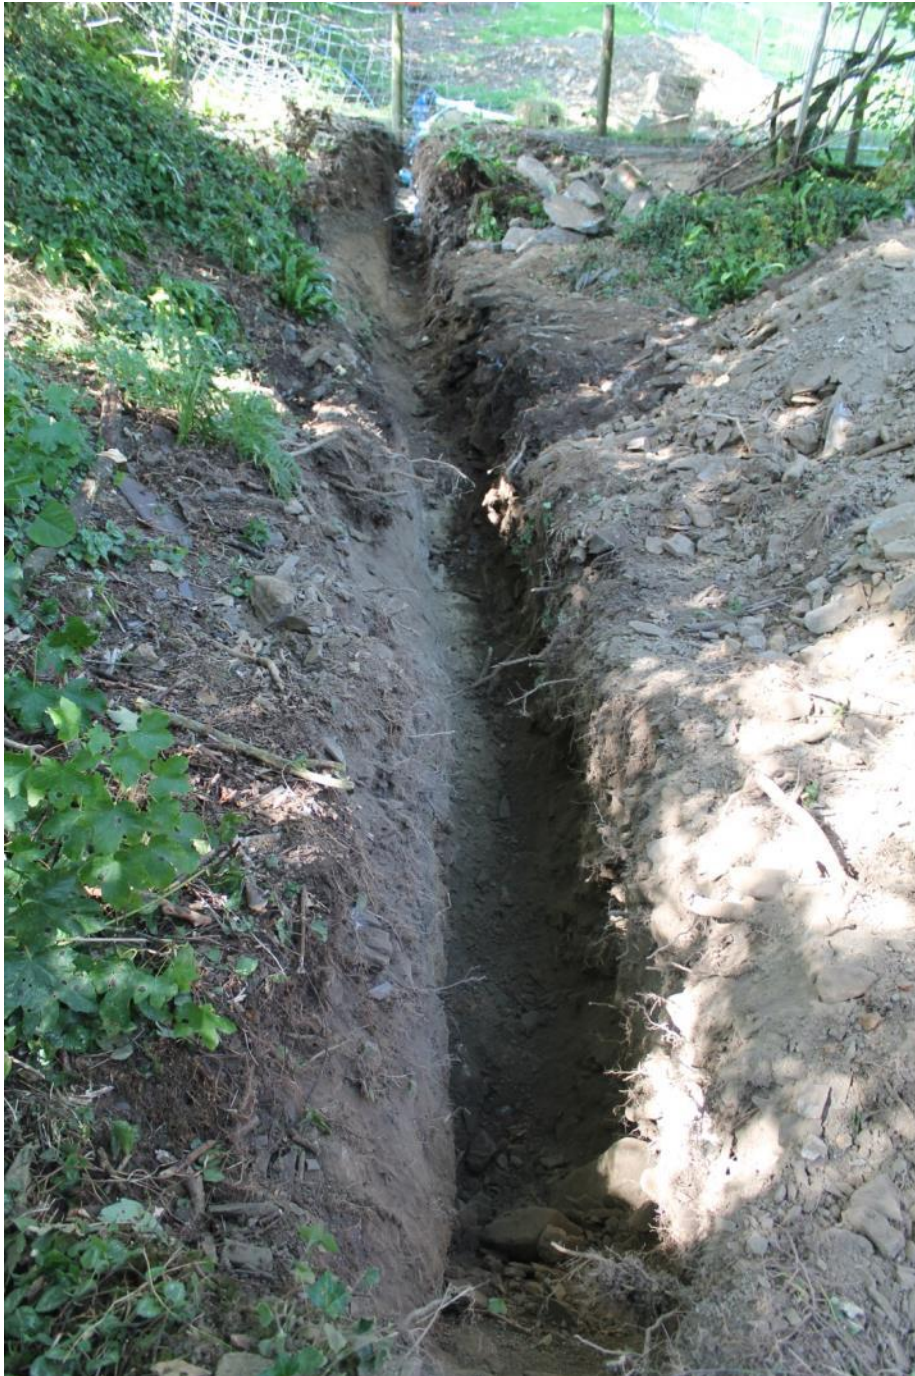
- 4.5 The excavation of the new water main pipe trench was observed from the edge of the pipe junction in the field to the north, to the roadside edge (Photo 5). The matrix of the material within the trench consisted of up to 0.3m of rubble/rubbish deposits overlying 0.9m of mixed material, believed to be backfill from the previous water main excavation, including large stones similar to those visible in the walling. The old water main was exposed towards the base of the trench.

Photo 5: The completed water main replacement trench situated to the northwest of the length of wall. Photograph taken facing northeast.

- 4.6 The pipe replacement scheme only required inserting a new narrower plastic pipe down the length of the old pipe and so there was no need to excavate the trench any deeper.

- 4.7 No further evidence was found for the structure that may be represented by the revealed walling within the area of excavation. However a number of large stones of similar character to those visible in the wall were found loose within the backfill of the trench, and in the fabric of the revetment.
