LAMPETER UNIVERSITY CAMPUS LANDSCAPING WORKS ARCHAEOLOGICAL WATCHING BRIEF (NGR SN 5800 4811)

RHIF YR ADRODDIAD / REPORT NO. 2014/58
RHIF Y DIGWYLLIAD / EVENT RECORD NO. 107535

LAMPETER UNIVERSITY CAMPUS LANDSCAPING WORKS ARCHAEOLOGICAL WATCHING BRIEF

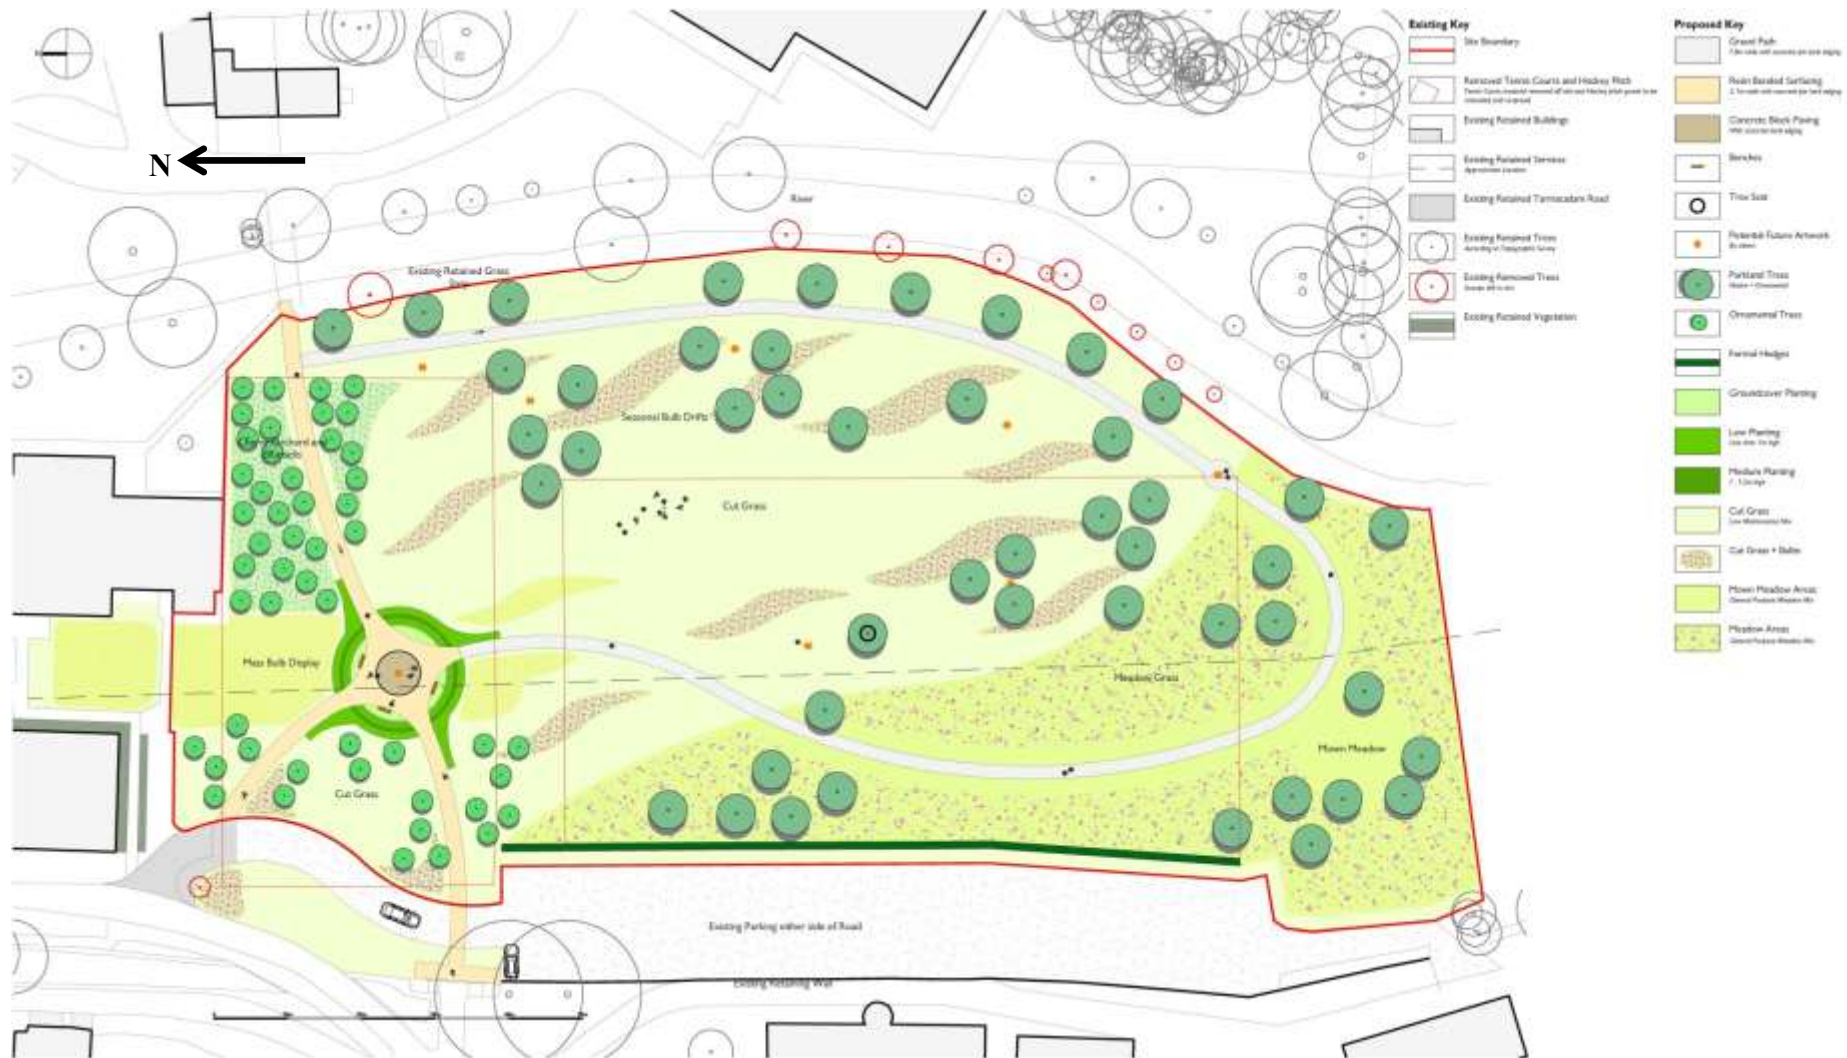
Figure 2: Development site proposals outlined in red, with former tennis courts and hockey pitches outlined (plan supplied by client)

- 2.3 The area for the landscaping works lies within the centre of the campus buildings (Figure 2). Former tarmac tennis courts, used as a car park in recent years, and a gravel hockey ground surrounded by grass existed on the area of development before works started.

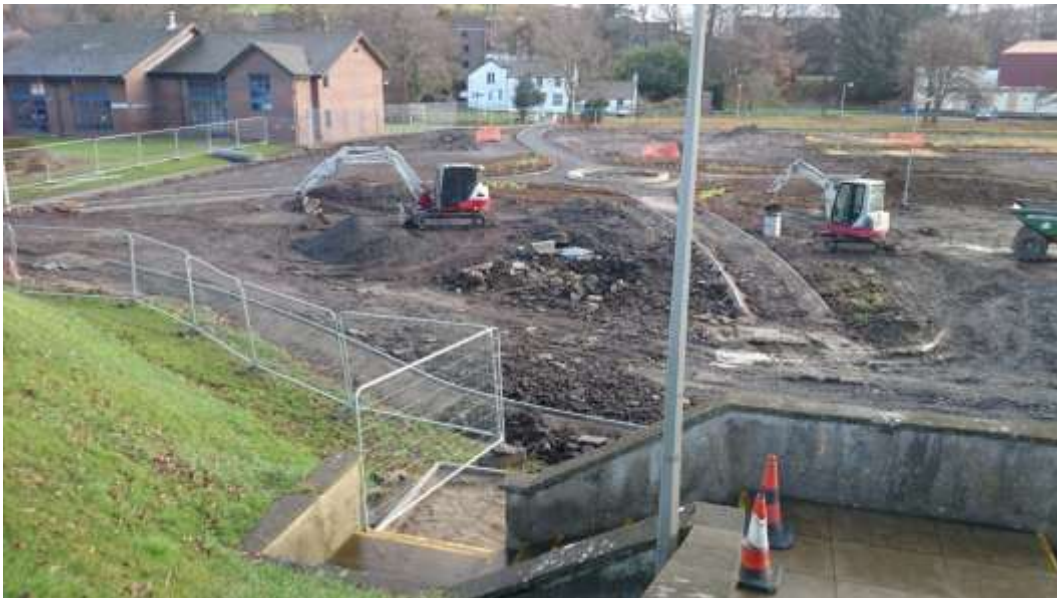
Photo 1: General overview, looking east-northeast, of a large part at the north of the development site after groundworks had taken place. Three of the square drainage pits can be seen, surrounded by orange netting.

- 5.5 The majority of the paths and small 'roundabout' feature in the north-western part of the site area had already been constructed (Photo 1). These stood proud of the stripped surface by around 0.20m, just above or at the previous ground level. The paths had been edged with wooden batons and then the path filled with tarmac. Seemingly no deeper excavations had been needed for the path.

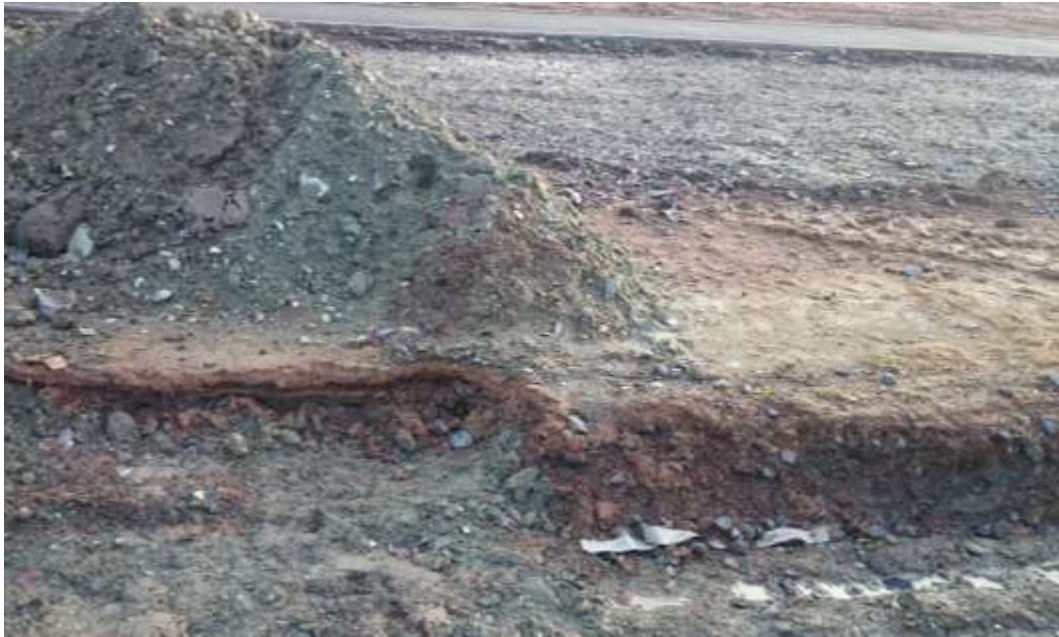
- 5.3 The hockey surfaces and the surface under the tarmac of the tennis courts appear to have comprised a mix of fine grey and red gravels in layers (Photo 2). A c.0.3m depth of these gravels could be seen within the drainage trench around the western edge of the area. This trench was approximately 1m wide. The base of the drainage channel was waterlogged and puddled in many areas.

Photo 2: A vertical section through the groundworks shows the mix of fine grey and red gravels in layers making up the old surfaces of the hockey pitch

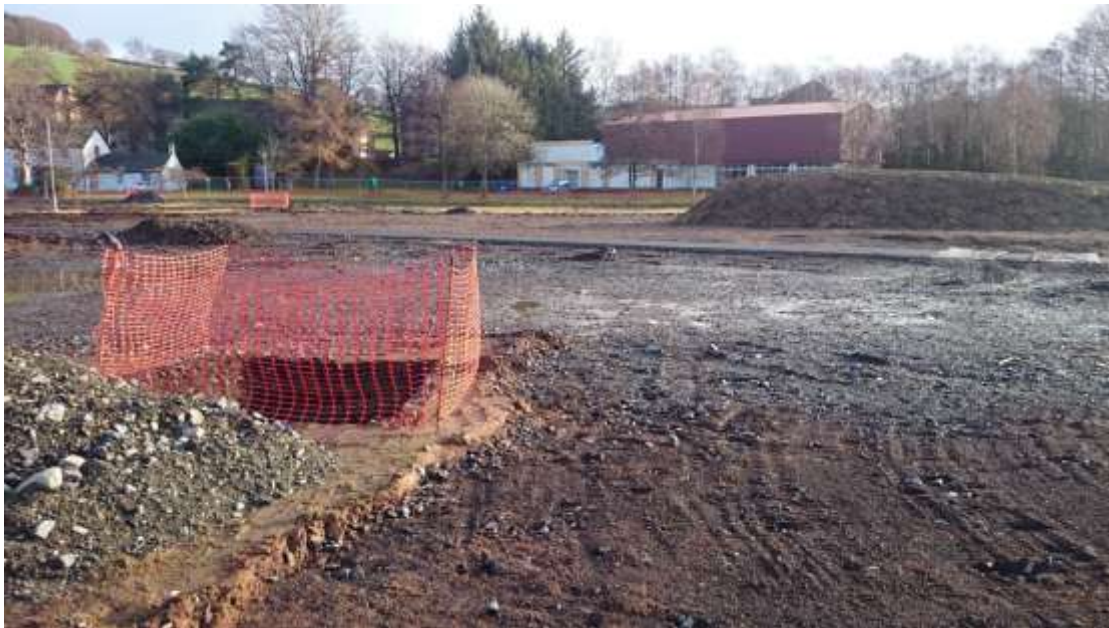
- 5.4 A number of larger pits had been excavated for drainage, measuring approximately 1.5m x 1.5m, possibly for soakaways (locations recorded by photograph only; examples shown in Photo 1 and Photo 3). These were very full of water so their depth could not be gauged.

Photo 3: Looking east: One of the larger drainage holes of approximately 1.5m x 1.5m that had been dug within the area, possibly for soakaways

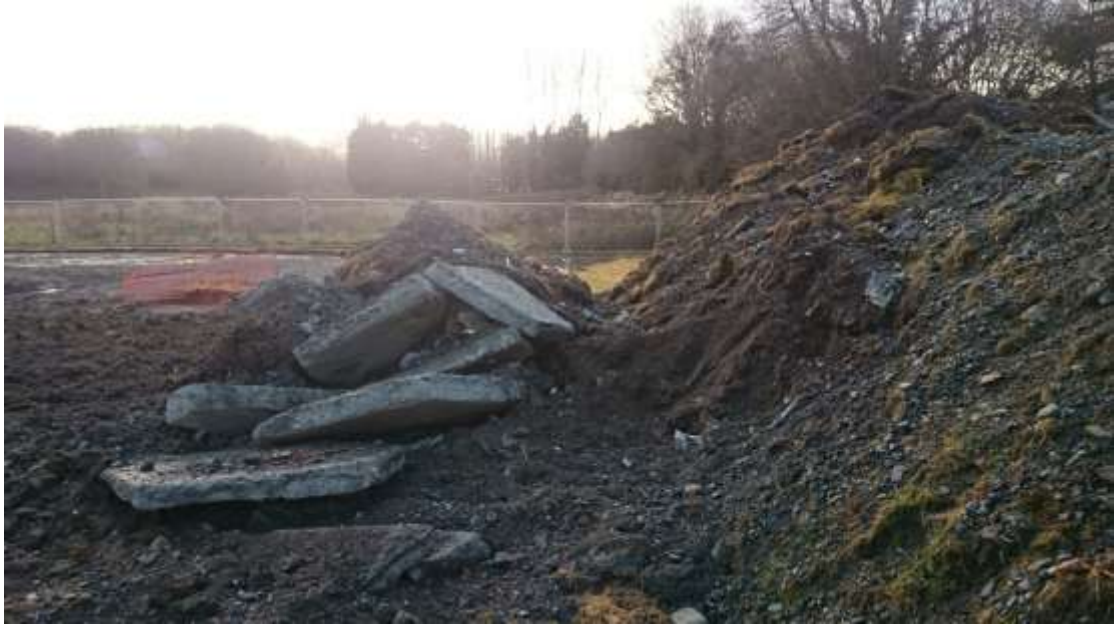
- 5.6 Spoil heaps scattered around the site were either almost entirely gravels, or where turf was present were probably around 40% a light sandy topsoil and turf mixed with former surface gravels. They also contained one area of broken concrete slabs (Photo 4).

Photo 4: Looking south: An example of the spoil heaps scattered around the site, showing light sandy topsoil and turf mixed with former surface gravels, and broken concrete slabs
