# **LAND ADJACENT TO CEFNCOED, LLANEGWAD, CARMARTHENSHIRE: ARCHAEOLOGICAL EVALUATION (NGR SN 51810 21365)**

RHIF YR ADRODDIAD / REPORT NO. 2015/04  
RHIF Y PROSIECT / PROJECT RECORD NO. 107549

# LAND ADJACENT TO CEFNCOED, LLANEGWAD, CARMARTHENSHIRE: ARCHAEOLOGICAL EVALUATION

*An archaeological evaluation was undertaken at Cefncoed, Llanegwad, Carmarthenshire (NGR SN 51810 21365; Figure 1) in order to address a condition placed upon the planning permission for the proposed development plot (Planning Ref. E/28843).*

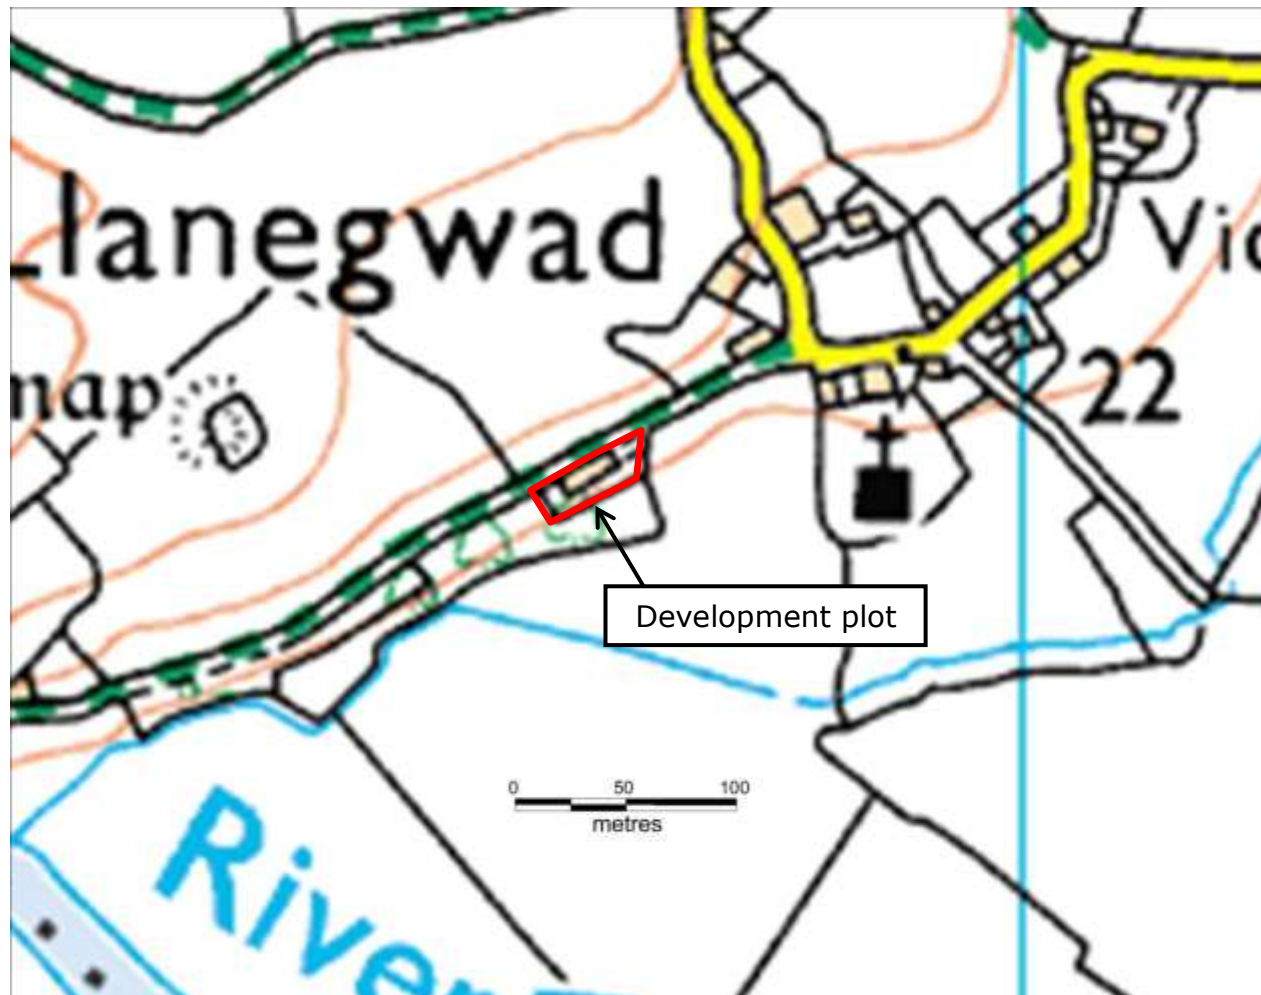
**Figure 2:** 1:25000 OS map showing position of plot. Notice that the former Mount Pleasant Stores building is still shown on the site.

- 2.1.1 The development plot is located on the western fringe of Llanegwad immediately adjacent to the house named Cefncoed (Figures 1, 2 and 3).
- 2.1.2 Topographically the plot is situated on a terrace of levelled ground towards the top of the east-west ridge which leads from Llanegwad to the Towy/Cothi confluence. Downslope, facing south-southeast, the ground steepens considerably before meeting the Towy valley floor.
- 2.1.3 The underlying geology is the Nantmel Mudstones Formation. This is sedimentary bedrock formed approximately 444 to 451 million years ago during the Ordovician Period in a deep sea basin. The drift geology is composed of a clay loam topsoil with downslope alluvial/colluvial processes contributing silty elements in places.

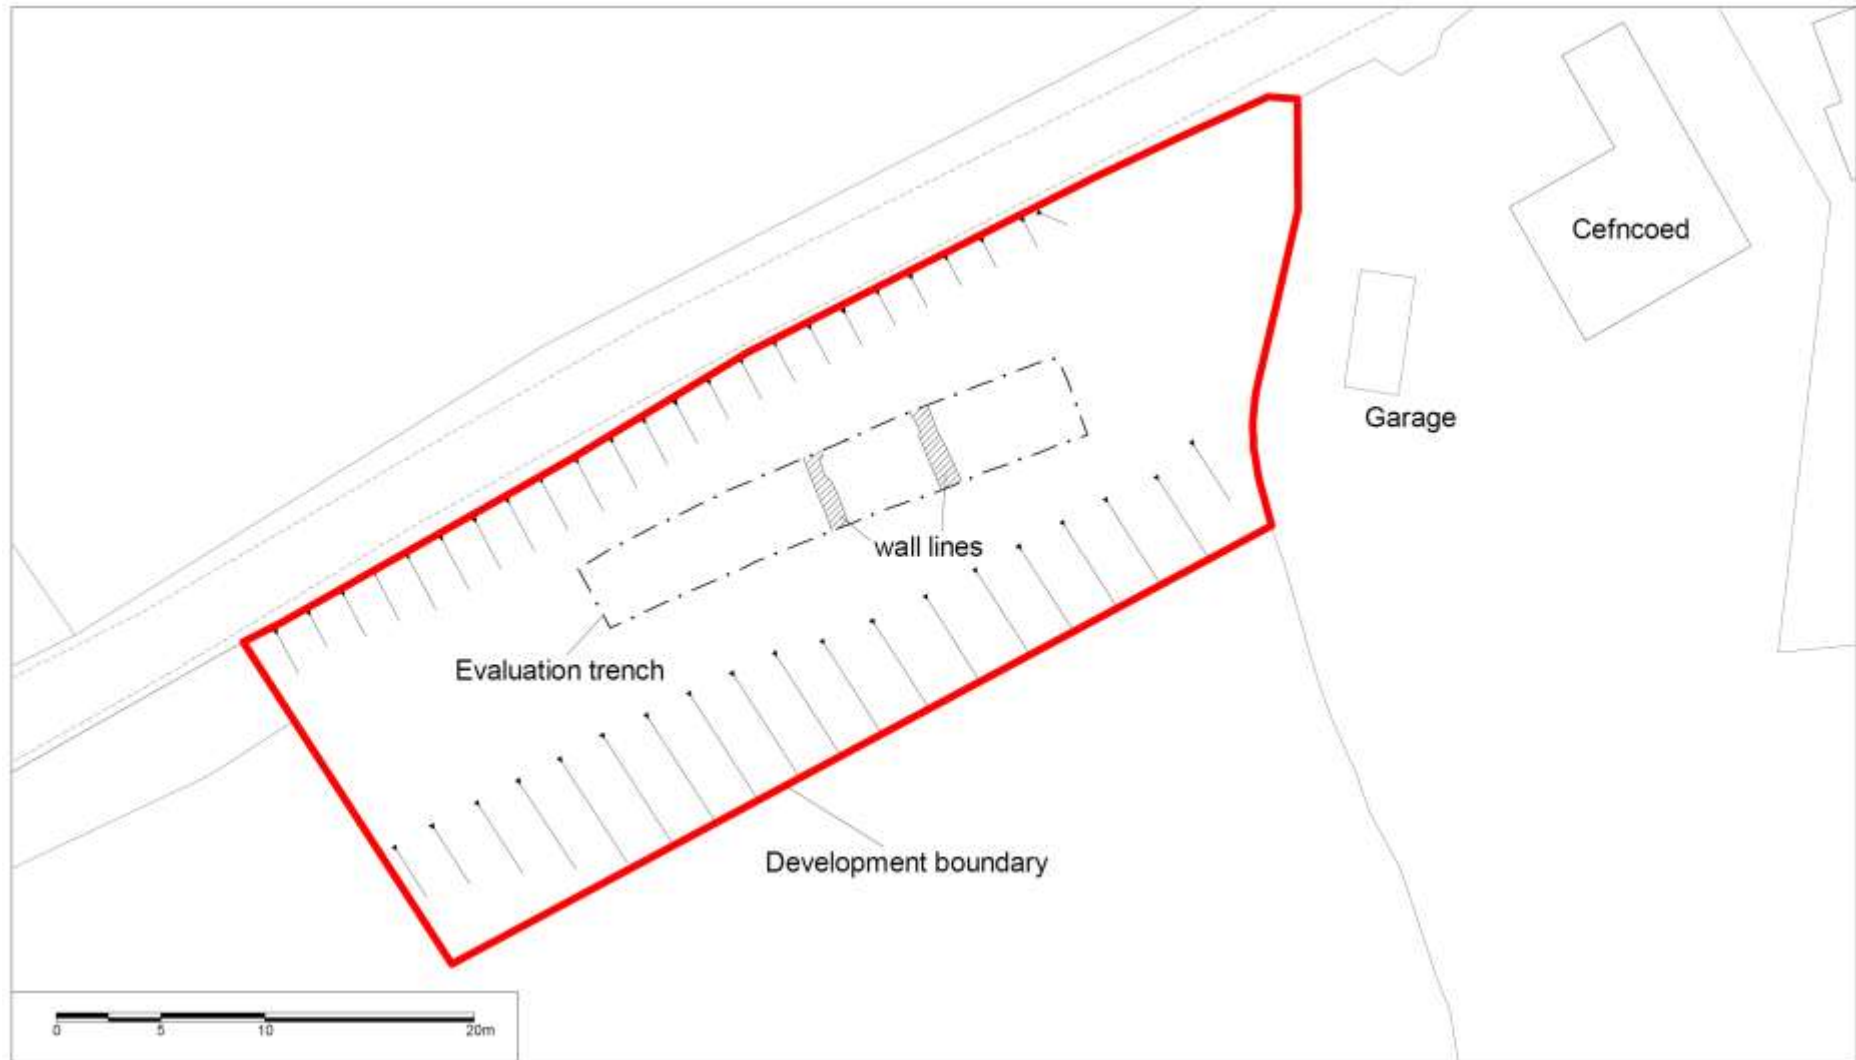
**Figure 6:** Detailed trench location plan, showing Cefncoed, Trench, development boundary and wall lines identified during the evaluation

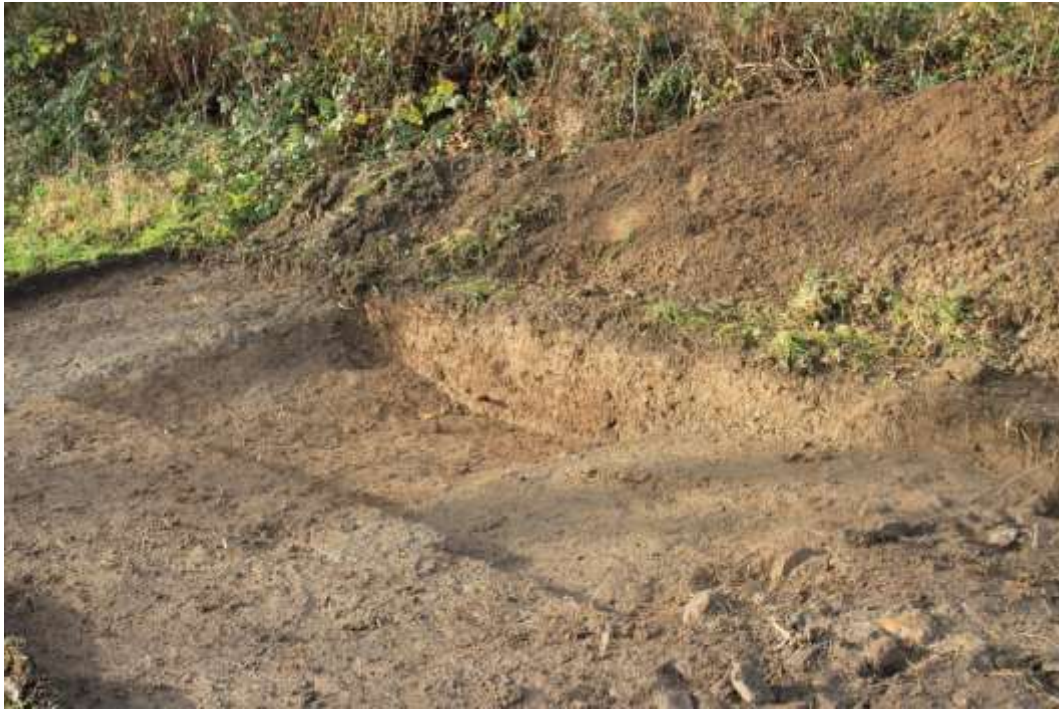
**Photo 1:** Oblique view of ditch towards WSW end of trench, contexts [102] and (103).

- 4.2 Cut [102] was a ditch containing fill (103), a silty clay containing some stone and occasional small fragments of charcoal. It was not fully excavated and yielded only one artefact, a piece of Devon Gravel Tempered Ware. It was possible to discern the corresponding cut on the other side of the ditch showing the width of the feature to be approximately 3m. It ran across the trench directly downslope and may have been a drainage channel (Photos 1 and 2).

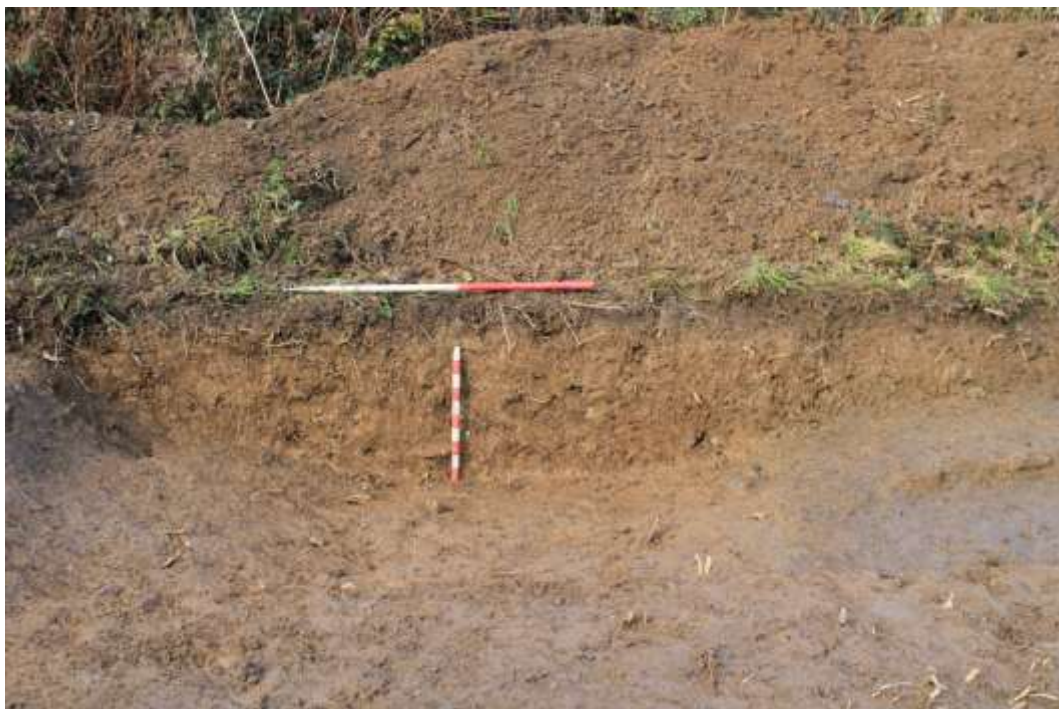
**Photo 2:** View of section across ditch facing NNW, contexts [102] and (103).

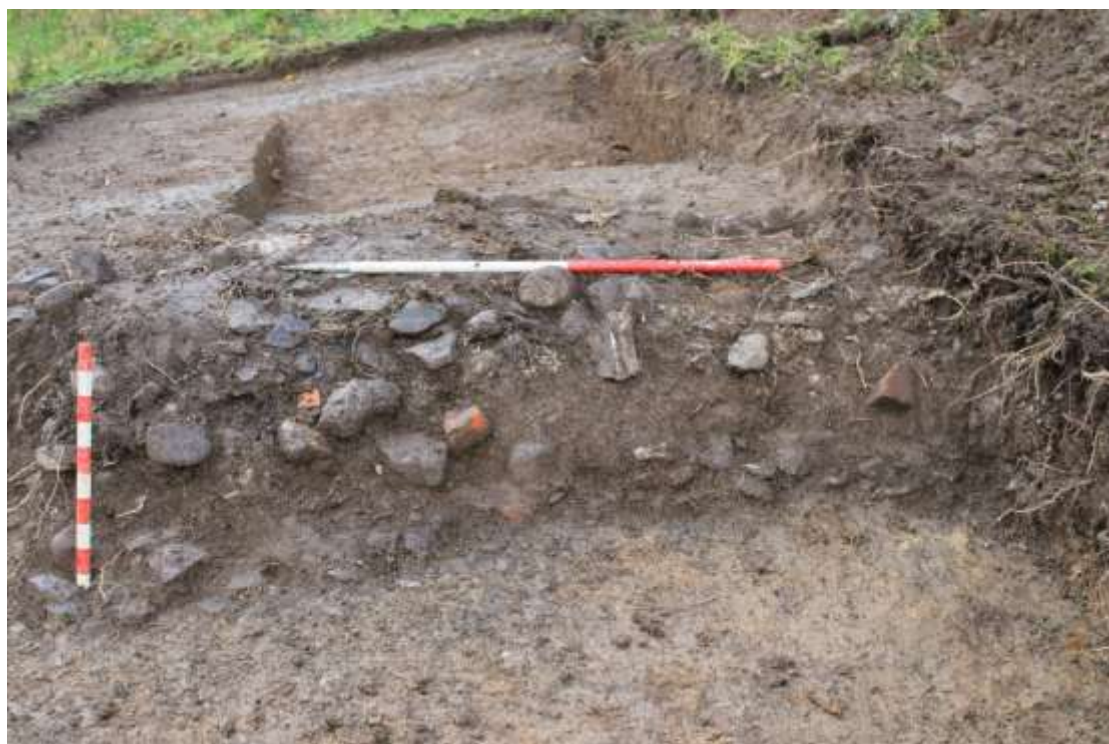
- 4.3 The rubble layer (104) was approximately 11m in length but was mainly excavated by the digger to enable access to the features beneath. It largely followed the contours of these features and was composed of 50% stones with charcoal, brick, and roofing slate in a silty clay loam matrix. Most of the artefacts recovered came from this layer (Photos 3 and 4).

**Photo 3:** Part of rubble layer, context (104).

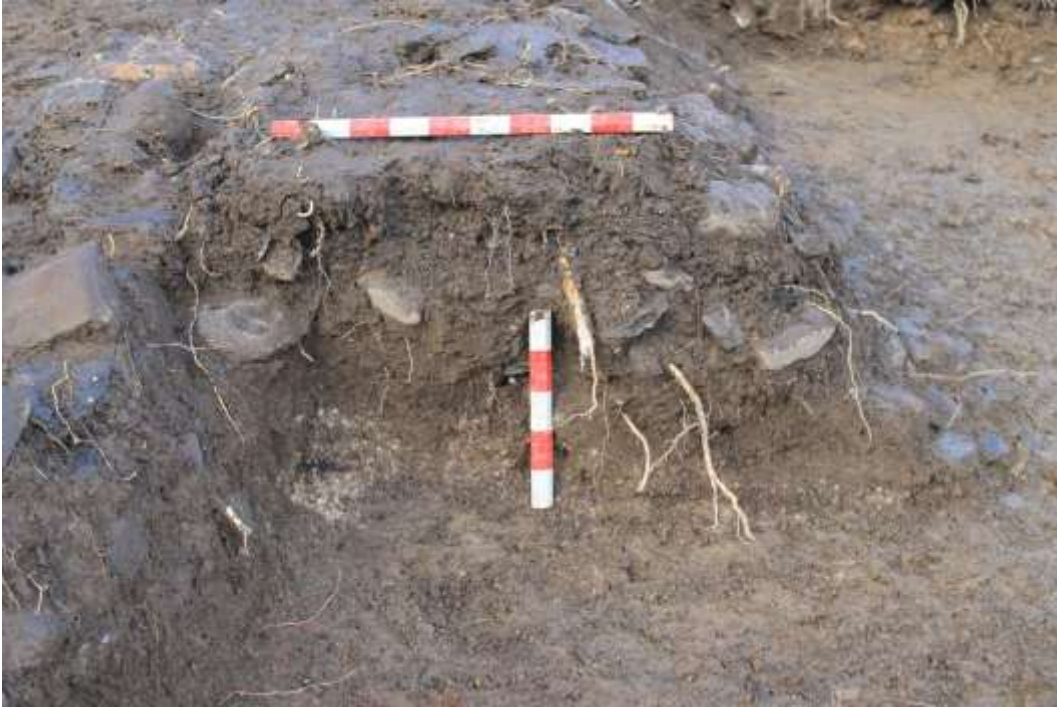
**Photo 4:** Partial section of rubble layer (104). The mortar rubble layer (107) is visible as pale specks along its base.

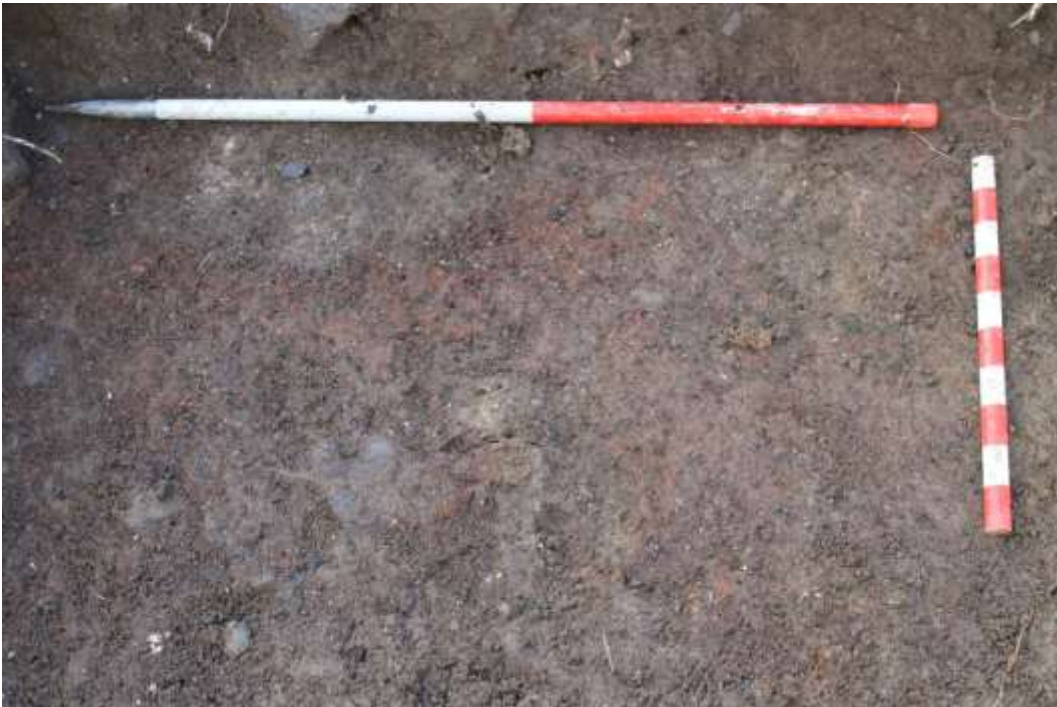
- 4.4 Context (106) was a small patch of what appeared to be packed or rammed clay. Initial interpretation was that it might be a remnant of flooring (Photo 3).
- 4.5 Context (108) was an area of heat-affected material containing small fragments of charcoal. The red tint to this layer is derived from inclusions which cannot be securely identified but could be stone, brick, pottery or any combination of the three (Photo 5).

**Photo 5:** Spread of heat-affected material, context (108).

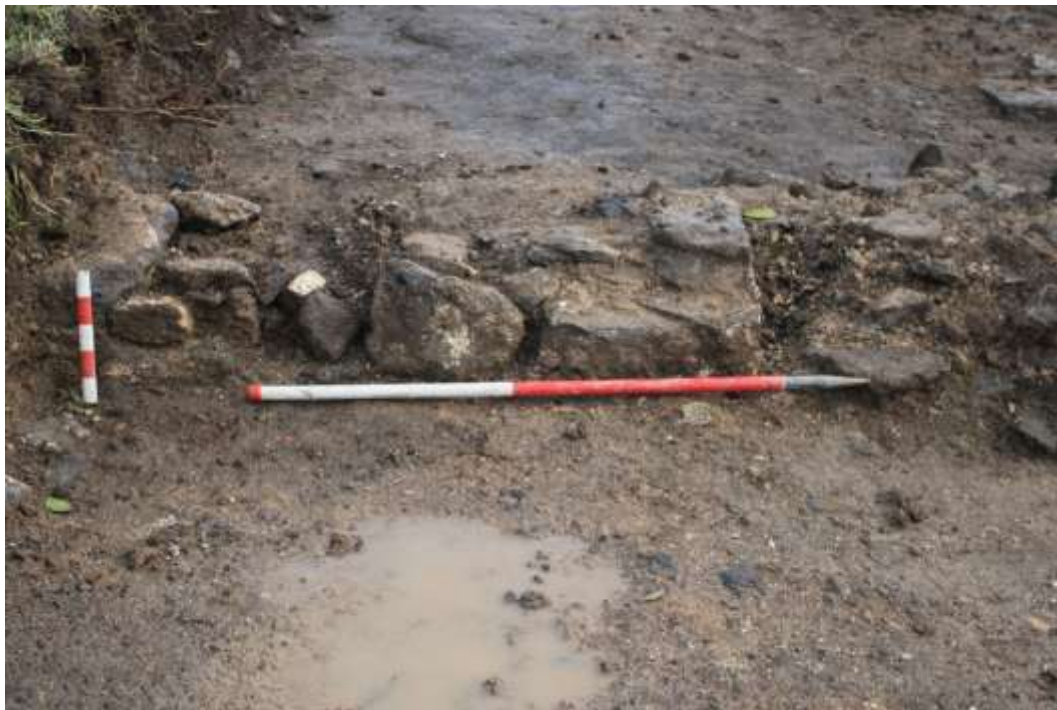
- 4.6 Context (107) was a layer of silt much modified by mortar rubble, fragments of plaster and stones resulting in a loose matrix. At its western extremity it underlay the rubble layer (104) and the heat-affected material (108). At its eastern extremity it abutted a masonry wall (109), (Photos 6 and 7).

**Photo 6:** Mortar rubble layer (107) abutting external surface of WSW wall (109).

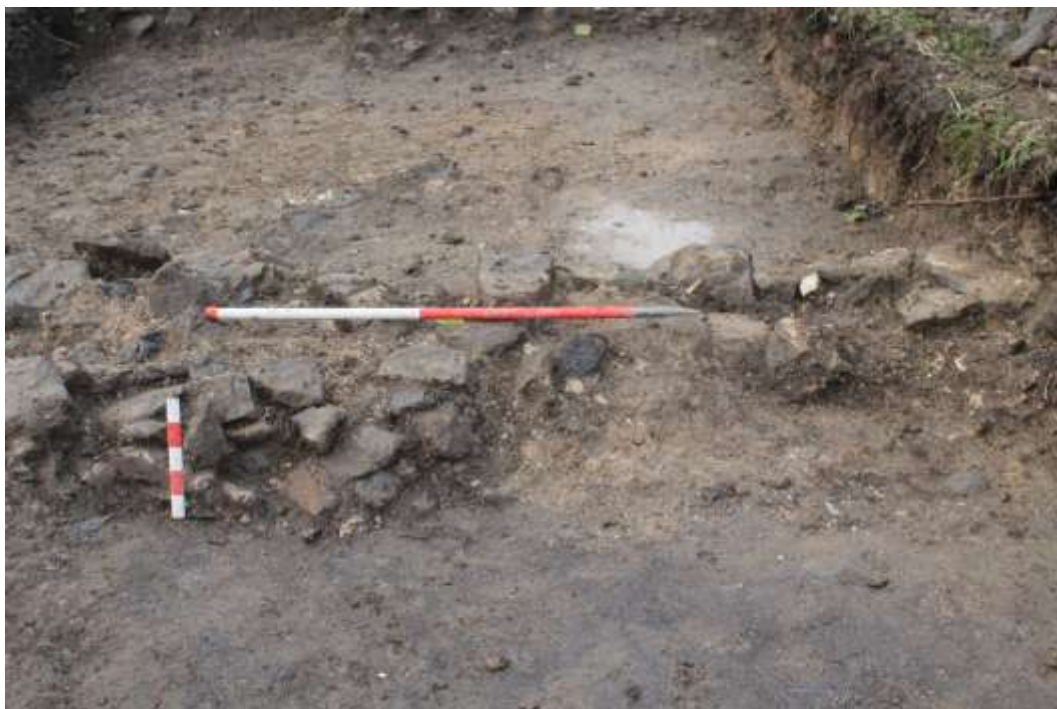
**Photo 7:** Internal surface of WSW wall, context (109).

- 4.7 This western wall (109), though lacking cohesive structure in places, clearly showed a north-northwestern/south-southeastern alignment running across the full width of the trench. There were also traces of limewash on its outer, western face, and on a small section running at right angles to its overall trend. The mortar was clearly visible and was largely homogenous in character lacking any inclusions. Its upper surface was indistinct towards the southern end and may have incorporated part of the overlying rubble layer (104), (Photos 6 and 7).

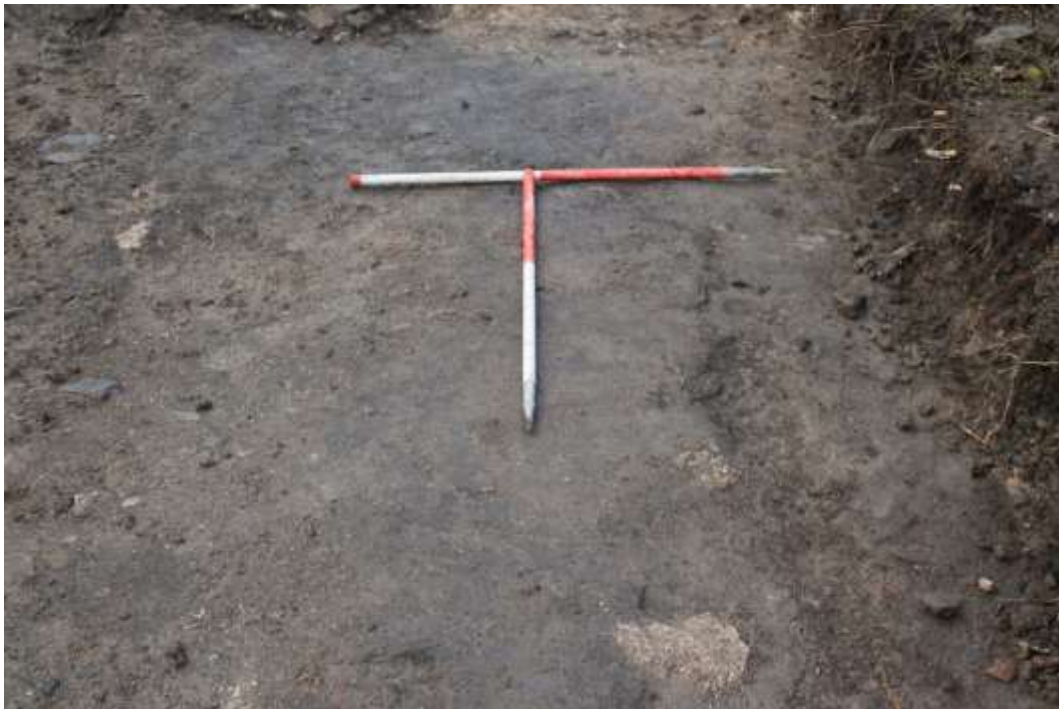
- 4.8 To the east of the western wall the most extensive feature recorded was a packed / rammed clay floor, context (110). Initially only a small section was visible and it was so compacted that it gave the impression of being a slate slab floor. Hand excavation revealed its true composition and a small selection of artefacts were recovered from the layer, some of which implied domestic activities. At its southern side the floor became less distinct and it is possible that deeper excavation would have shown it to extend throughout the entire area. It was noticeable that, while this context did yield some artefacts, they were relatively sparse compared with the overlying rubble layer, context (104). Conjoining pieces of a ceramic vessel were found in context (104) and also in the underlying floor layer (110) which indicated downwards contamination from the rubble context. The lack of artefacts would be typical of a clay floor within the interior of a dwelling, i.e. a living space that was kept clear of household waste and debris (Photo 8).

**Photo 8:** Packed / rammed clay floor, context (110).

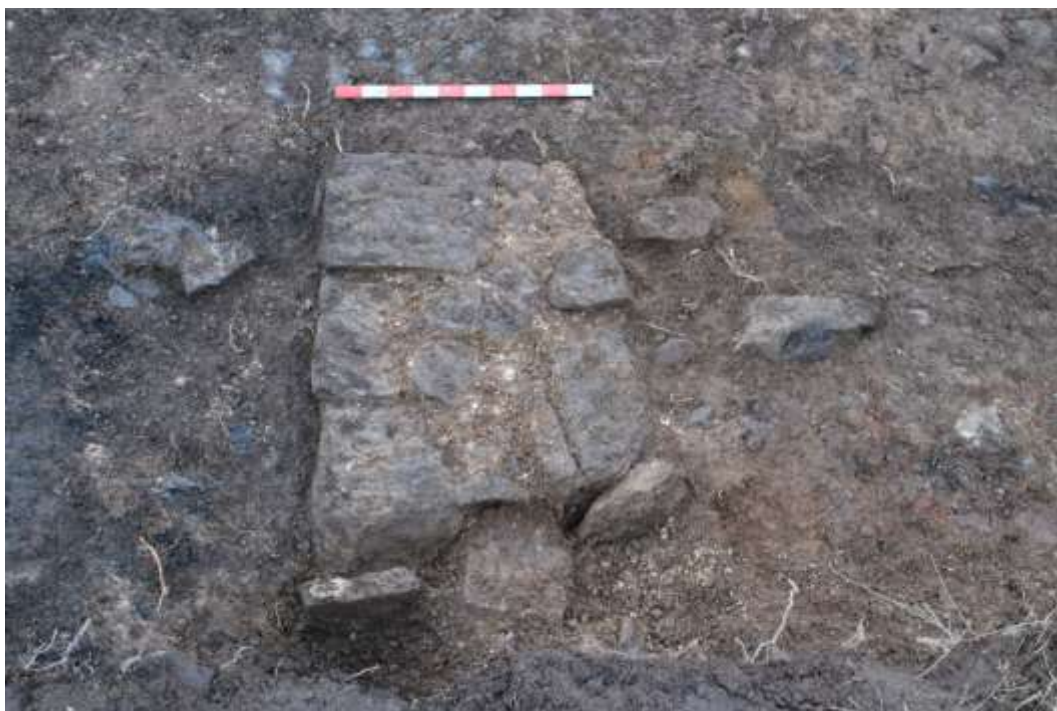
- 4.10 Immediately to the east-southeast of this layer was an area of stones set into the exposed surface, context (112), which formed a small level platform. A large rock appeared to be in alignment with this feature as though it continued under the edge of the trench towards the south-southeast (Photos 9 and 10).

**Photo 9:** Ambiguous feature composed of set masonry, context (112).

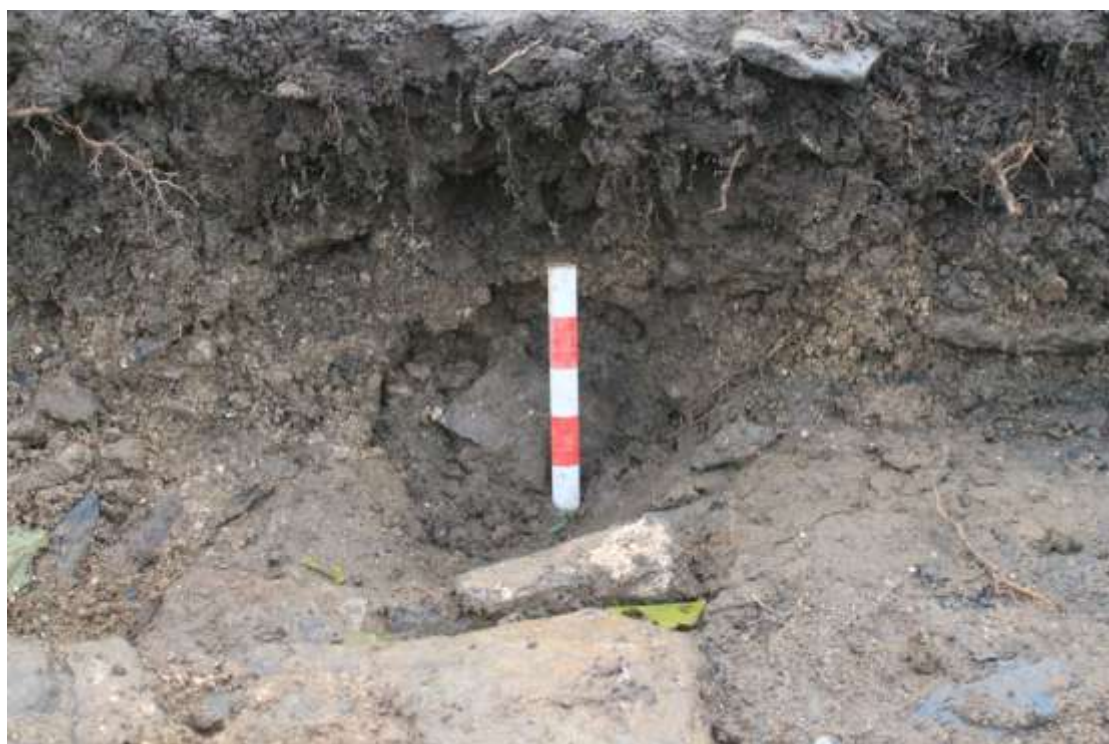
**Photo 10:** Hole where large rock was situated immediately adjacent to masonry, context (112).

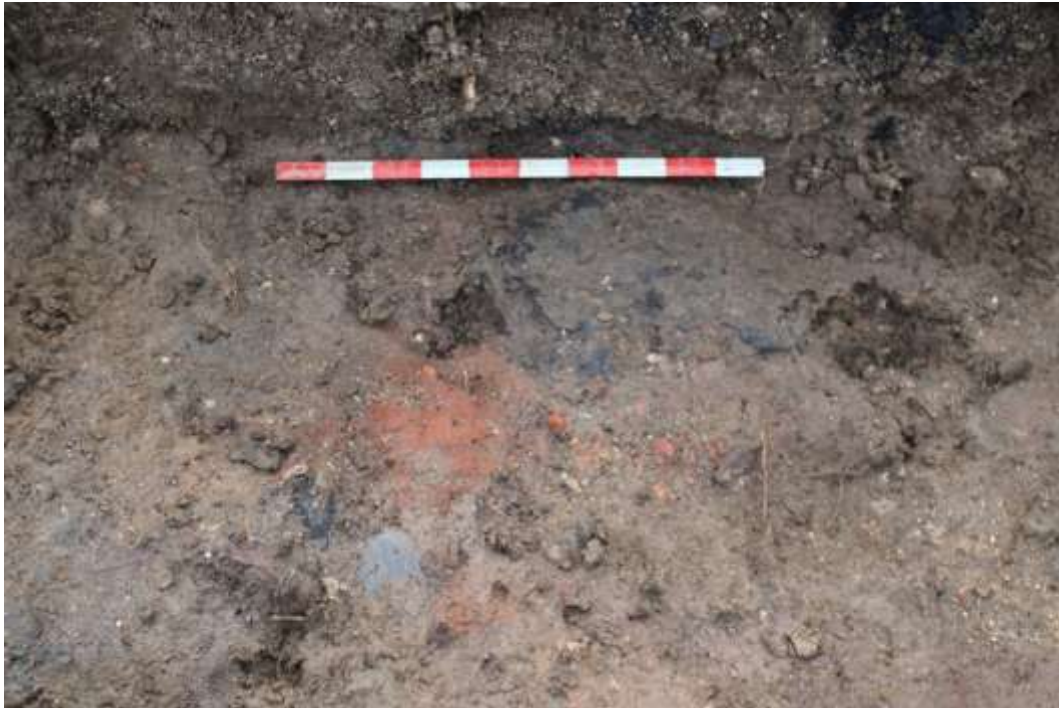
- 4.11 To the east of the stones was small area containing heat-affected materials and a slab of slate laid flat on the surface. Some artefacts were recovered during cleaning – bone, daub, ceramic and mortar – but no clues were forthcoming as to the exact purpose of this area (Photo 11).

**Photo 11:** Spread of heat affected material within building, context (115).

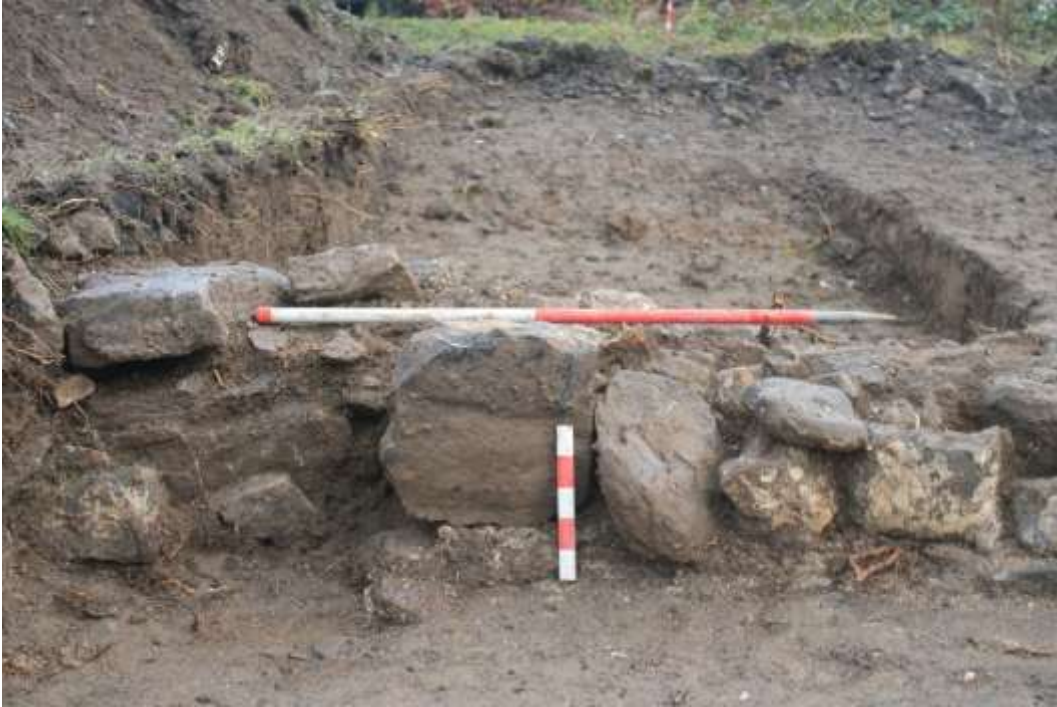
- 4.12 The next feature examined was a wall, context (113). It retained more structural cohesion than its counterpart further to the west with both internal and external faces clearly discernible. Layers of limewash were apparent on the inner surface showing multiple phases of redecoration. The mortar was clearly visible and was largely homogenous in character lacking any inclusions. Towards the southern end the wall took a 90° turn to the west and it was briefly considered that it might be part of the same structure as context (112). However, cleaning did not reveal any other stones or slabs on the same alignment. It is possible that deeper excavations might reveal a connection but at present this has to remain unverified (Photos 12, 13, 14, 15).

**Photo 12:** Internal surface of wall towards ENE end of trench, context (113).

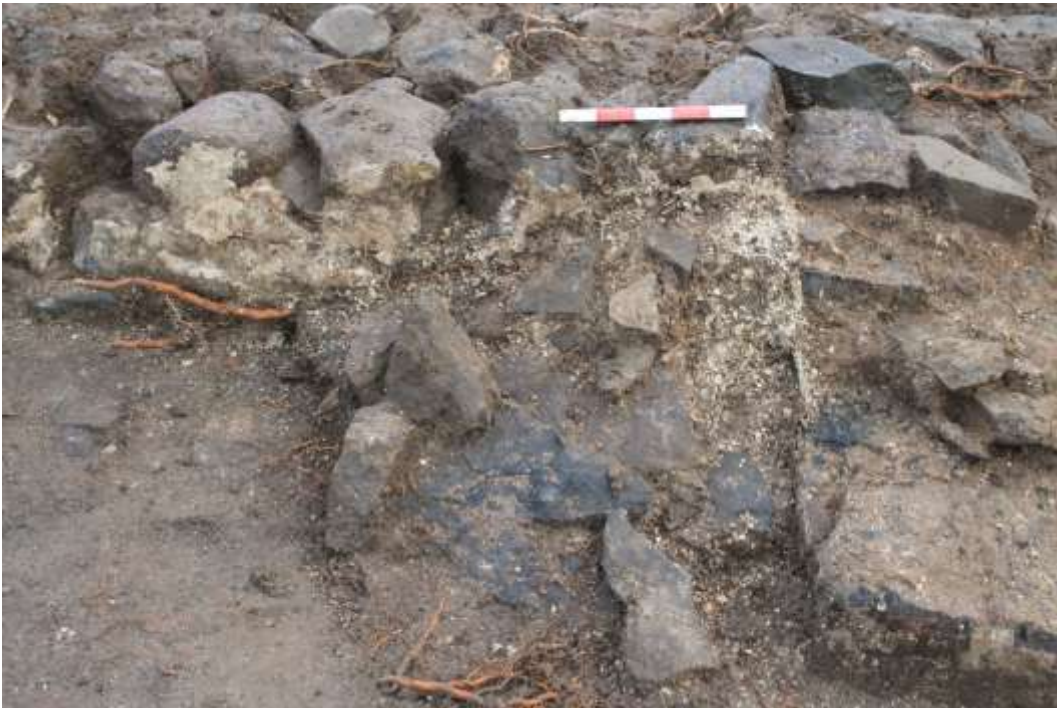
**Photo 13:** Close up of limewash on internal surface of ENE wall. It can clearly be seen how it changes direction by 90° just to the right of the scale.

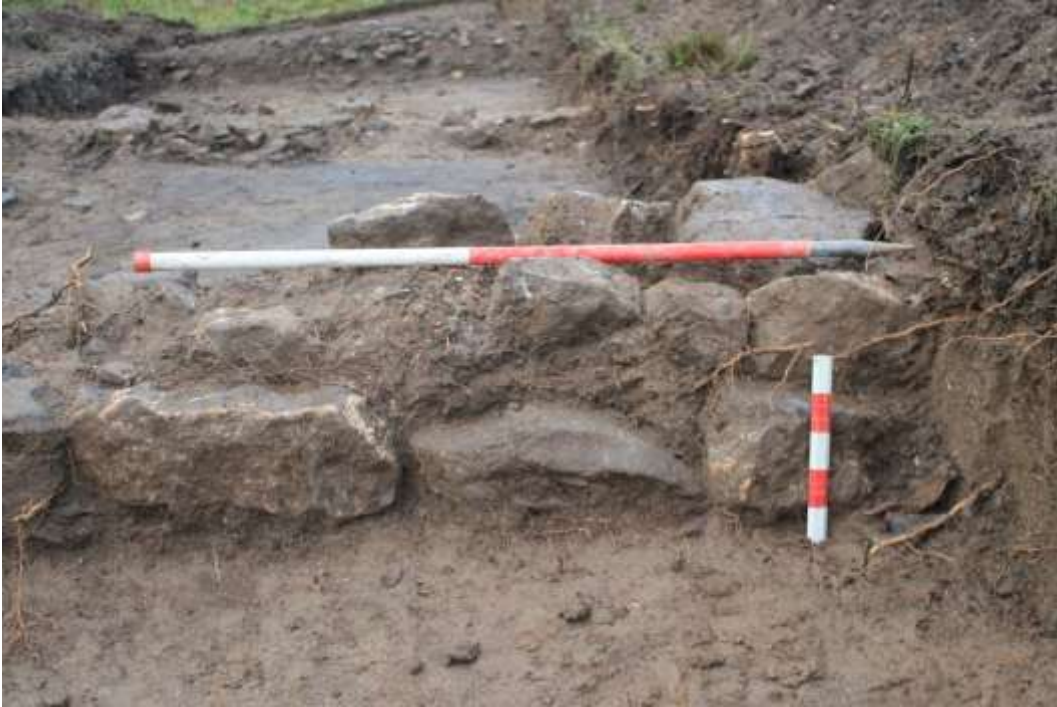
**Photo 14:** External surface of ENE wall.

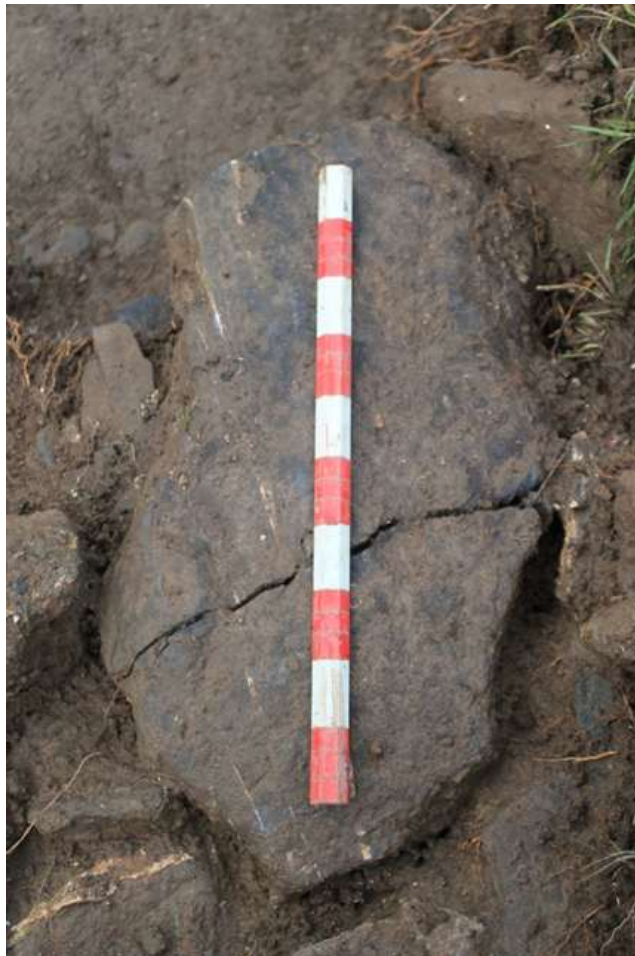
**Photo 15:** Large slate slab in ENE wall.

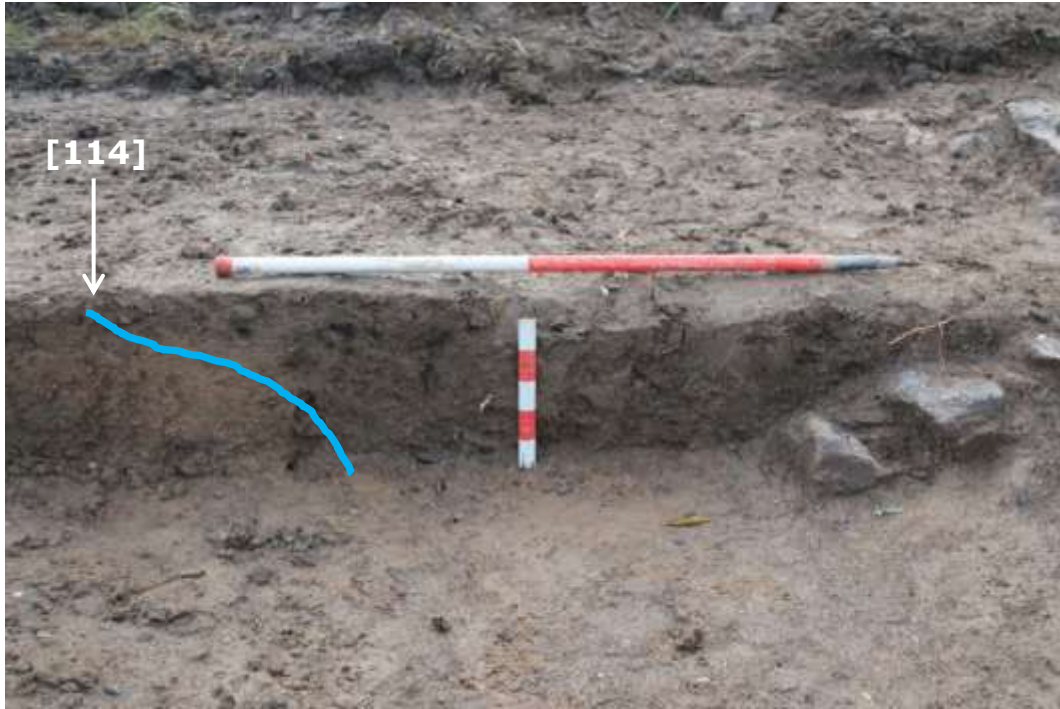
- 4.13 To the eastern side of this wall was a cut, context [114], with an associated fill, context (116). The latter context was largely homogenous in character and gave evidence of downslope alluvial / colluvial processes involving sediments higher up the hill being redeposited them against the outside of the building, thus filling the eastern end of the terrace. These features were not fully excavated and so their relationship to the wall cannot be fully established (Photo 16).

**Photo 16:** Platform cut [114] left, with tumble external to ENE wall on the right.

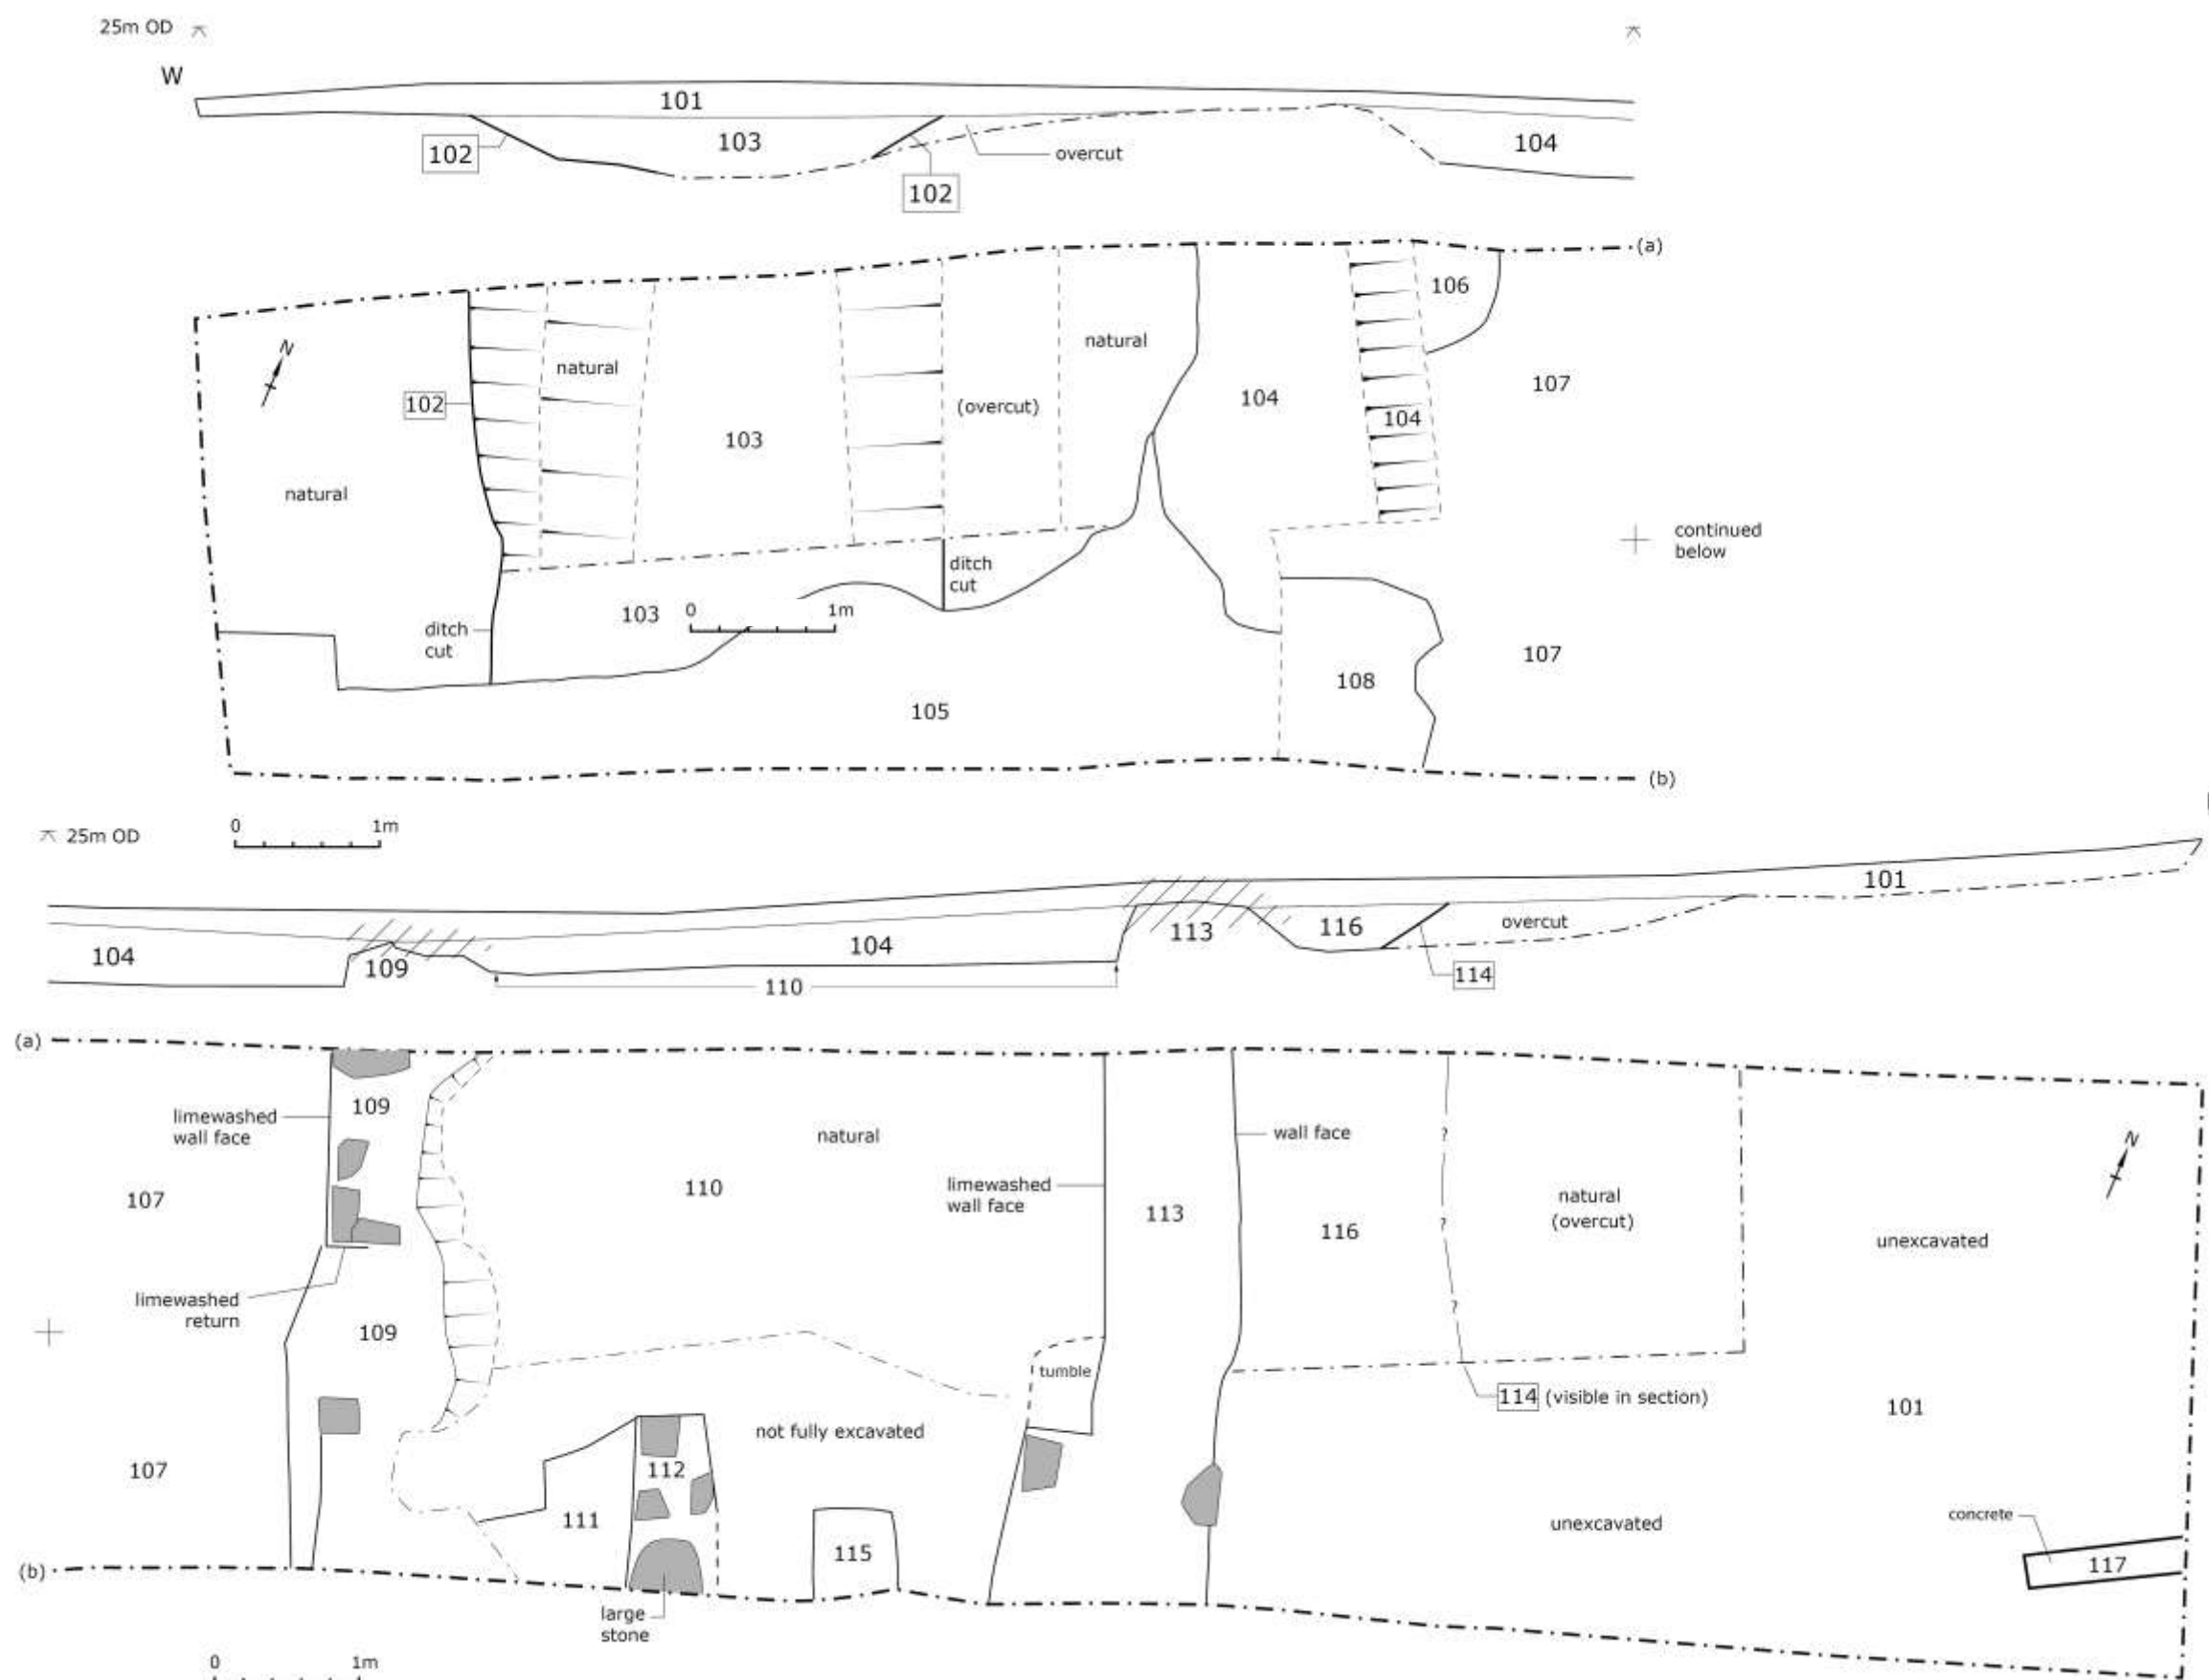
- 4.1 Descriptions of the archaeological contexts recorded in the trench can be found in Table 3 and illustrated in Figures 6 and 7.
- 4.2 Working from west to east the features revealed were as follows.
- 4.3 At the WSW end of the trench was an expanse of natural deposits bounded on its southern edge by a spread of rubbish, context (105). This was largely composed of small fragments of pottery, brick and charcoal with some stones of various sizes. It is unclear as to whether this layer was a distinct context or whether it was an unexcavated remnant of the topsoil. At its eastern end the rubbish layer abutted a rubble layer, (104).

**Figure 7:** Plan view of trench with south facing section.
