# **LAND ADJACENT TO CEFNCOED, LLANEGWAD, CARMARTHENSHIRE: ARCHAEOLOGICAL EVALUATION (NGR SN 51810 21365)**

RHIF YR ADRODDIAD / REPORT NO. 2015/04  
RHIF Y PROSIECT / PROJECT RECORD NO. 107549

# LAND ADJACENT TO CEFNCOED, LLANEGWAD, CARMARTHENSHIRE: ARCHAEOLOGICAL EVALUATION

*An archaeological evaluation was undertaken at Cefncoed, Llanegwad, Carmarthenshire (NGR SN 51810 21365; Figure 1) in order to address a condition placed upon the planning permission for the proposed development plot (Planning Ref. E/28843).*

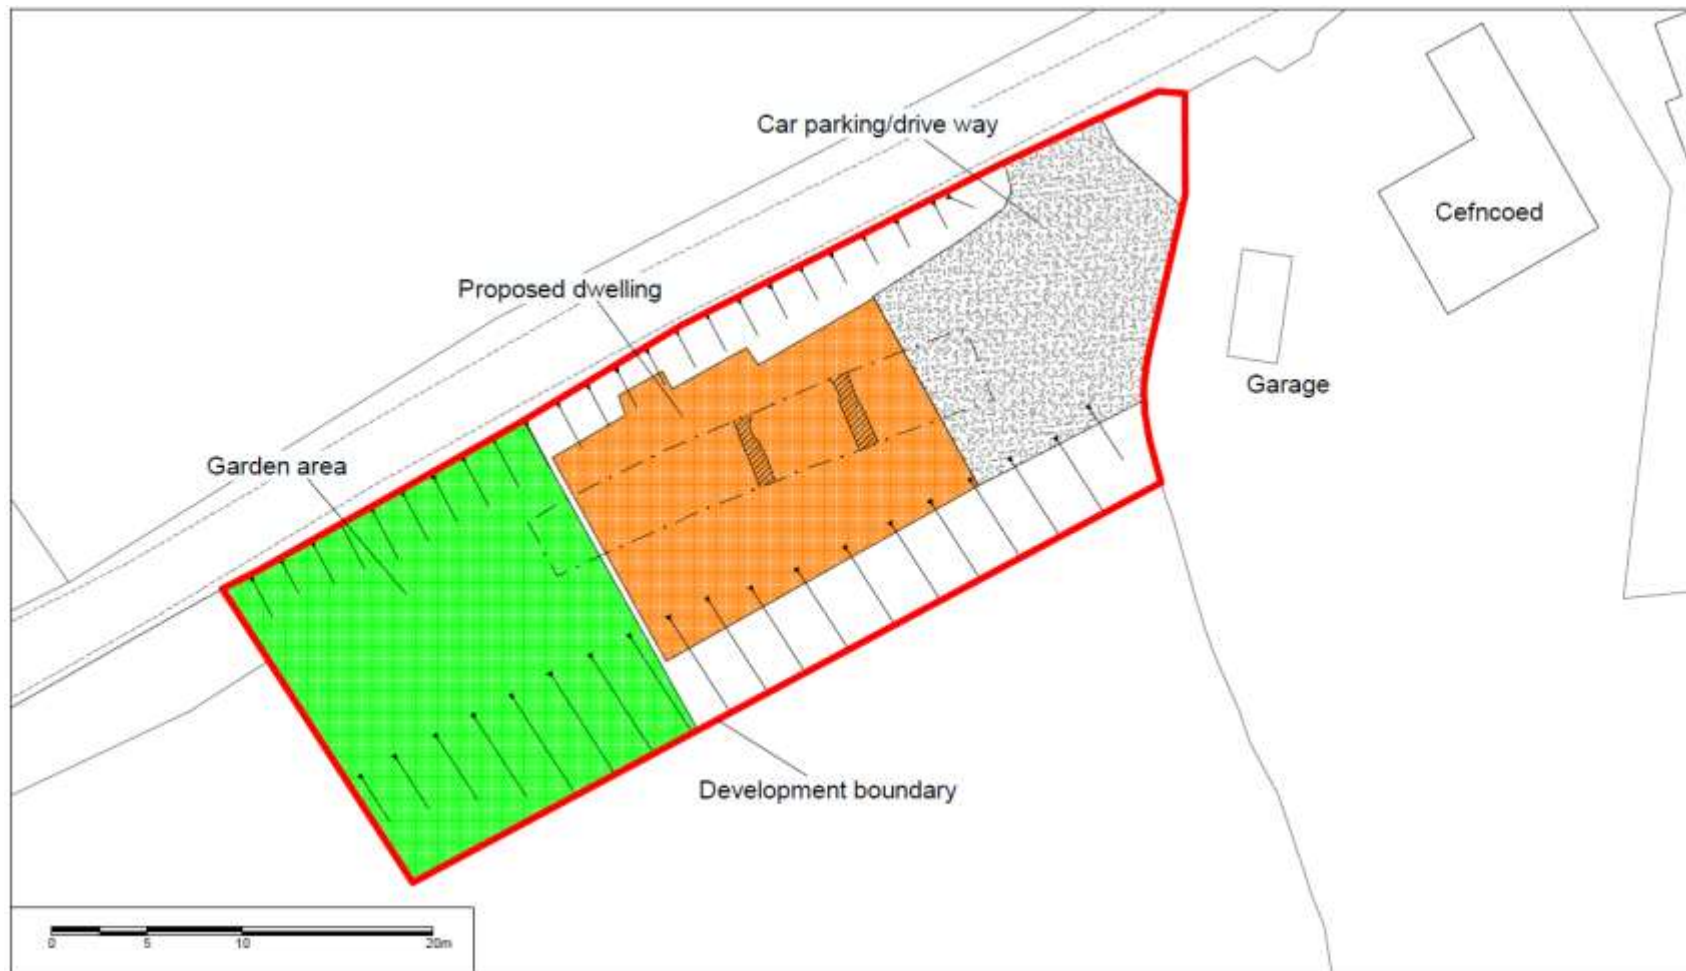
**Figure 8:** Development proposals overlaid on trench plan

- 5.8 The development proposals indicate that the western third of the site area will be utilised as gardens, which is likely to cause little disturbance to any below ground remains. The eastern part of the development plot will be used as parking for the new house, which could require some ground disturbance although this will be located on top of existing car park material. Disturbance to below ground remains could occur here. The proposed dwelling lies within the centre of the site area, directly on top of the recorded structure. Ground disturbance of the surviving remains of the cottages is very likely to occur from the erection of the new dwelling, although the extent of this would depend upon the method of construction used (Figure 8).
