TIN SHED MUSEUM AND PLOT 1, ELDON, CLIFTON STREET, LAUGHARNE: ARCHAEOLOGICAL WATCHING BRIEFS

RHIF YR ADRODDIAD / REPORT NO 2014/16
RHIF Y PROSIECT / PROJECT RECORD NO. 107551 – Tin Shed Museum
RHIF Y PROSIECT / PROJECT RECORD NO. 106478 – Plot 1, Eldon

Ionawr 2015
January 2015

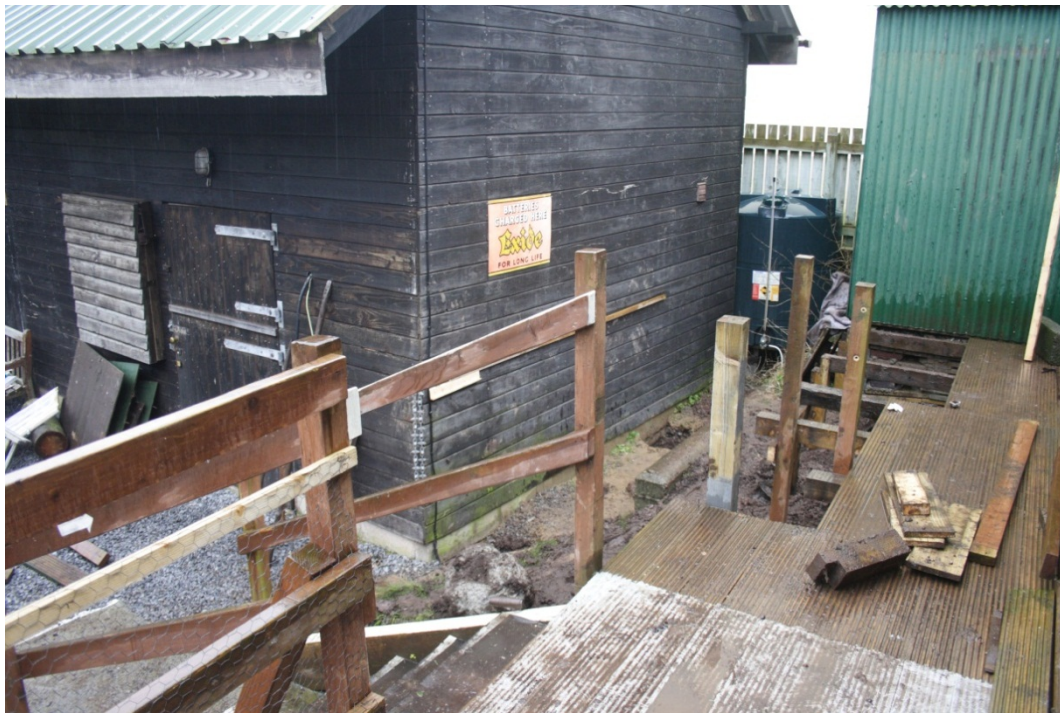
Photo 1: Location of the new toilet to the rear of the Tin Shed Museum and east of the wooden stable (with oil tank behind). Facing northwest.

- 4.1.1 The location of the toilet and waste pipe trench were established by the site contractors according to the plan laid out by the architect (see Figure 2).
- 4.1.2 The area of the proposed toilet was partially covered by raised decking which had been removed prior to the works commencing. The decking was raised some 0.58m above the underlying ground surface, which comprised a very dark garden soil. To the west of the decked area was a concrete revetment wall of 0.46m height which dropped down to a crushed stone area some 0.76m in width between the wall and the adjacent wooden stable (Photo 1, Figure 5).

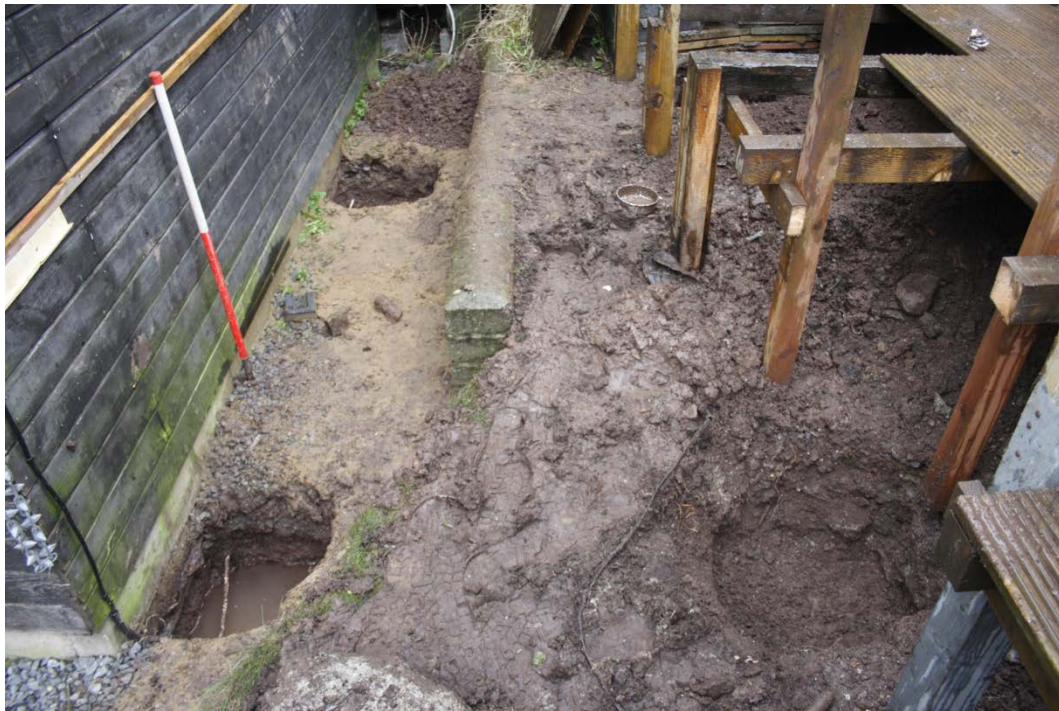
Photo 2: View north showing pits for the foundation pads. 1m scale.

- 4.1.3 Four roughly square pits for the foundation pads for the toilet were hand excavated through the exposed ground surface, two on the raised area of the garden soil and two in the lower part adjacent to the wooden stable through the crushed stone (Photo 2).

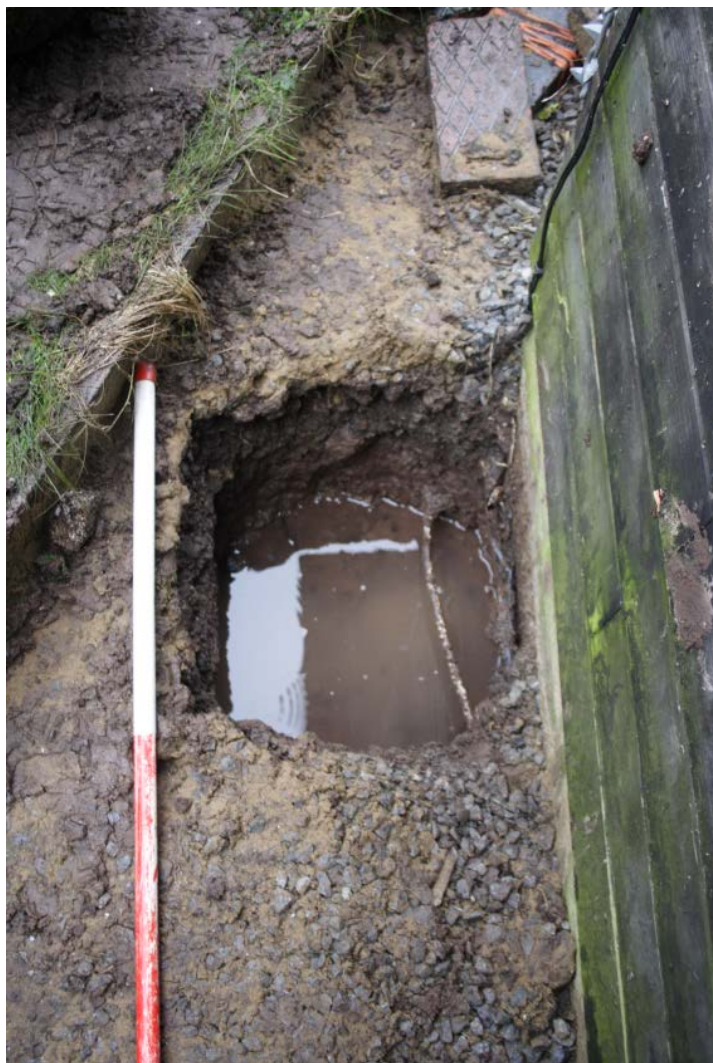
Photo 3: Northwestern pit against end of wooden stable wall, with oil pipe exposed, viewing east with 1m scale

- 4.1.4 The northwestern pit was roughly 0.55m square located directly adjacent to the foundations for the adjacent stable (Photos 2 and 3). It was excavated to a depth of 0.44m through layers of crushed stone. Within these layers of crushed stone was a thin metal pipe which carried heating oil from the oil tank to the north to the nearby boiler for the museum.

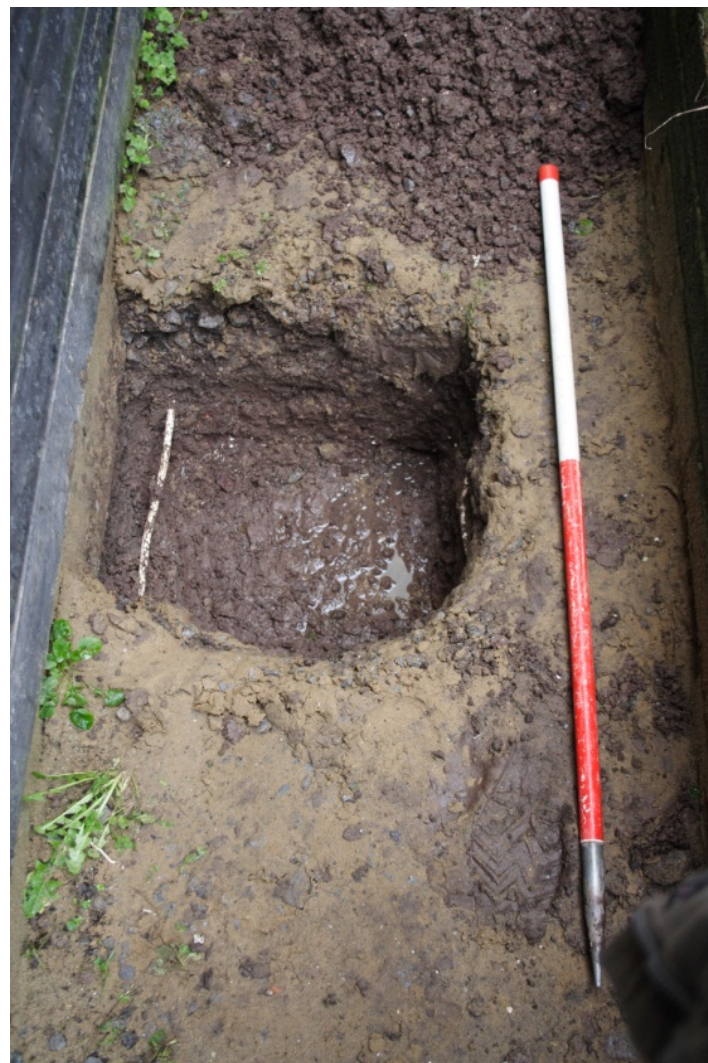
Photo 4: Southwestern pit against wooden stable wall, with oil pipe exposed, viewing west with 1m scale

- 4.1.5 Located 1.75m to the south of the northwestern pit was a second excavated at the lower level through the crushed stone layers. This pit measured roughly 0.50m square and again of 0.44m depth. The oil pipe was again exposed within the pit, as were the foundations for the wooden shed (Photos 2 and 4).

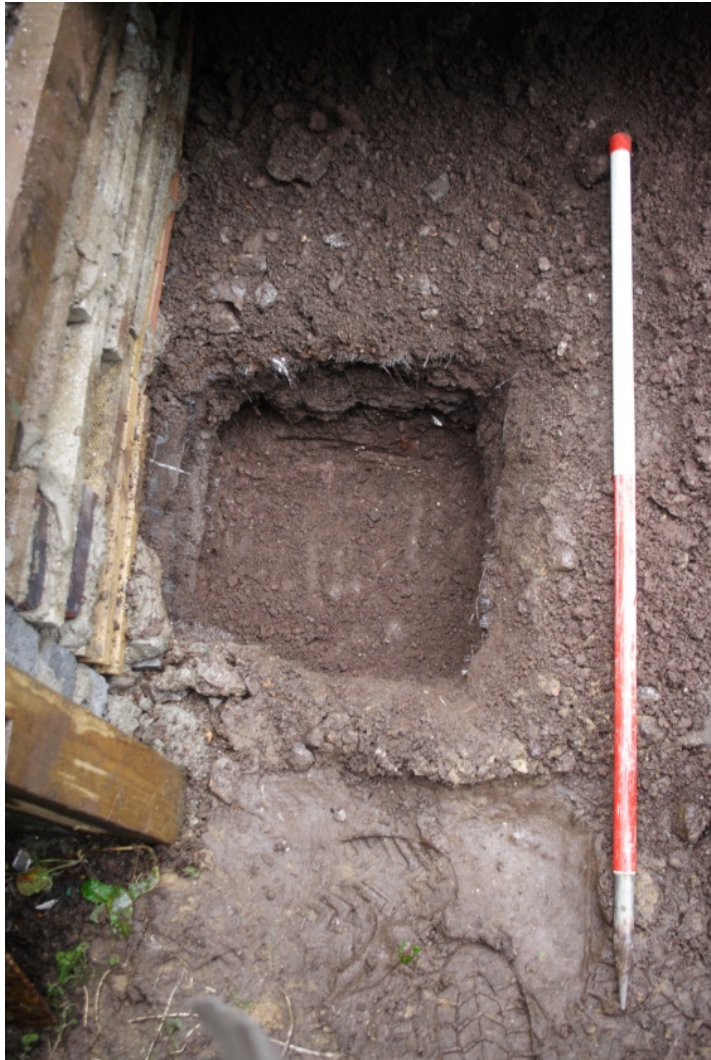
Photo 5: Northeastern pit excavated through garden soils with decking supports visible, viewing north with 1m scale.

- 4.1.6 The northeastern pit was 0.50m square and excavated to a depth of 0.47m depth through layers of very dark garden soils (Photo 2 and 5). The pit was excavated adjacent to supports for the former decking and a smaller galvanized steel building to the north. A single soil layer was excavated from which a number of pieces of modern detritus were recovered, mostly comprising broken ceramics and glass. This pit was located 1.10m east of the northwestern foundation pit.
- 4.1.7 The southeastern pit was located 1.70m south of the northeastern pit and 0.96m east of that to the southwest. The pit measured 0.60m x 0.55m and was excavated to a depth of 0.45m. This pit was again excavated through a homogenous garden soil layer containing fragments of modern detritus.

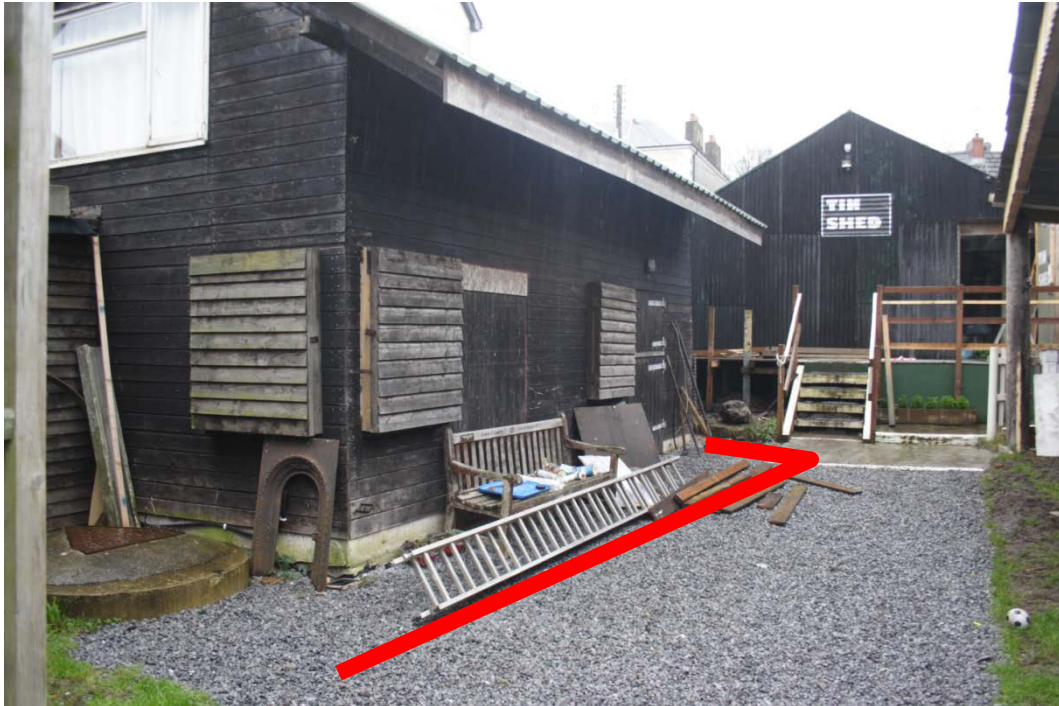
Photo 7: Route of the waste pipe from the toilet east of the stable, turning along the front of the stable towards existing sewer, with manhole for sewer on left of photo

4.1.9 At a later date the waste pipe from the toilet was excavated, leading down to the existing large manhole and sewer run which passes through the western part of the Tin Shed plot, immediately west of the wooden stable (Photo 7). This was viewed following excavation (no photographs illustrated), as it was known that the area had been previously disturbed. The sewer trench was cut through layers of stone which formed the ground surface outside of the wooden stable. This overlay layers of waste material and garden soil and no significant archaeological remains revealed. The join with the existing sewer cut through previously disturbed ground.

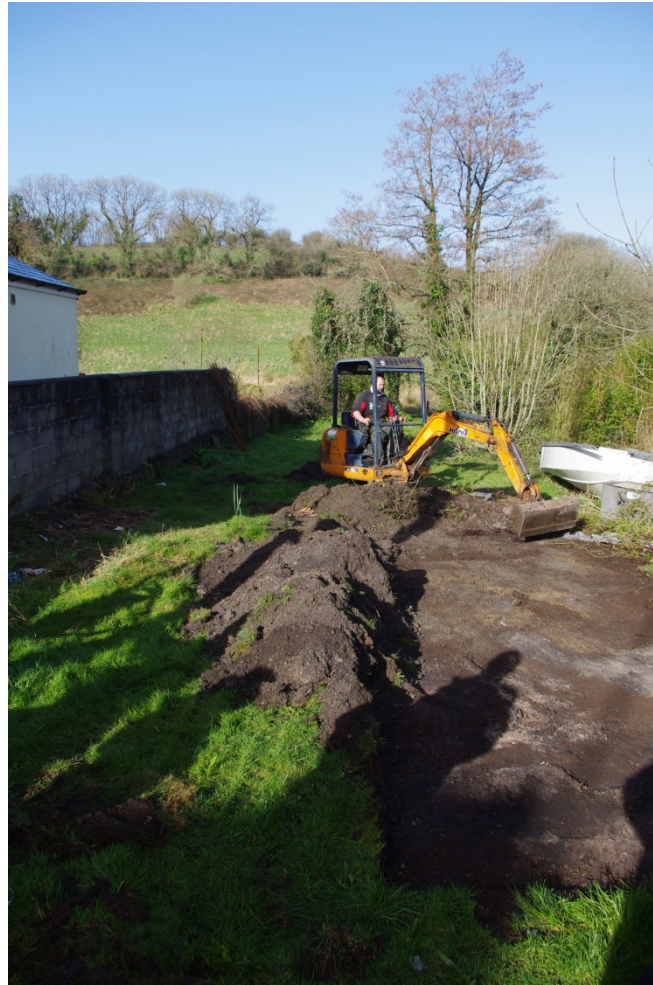
Photo 8: Topsoil stripping across site area, viewing west across Plot 1, Eldon from Clifton Street entrance

- 4.2.3 The topsoil was stripped to an approximate average depth of 0.15m using a mini-digger with a toothless ditching/grading bucket (Photo 8). The footprint of the building was reduced to the formation level on top of which a concrete raft foundation was to be constructed, and so the depth of groundworks was minimal.

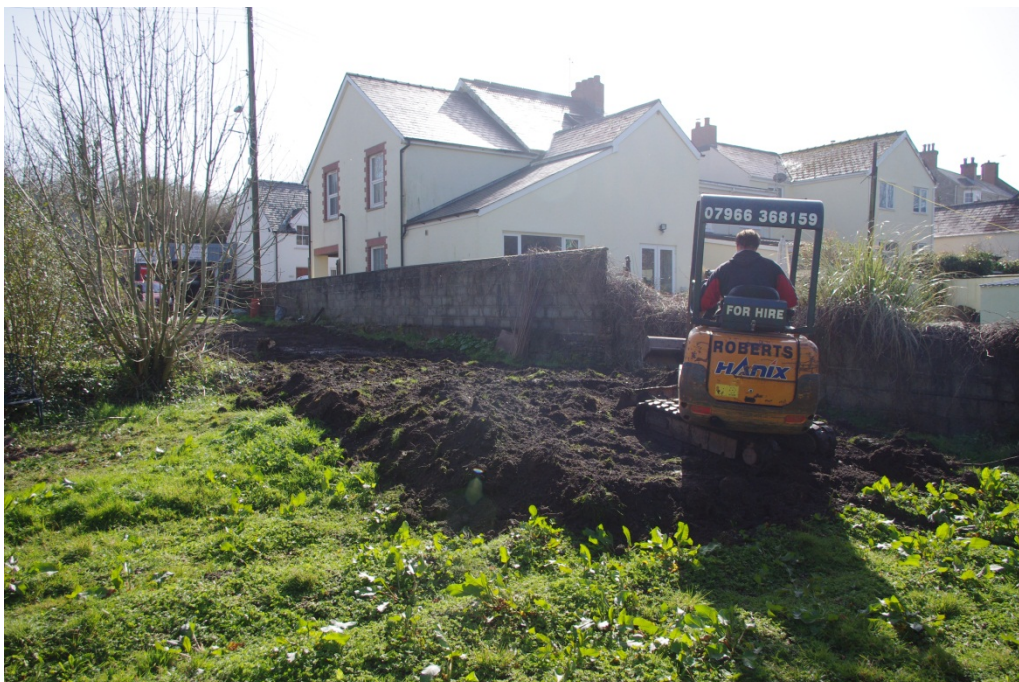
Photo 9: View of Plot 1 facing southeast towards Eldon

- 4.2.4 The topsoil removed from the site was levelled across the area directly to the west of the plot (Photo 9). All material removed from the footprint of the building was observed by the attending archaeologist (Photos 10 & 11).

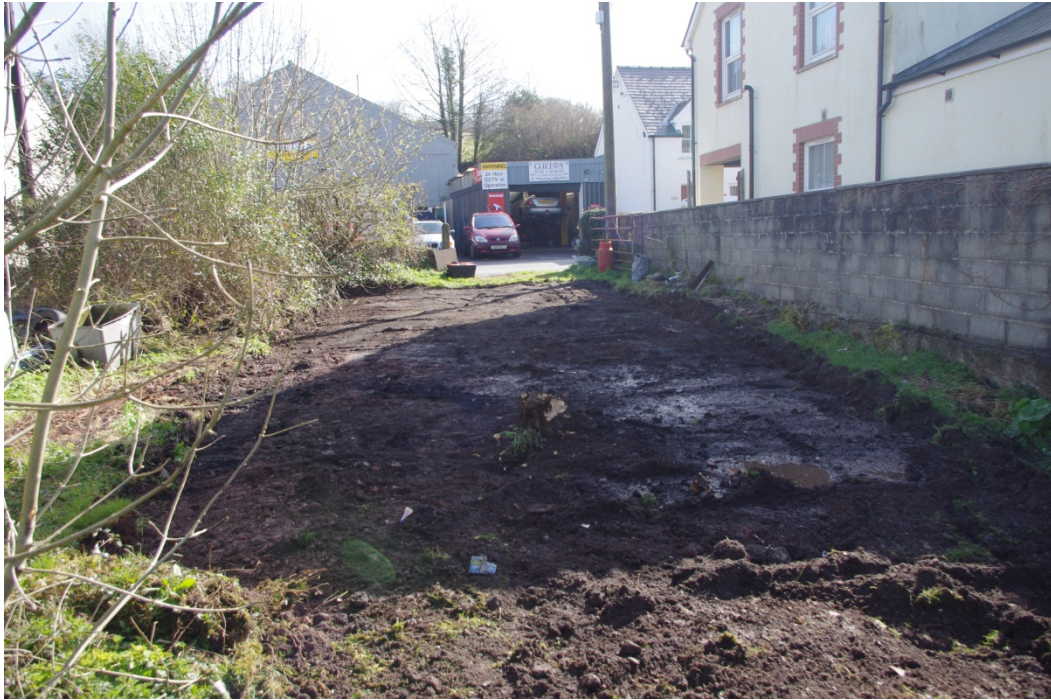
Photo 10: Completed topsoil strip of Plot 1, Eldon, viewing east

- 4.2.5 No archaeological features were apparent in the exposed surface, which still contained compacted layers of modern waste material. In only a few areas what appeared to be natural undisturbed ground was exposed.

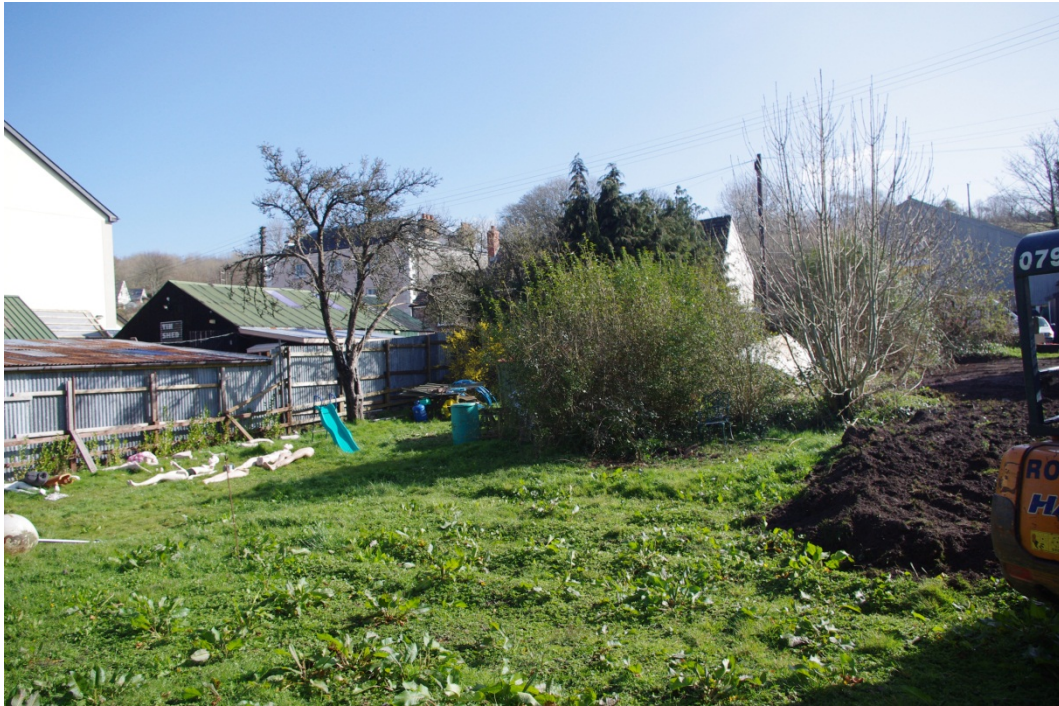
Photo 12: Western part of development plot showing narrow ridges in the ground surface (centre front of photo)

- 4.2.6 During the watching brief it was noted that a north to south aligned bank ran across the centre of the development plot, directly to the west of the proposed house footprint. This was not removed. It spanned the width of the plot, although had been partially removed in the past in certain areas. To the west of this boundary the plot was slightly lower and closer to the River Coran. A small area of former cultivated ground was noted nearer the river comprising a series of raised ridges.
