# **THE BLACK LION HOTEL, LAMPETER, CEREDIGION: ARCHAEOLOGICAL EVALUATION (NGR SN 57361 48057)**

RHIF YR ADRODDIAD / REPORT NO. 2015/11  
RHIF Y PROSIECT / PROJECT RECORD NO. 107907

## THE BLACK LION HOTEL, LAMPETER, CEREDIGION: ARCHAEOLOGICAL EVALUATION

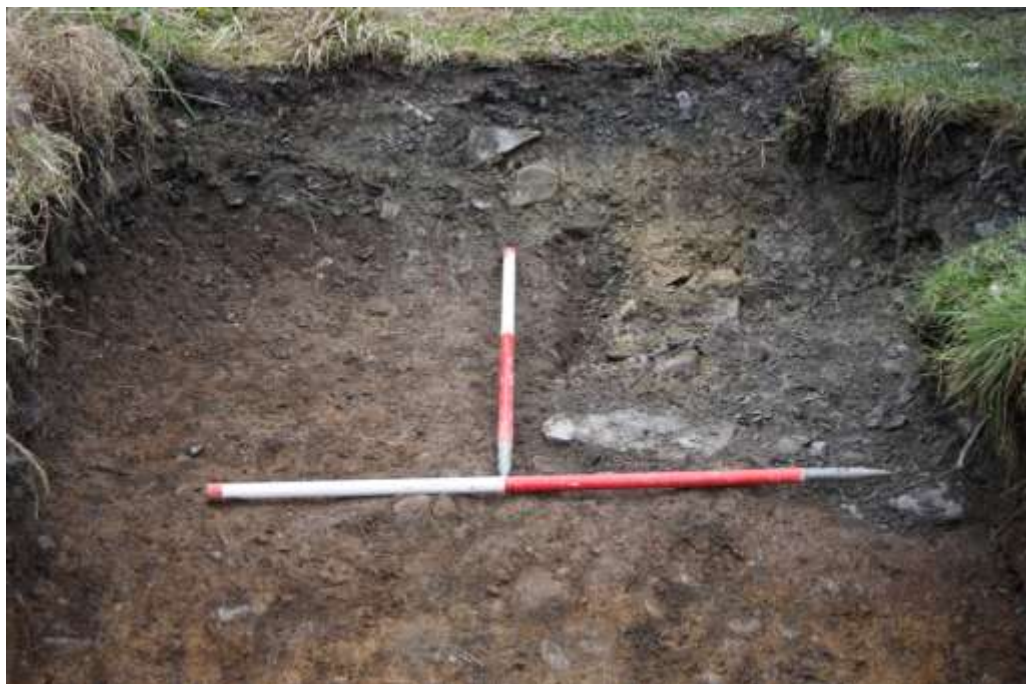
- 4.3.4 A lens of mortar was also noted lying within the buried topsoil (101) above the cobbled surface.
- 4.3.5 At the northern end of the trench a feature cut [104] was recorded. This contained a fill of degraded mortar and slate fragments (105), the upper surface of which lay just below the current land surface (Photo 4), indicating it is a modern feature.

**Photo 4:** Top right is cut [104] and fill (105) of modern feature in Trench 1 facing NNE. Scales – 2 x 1m.

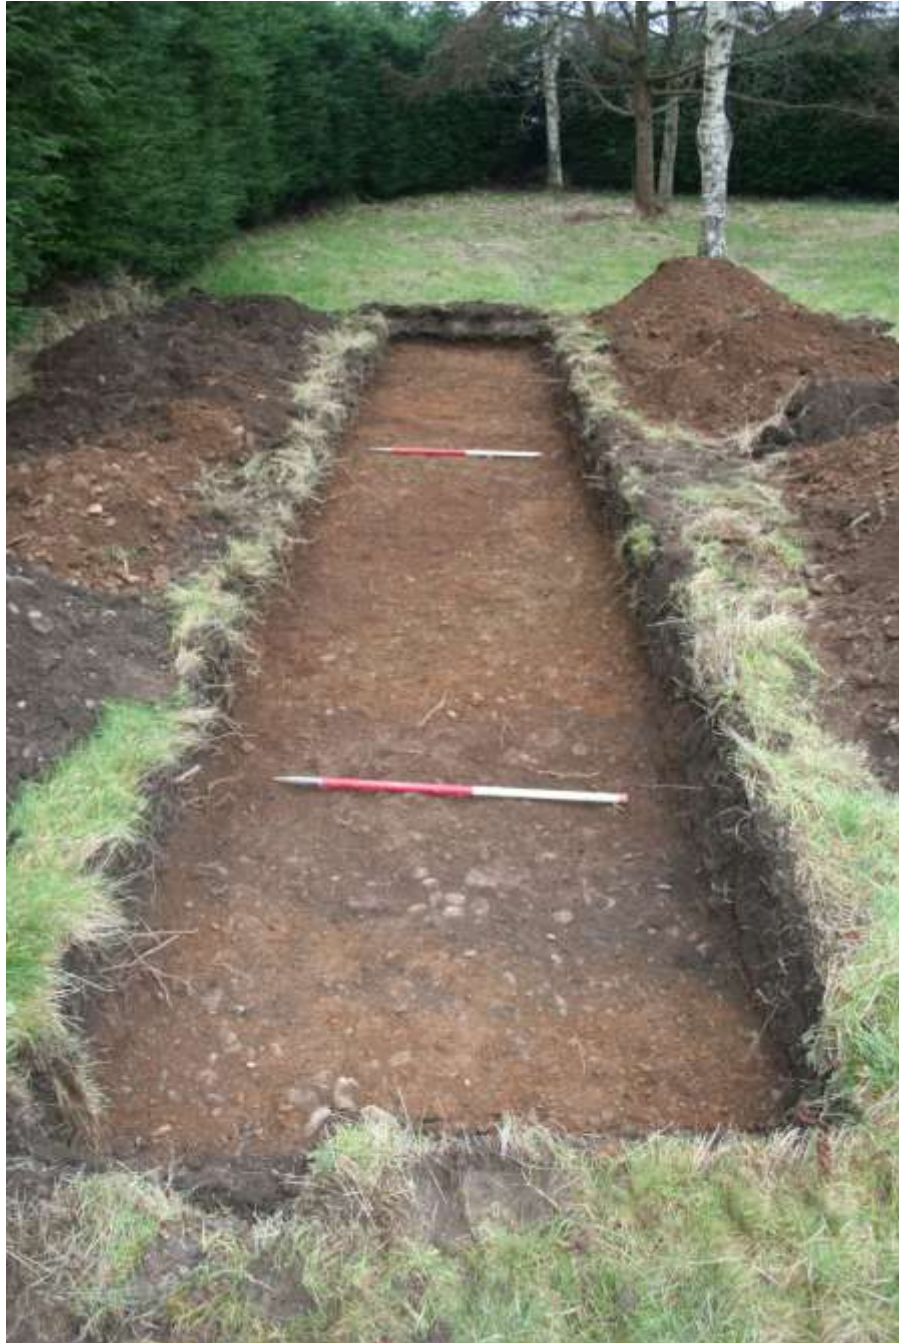
**Photo 5:** Trench 2 facing ESE.  
Scales – 2x 1m.

- 4.4.1 Trench 2 was located in the northwestern part of the beer garden (Figures 6 & 8; Photo 5). The topsoil (200) was composed mainly of silt with some sand and clay and was approximately 0.50m deep throughout the length of the trench. This overlay a subsoil (201) which was orange/yellow brown in colour, seemingly a common deposit throughout the site. There were no finds in these layers.

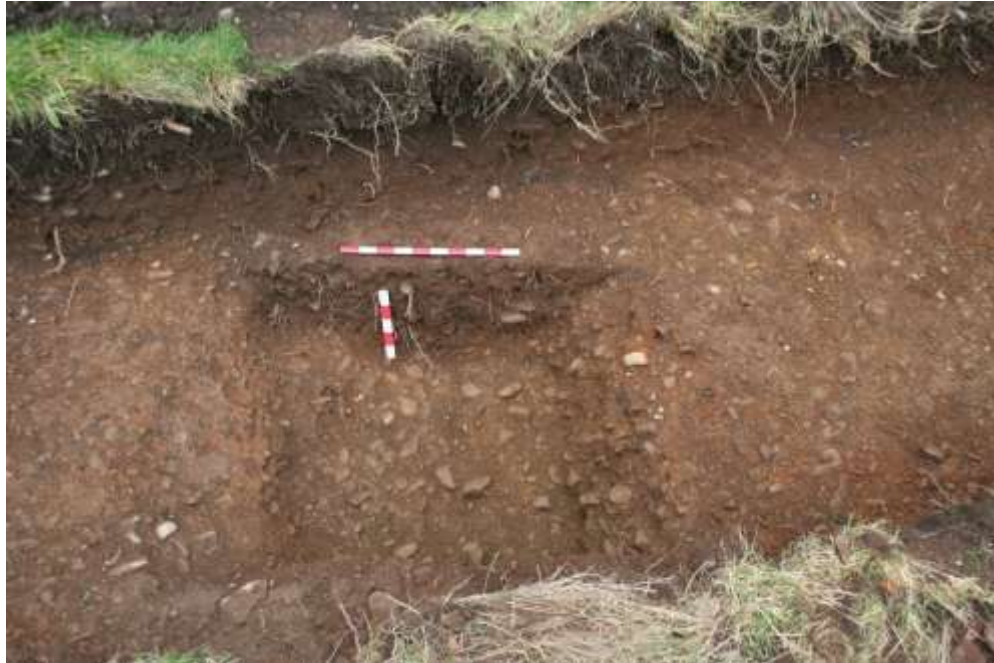
- 4.4.2 A linear feature was recorded crossing the trench towards its western end, fill (202) and cut [203]. The fill (202) was a mid-brown silt with clay, with pebble and gravel inclusions. The cut [203] was aligned north to south

across the trench with a shallow U-shaped profile, with a depth of c.0.32m and a width of 1.05m. There was the suggestion of another deposit at the base of the cut composed of gravel eroded from the sides of the ditch.

**Photo 6:** Trench 2 facing NE, contexts (202) and [203],  
section c-d on Figure 9.  
Scales – 1x 0.5m and 1x 0.25m.

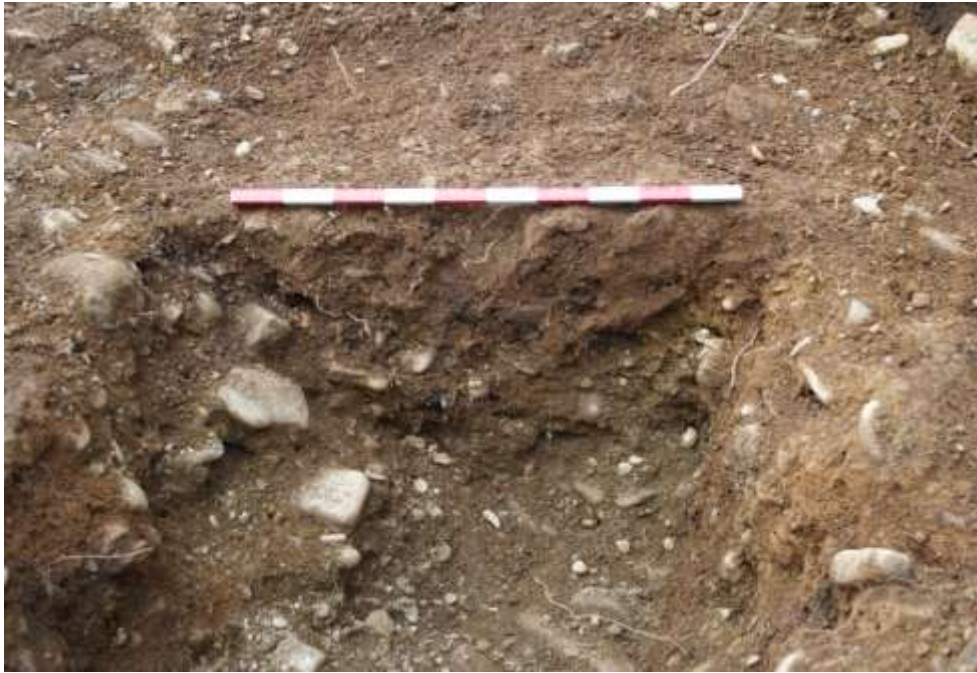
- 4.3.4 A second linear feature was recorded in the trench to the east of cut [203]. This was again a linear feature aligned roughly northwest to southeast (Figure 8). The fill (204) was light pinkish brown in colour, comprising silt with clay, with frequent small subangular/subrounded stone inclusions. The base of the ditch contained larger rounded stones. The cut was 0.3m in depth and 0.69m wide, steep-sided on the southern edge with a flattened base. The feature was 2.8m long and seemed to butt end at its southeastern end within the trench. No finds were recovered from the feature.

**Photo 7:** Trench 2 facing NNW, contexts (204) and [205], section e-f on Figure 9  
Scale 1x 0.5m.

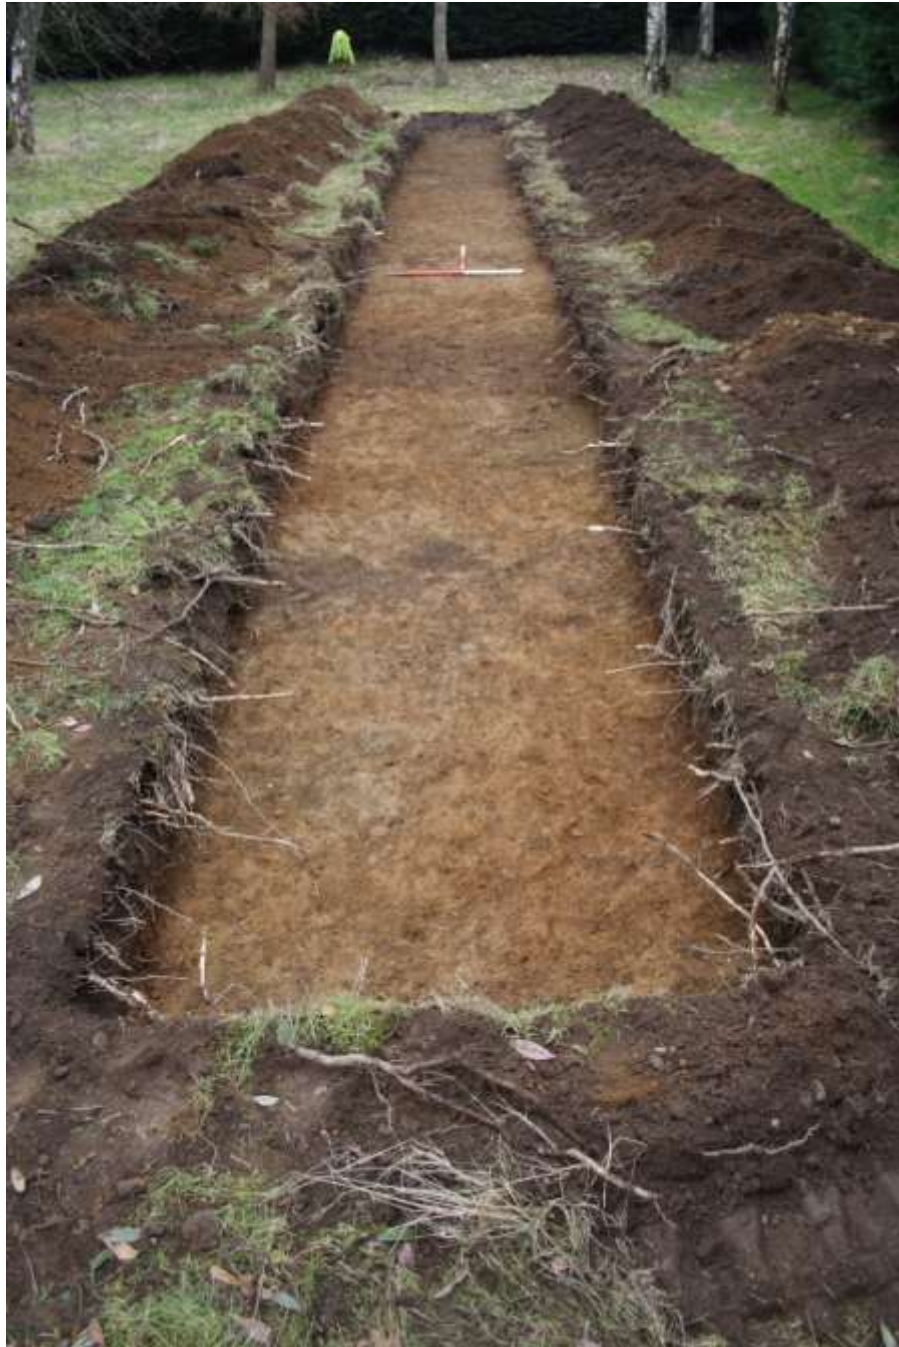
**Photo 8:** Trench 3 facing NE. Scales - 2x 1m.

- 4.5.1 Trench 3 was located along the eastern edge of the beer garden (Figures 6 & 9; Photo 8). The topsoil (301) was a dark brown silty clay-loam with occasional small rounded pebbles and abundant roots due to the close proximity of trees. The subsoil (302) was a reddish-brown silty clay with occasional small subangular stones. This too was well laced with roots. There were a number of areas of root disturbance revealed in the base of the trench on top of the exposed natural soils, a number of which were sample excavated to confirm they were caused by root action. A small fragment of post-medieval ceramic was recovered from subsoil (302).

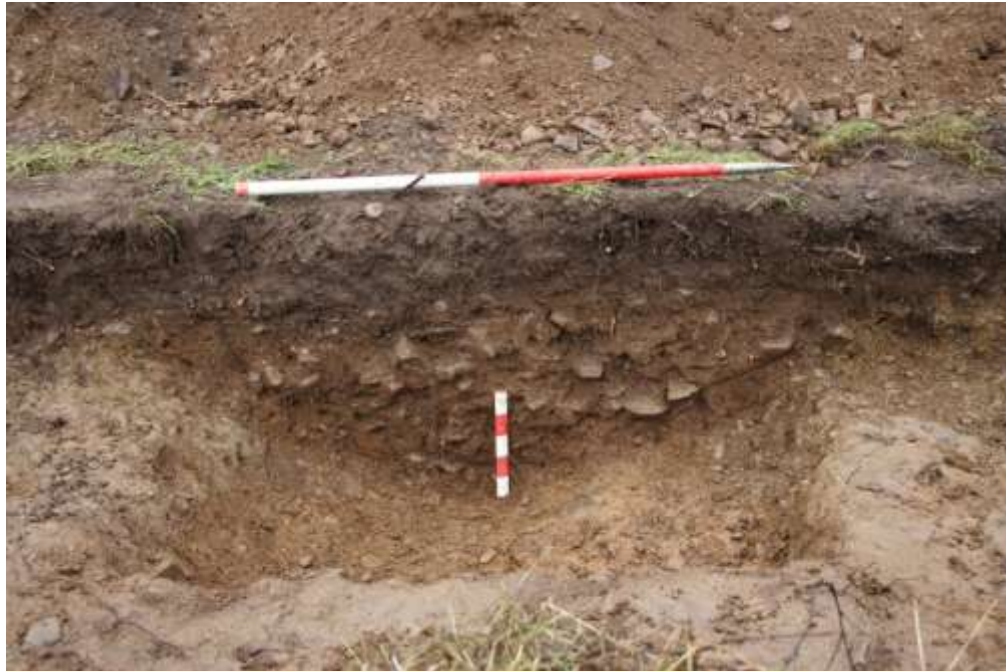
- 4.5.2 A linear ditch, aligned northwest to southeast was recorded towards the southern end of the trench, cut [303] (Photo 9). The cut [303] was approximately 0.35m deep by 1.2m wide, with a shallow U-shaped profile. The upper fill of the feature, (304), was composed of a grey-brown silty clay with approximately half its volume comprising subangular/rounded stones up to 0.1m in size. The lower fill (305) was similar but was redder in colour, more compact and had significantly less stones in it. No finds were recovered from the feature.

**Photo 9:** Trench 3 facing SE, contexts (304), (305) and [303], section g-h on Figure 10.  
Scales - 1 x 1m and 1x 0.25m.

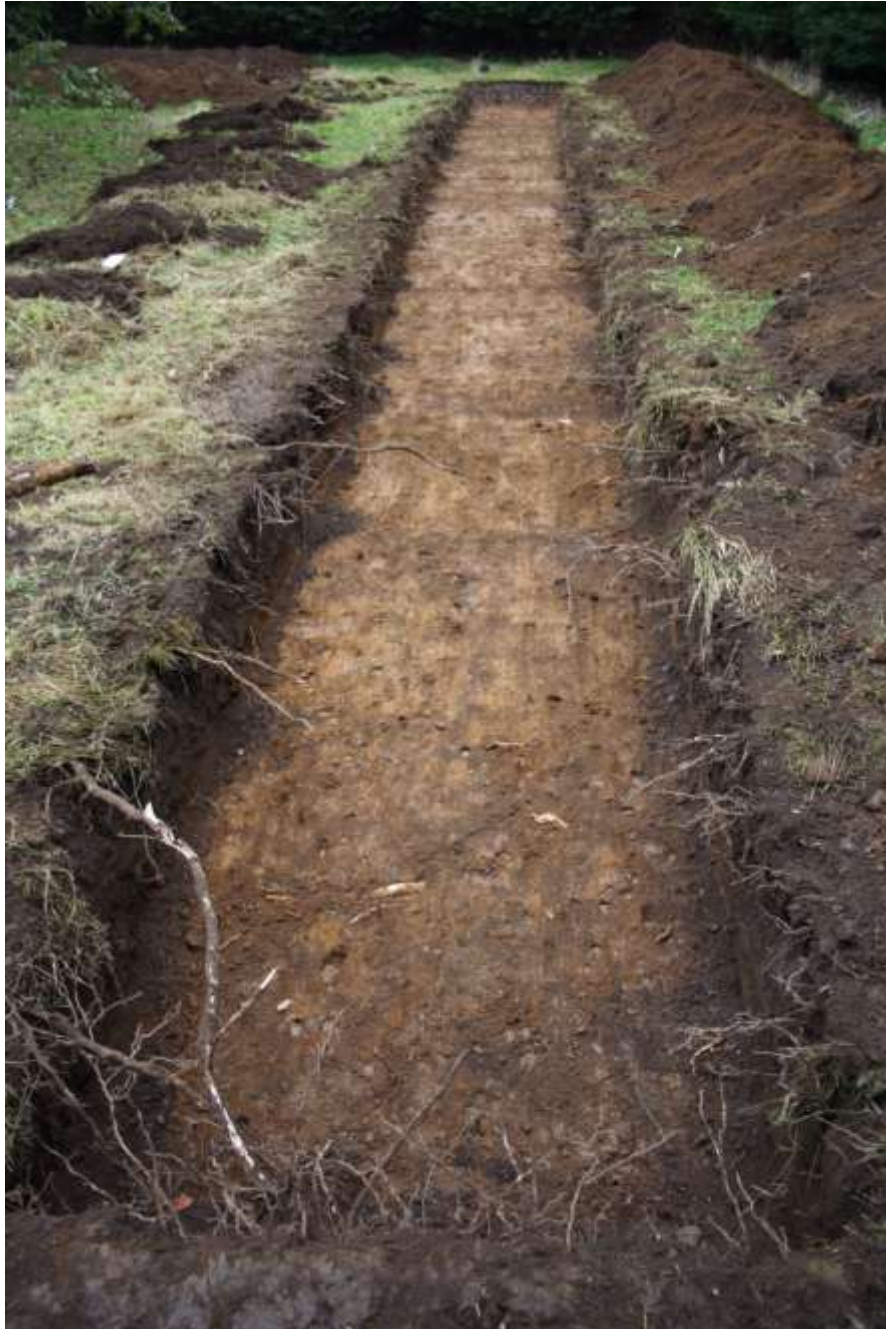
- 4.6.1 Trench 4 was located along the southern part of the beer garden (Figure 6; Photo 10). The topsoil (400) was loose, mid grey-brown in colour, and composed mainly of silt with some clay. Inclusions included occasional shale fragments and pebbles. The subsoil (401) was friable, pale yellow-grey in colour and similar to (400) in composition but with a higher clay content. Inclusions comprised occasional shale fragments and pebbles. No features were apparent after cleaning and there no finds were recovered from the trench.

**Photo 10:** Trench 4 after cleaning facing ESE.

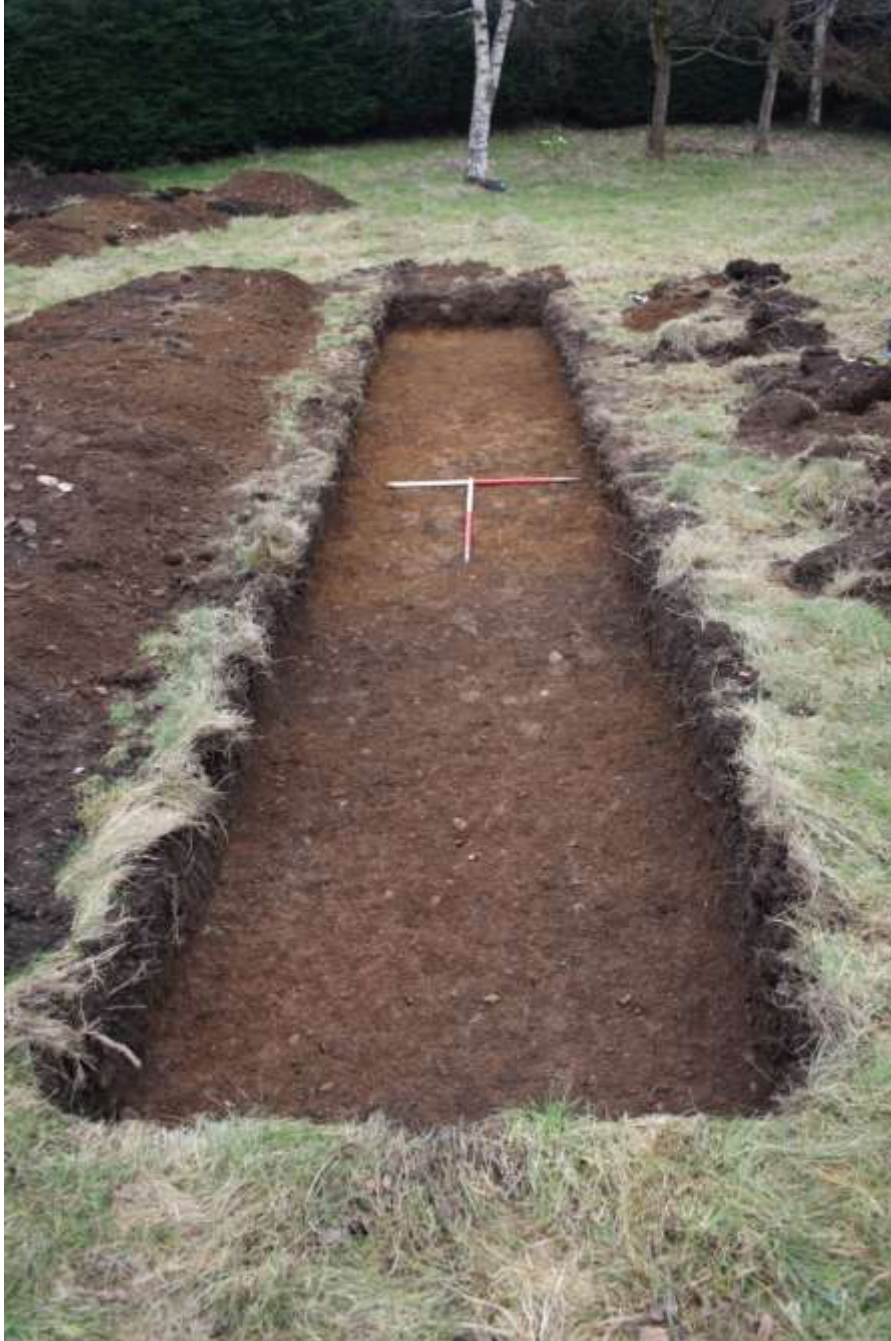
**Photo 11:** Trench 5 facing SSE.  
Scales – 2 x 1m.

- 4.7.1 Trench 5 was located on the eastern side of the beer garden, and was excavated as an additional trench once it was ascertained that no features were present within Trench 4 (Figures 6 & 11; Photo 11). The topsoil (501) was a dark grey-brown silty clay with occasional subangular and rounded stones. It yielded the only finds from the trench – 2 fragments of modern ceramic.

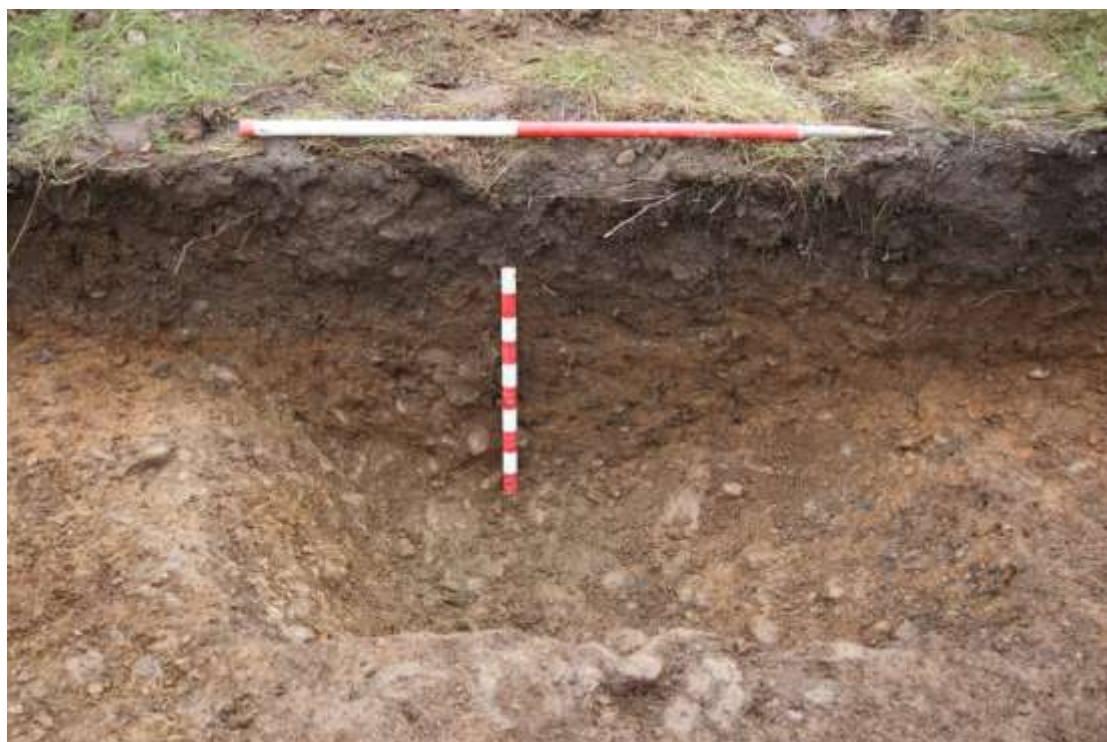
- 4.7.2 A single linear feature was recorded in the trench, aligned north-northwest to south-southeast, cut [506]. The feature was 0.40m deep and 1.4m

wide with a flattened profile towards its base, although possibly slightly overcut into the underlying natural strata.

- 4.7.3 The upper fill (502) was a dark reddish-brown silty clay with approximately 10% medium-sized subangular/rounded stone inclusions.
- 4.7.4 The other three contexts associated with Trench 5 all appear to be variants on natural deposits. Context (503) corresponds to the glaciofluvial deposits underlying the site – light yellow-grey in colour and composed of cobbles of various sizes, gravel and silt. Context (504) corresponds with the light orange/yellow silty clays found elsewhere. Context (505) is an anomaly being a red-brown deposit at first glance analogous to other deposits found around the site. However, after reconsideration it is a subsoil overlying context (504) (Photo 12 below).

**Photo 12:** Trench 5 feature facing WSW.  
Scales – 1 x 1m and 1 x 0.5m.
