CARDIGAN CASTLE: AN ARCHAEOLOGICAL AND HISTORICAL SURVEY, 2009

K Murphy

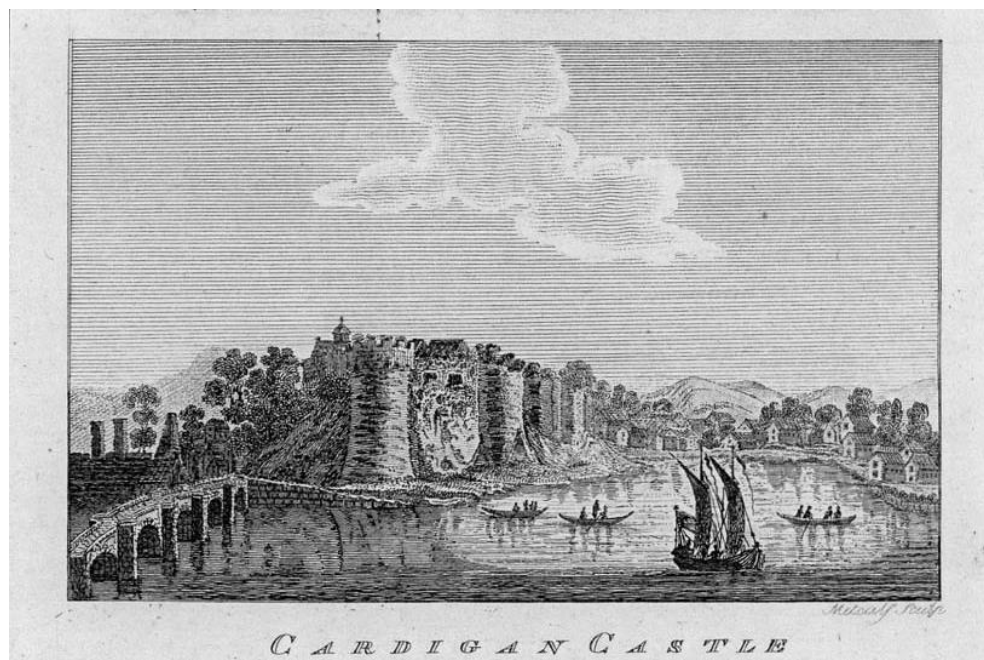
Figure 2. Engraving of Cardigan Castle, c.1804

The engraving of Cardigan Castle reproduced in Figure 2 dates to the turn of the 19th century, but appears to be based on an earlier drawing made by Samuel and Nathaniel Buck in 1741, now housed within the National Library of Wales. The picture clearly shows the impressive south and east-facing façades of the castle, with the South East and East Towers as dominant structures, and the East Tower sporting angle spur buttresses, which must be now buried within the area of the Hanging Garden. These angle spur buttresses bear similarities with those forming the fabric of the North Tower, and suggests that these builds are contemporaneous, and most likely date to the mid-thirteenth century, when expenditure on the castle was recorded in 1250 and 1261 for the building and raising of a stone keep (the North Tower) under Waleran. The snapshot of the castle as it stood in 1741 also shows that the curtain wall between the two visible towers had already been demolished (or had collapsed), possibly one of the acts of deliberate ruination of the castle's defences at the end of the Civil War, and moreover illustrates what appear to be two vaulted undercrofts within the castle yard. There also appear to be some timber-roofed buildings lying behind the East Tower within the ward, with the North East Bastion also visible further round the river.

The Buck print of 1741 (reproduced by several others, including Eastgate in 1804 as pictured in Figure 2) depicts angle-spur buttresses at the base of the tower, which are most likely today to be buried within the area of the Hanging Garden (Area 14). Also, the print shows that the curtain wall between this tower and the next one at the southeast corner of the castle site was already ruinous, and may have collapsed some time after the Civil War (1642-8). The river is also likely to have lapped at the bottom of this and the South-east Tower during the early history of the site.

The 1741 print of Cardigan Castle by the Buck brothers already shows the medieval curtain wall between the East and South-east Towers as having largely collapsed, although it was also noted by Carlisle in 1811 that 'the wall between the two towers was lowered and the Green sloped down to form the hanging Garden'.

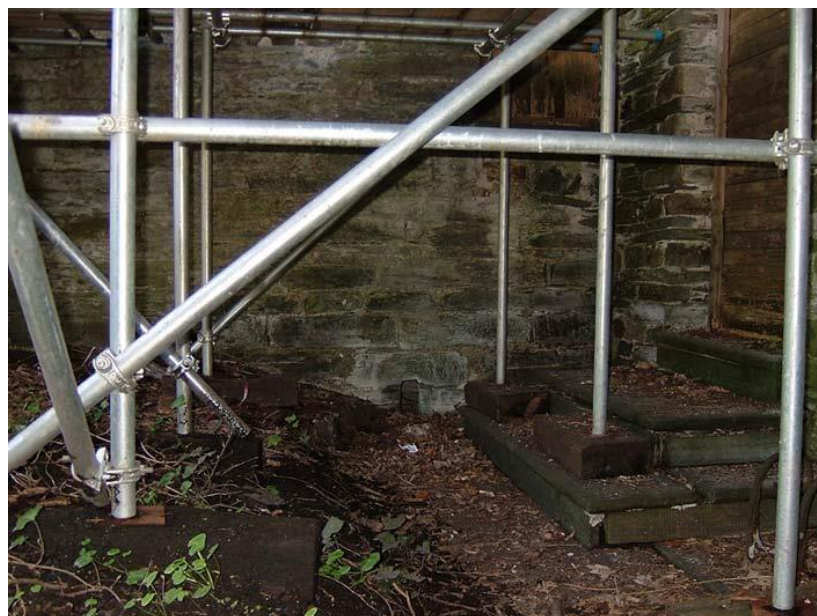
Photo 1 Submerged arrow slit on the west side of the North Tower

One of the few surviving portions of medieval masonry from the original stone-built castle, the three-storey North Tower is now incorporated into the 19th century Castle Green House. Originally this would have been an imposing tower, and is likely to be the 'Great Round Tower' or 'Great Watch Tower' mentioned in historical references to the site. Currently the tower is under scaffold. The basement of the tower is rectangular, with part of its foundations lying on bedrock. Within the basement, which is almost completely buried outside by an artificially raised ground level, there are three arrow slits: the eastern one enlarged for access, the northern one adapted as a coal chute, and the western one just visible above the surrounding garden soil (see Photo 1).

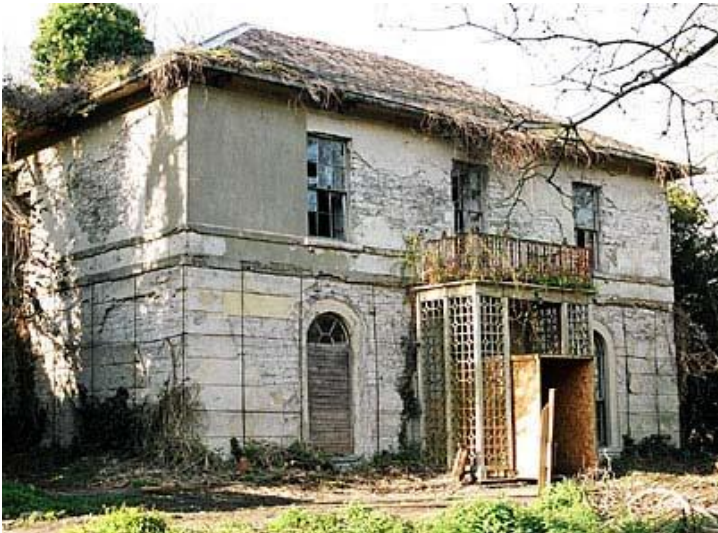
Photo 2a Front of Castle Green House c.1990 (from <http://www.bbc.co.uk/history/programmes/restoration/gallery/?9>)

The house is currently boarded up and largely behind scaffold. Some of the impressive architectural features are still visible, such as the large round arched windows on the south elevation flanking the entrance porch, with its surrounding wooden trelliswork, above which stands an ornate wrought iron balustrade. At the rear of the property the ground floor of the east annexe is partly submerged by the current ground level of the Kitchen Garden.

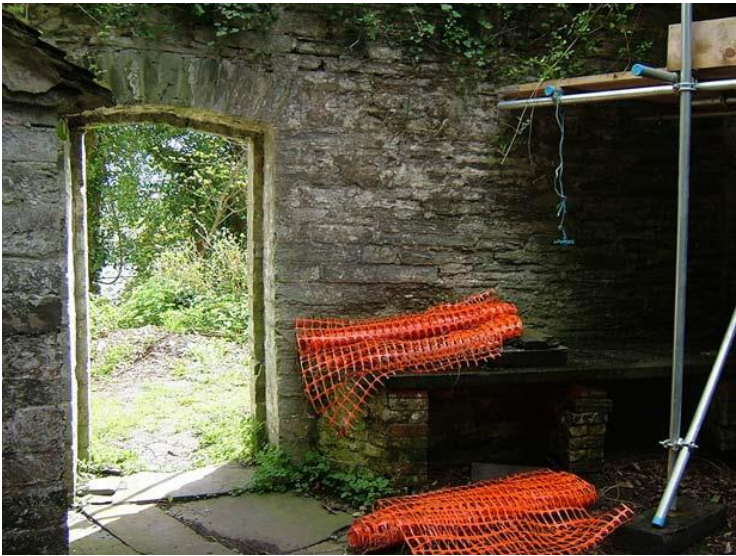
An entrance off the Carriageway gives access to the servant's quarters in the rear of the East Wing, with a courtyard area linking the main house to the Gardener's Cottage. Within the courtyard there is an outside toilet, and two roofed storage areas, one housing a deep slate trough, and a long slate work/cool bench. It is believed that at one time this area was used as a dairy, and certainly the 3m long slate bench could have been used for this purpose. The courtyard itself has a flagstone floor. It is clear that this area functioned as a 'tradesman's entrance' serving the main house. There is a doorway into the east wing in one corner (the former butler's quarters), whilst the door to the Gardener's Cottage opens onto the courtyard on its northern side. Within the central roofed storage area there is also the remains of a doorway leading into the rear Kitchen Garden.

Photo 3a View of the entrance to the courtyard and the slate bench

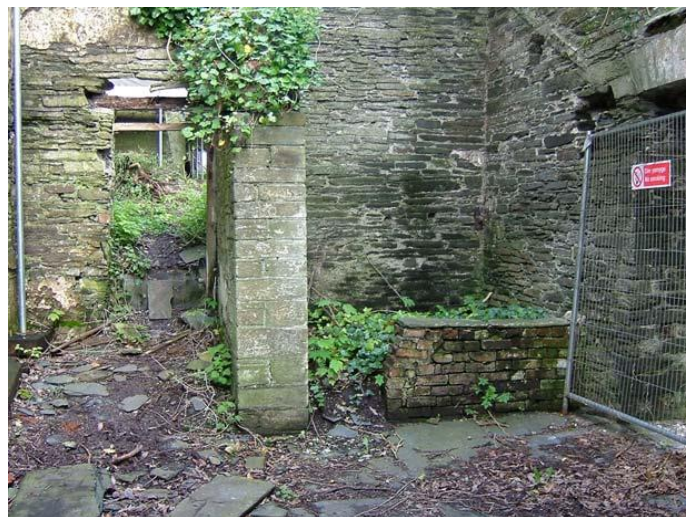
Photo 3b View of the courtyard from the entrance, looking west

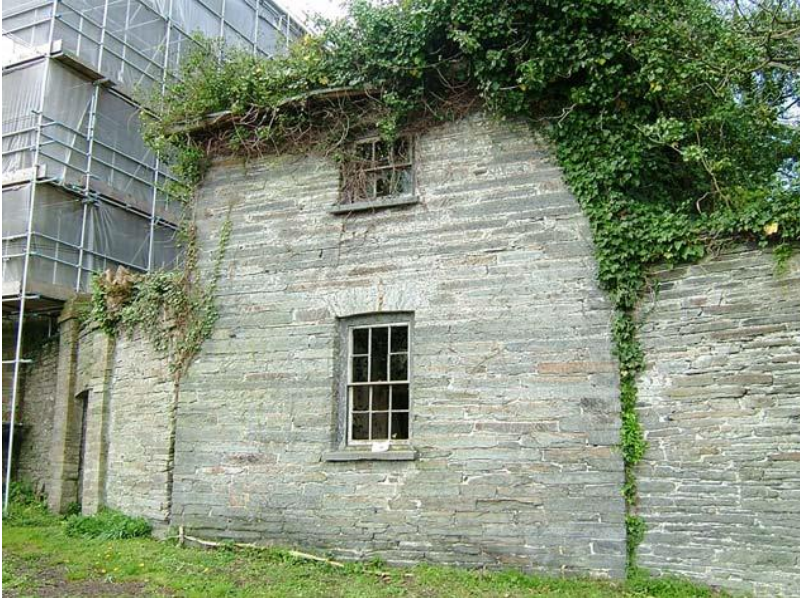
The doorway into the cottage was accessed via the tradesman's entrance and courtyard mentioned above. The cottage is currently derelict and overgrown, and was apparently abandoned in 1954. It is a detached cottage, attached to the main house via enclosure walls, and appears to have been built during Jones' ownership of Castle Green House sometime after 1827, but certainly before 1834, as the cottage clearly appears on Wood's map with an attached small shed (located within the Dairy).

Photo 4a Rear of Gardener's Cottage

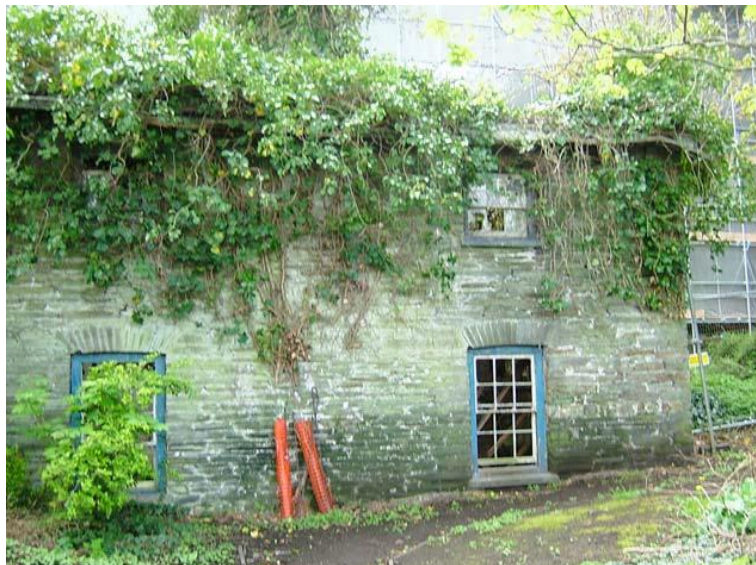
Photo 4b North elevation of Gardener's Cottage

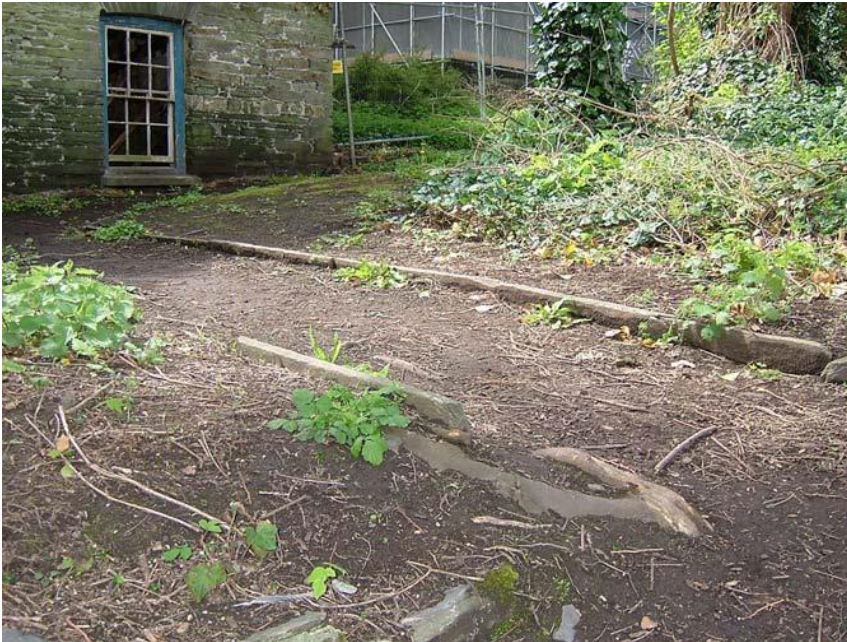
Photo 5. Remnants of pathways within the Kitchen Garden

The level of earth within this area has been artificially raised and is evidenced by the depth to which the North Tower, the East annexe of the main house and the Gardener's Cottage are partly submerged. Beneath the area of the kitchen garden are the likely remains of the secondary bailey of the early medieval castle, and excavations in 1984 also recovered evidence of a substantial defensive ditch and bank associated certainly with the mid-13th century North Tower.

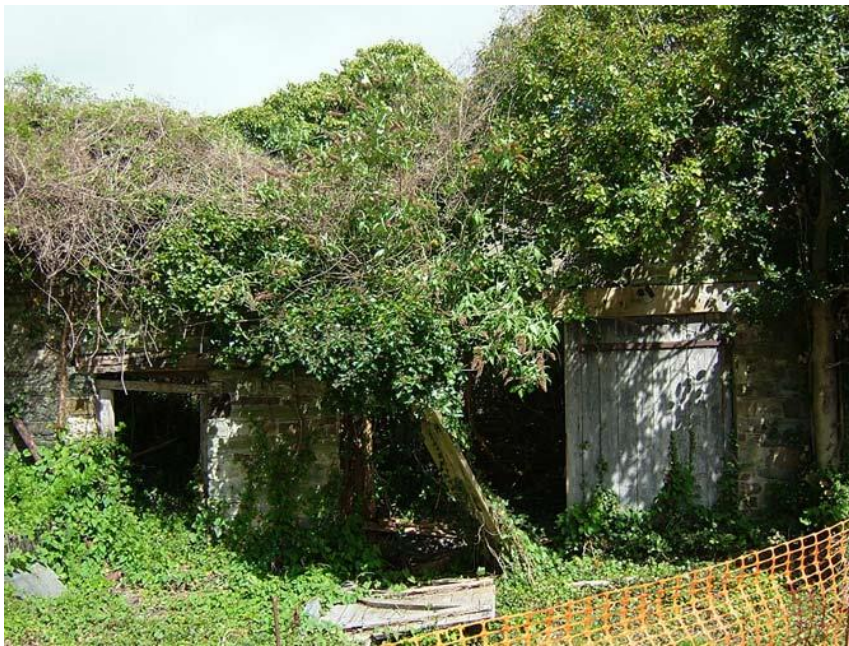
Within the dilapidated garages can just be seen the remains of two cars (an Armstrong-Siddeley and a Morris 8), onto which the garage roof has now collapsed. A small slate trough stands just outside the garages against the Kitchen Garden wall. An ornate wrought iron fence separates 43 St Mary's Street from the other properties in Area 29 and demarcates the boundary of the Castle Green estate in this area, eventually linking up with the crenellated Victorian wall separating the Carriageway from the Additional Gardens (Area 8). The garages, which re-used the former coach-house, came into use in the early 20th century, and the remains of a fireplace is still visible.

Photo 6 View of the derelict garages

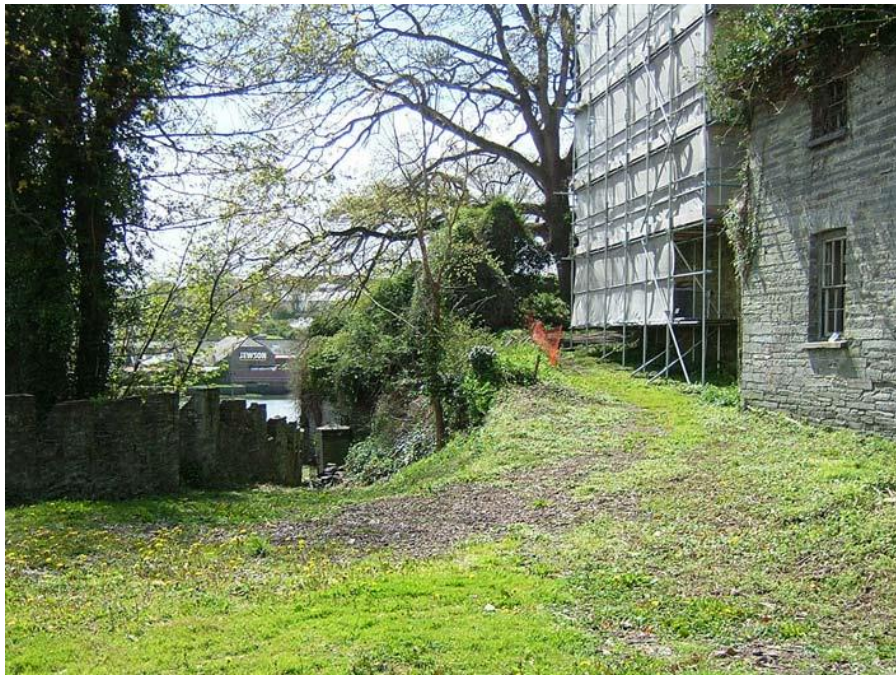
The slope that the hairpin bend negotiates is the likely course of the medieval town wall, which can be projected back along the Carriageway to the north towards the Garages (Area 6) and The Old Stables (Area 28). Within the crenellated wall on the east side of the driveway there is a small, gated entrance, which gives access to the top of the Additional Gardens.

Photo 7a View of the Carriageway showing the hairpin bend and the rear of the Gardener's Cottage

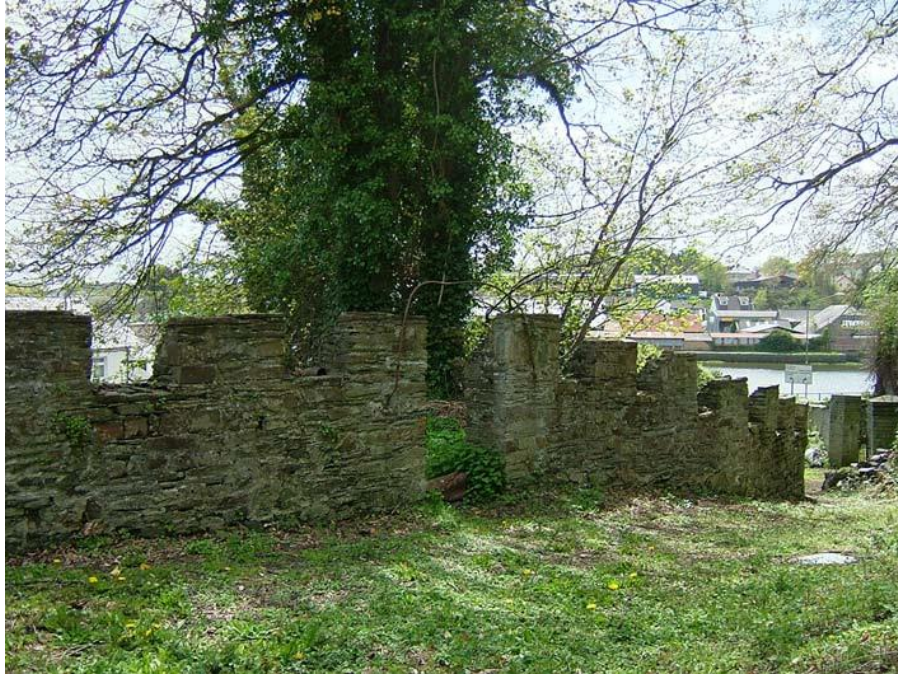
Photo 7b View showing the 19th century crenellated wall and entrance to the Additional Gardens

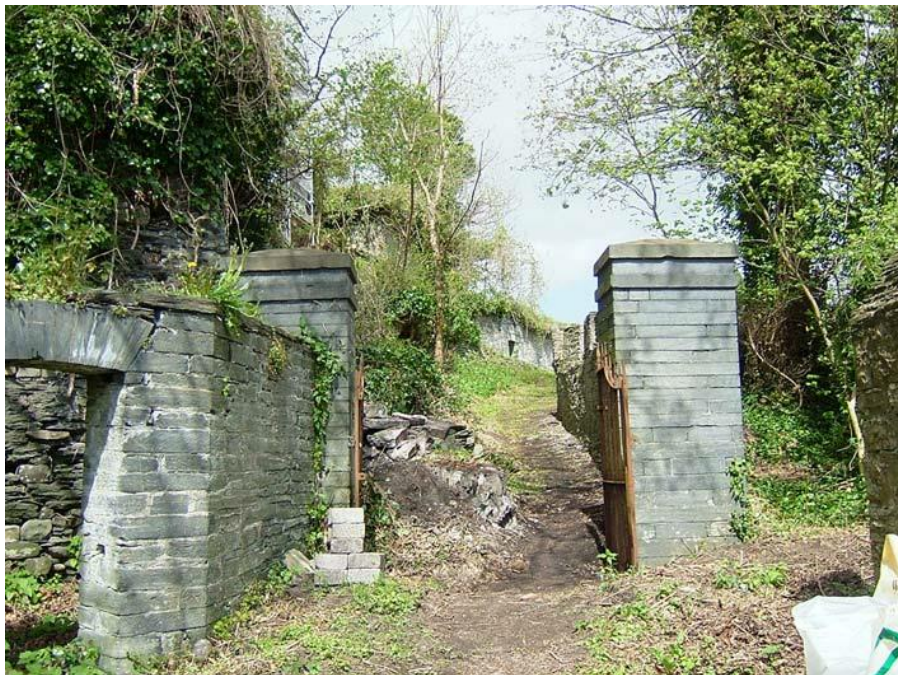
Photo 7c Entrance gate and stone piers to the Carriageway

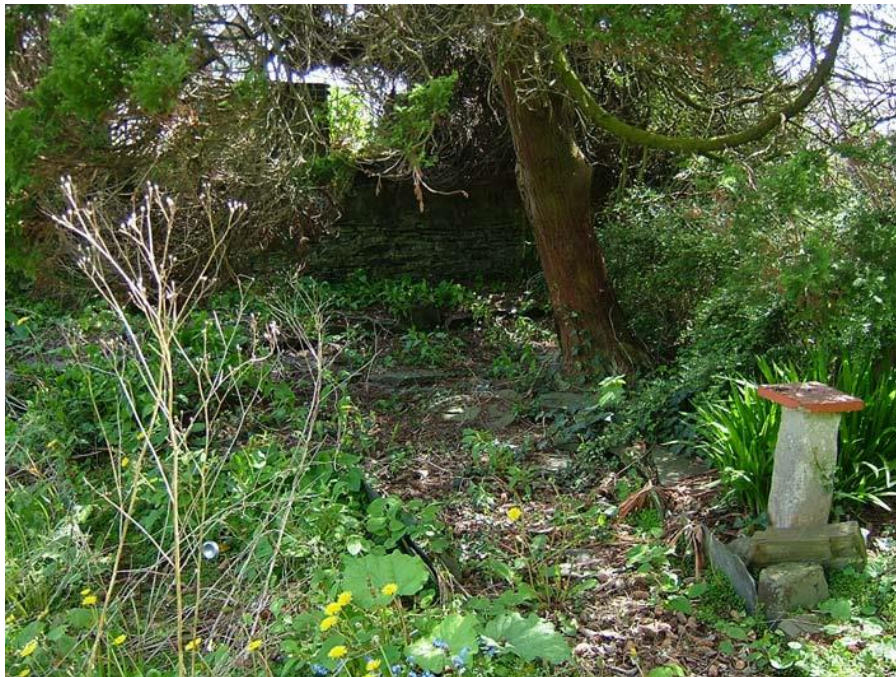
The gardens, which are currently largely overgrown, were accessed via a gateway in the 19th century wall along the Carriageway, and comprise two terraces. The upper terrace consists of a moderate slope with views over the river and Carriers' Lane, and is quite exposed. At the southern end of this terrace a set of slate steps lead down to a lower terrace, passing the inglenook of one of the demolished cottages that is still visible in the fabric of the 19th century crenellated wall. The lower terrace, altogether more private, is enclosed by an embanked stone wall, which divides these sloping gardens into their two terraces. Although heavily overgrown, this lower terrace did yield traces of a patio area, with a slated footpath running adjacent to the embanked wall, and a slate seat against the outer wall on its east side. Traces of a rockery were also noted during our site visit in May 2006, as was also a tree within a metal planter. A possible makeshift bird-table was discovered, comprising a thick ceramic tile mounted on a small stone pillar. It seems this area was designed to be a secluded and restful garden area, although the volume of current traffic makes the area far from tranquil today. The gardens lie below the line of the projected medieval town wall, but may still overlie areas of significant archaeological deposits, not least the 18th/ 19th century dwellings.

Photo 8 Patio area within the lower terrace

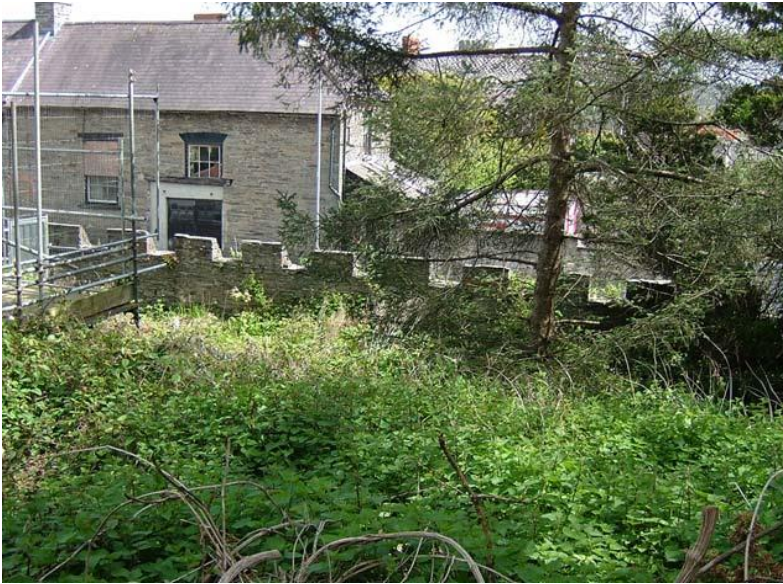
As noted above, this wall was built to retain the Additional Gardens and to form the boundary of the Castle Green estate with Carriers' Lane. The wall was built during the 1920s and was clearly constructed to match the earlier 19th century crenellated walls, which had previously bounded the Carriageway and extent of the estate grounds on this eastern side of the site. Currently a doorway through the wall from Carriers' Lane provides public access to a viewing platform, which overlooks the east elevation of Castle Green house, the Gardener's Cottage, the Kitchen Garden curtain wall, the Garages and the rear of the properties on the corner of St Mary's Street and Carriers' Lane (Area 29).

Photo 9a General view of the modern wall, retaining the Additional Gardens.

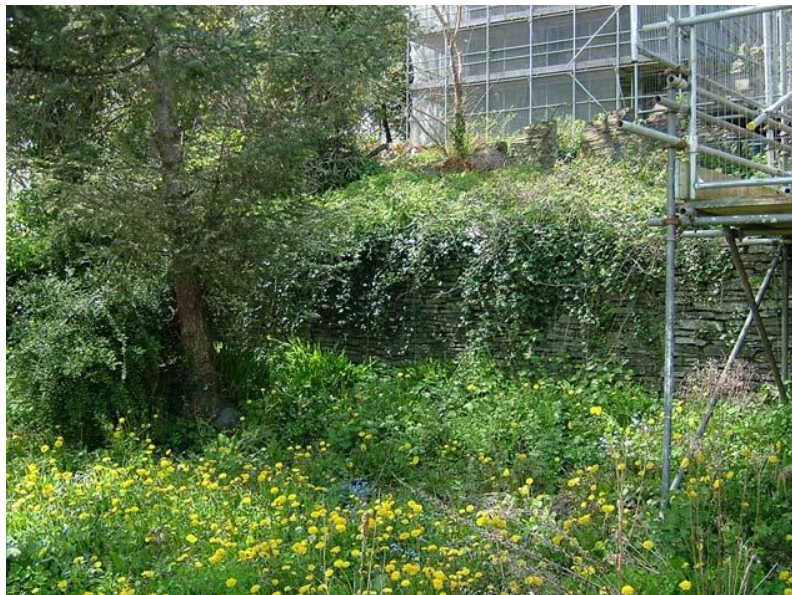
Photo 9b Embanked stone wall forming the upper and lower terrace

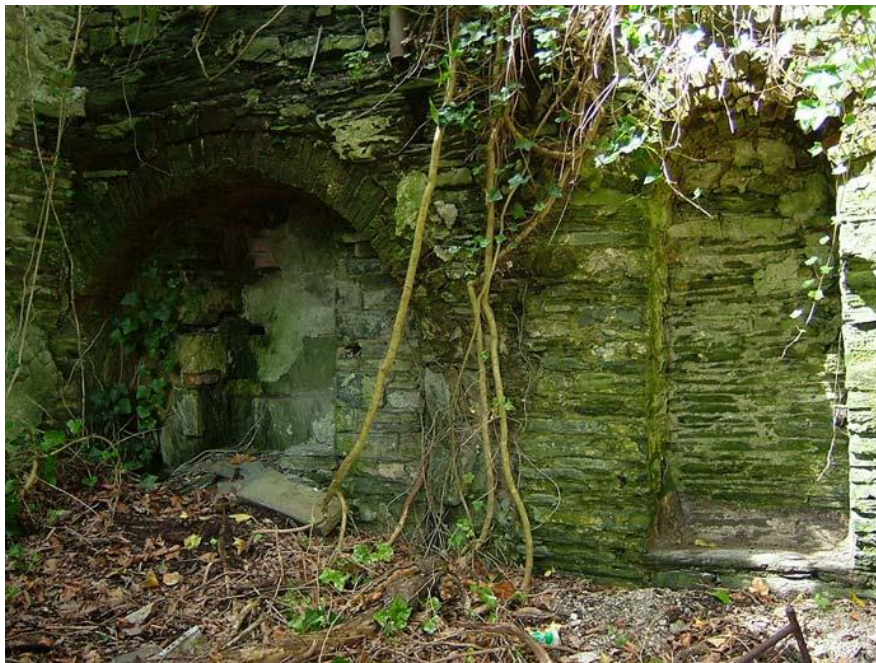
Photo 10a Possible forge within NW stable block, built against the medieval wall

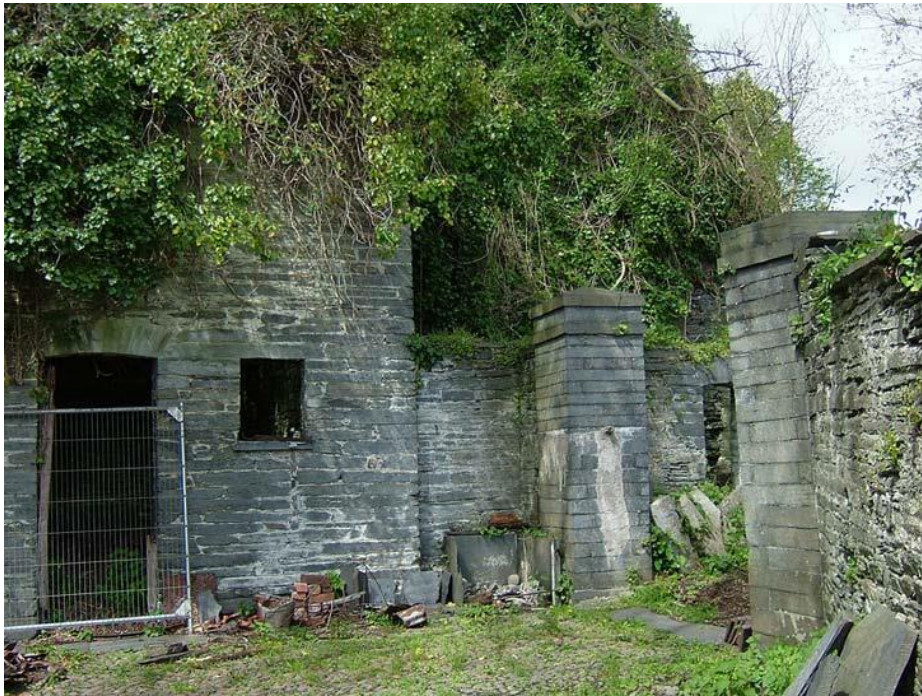
Photo 10b Entrance to the Stables taken within the cobbled yard

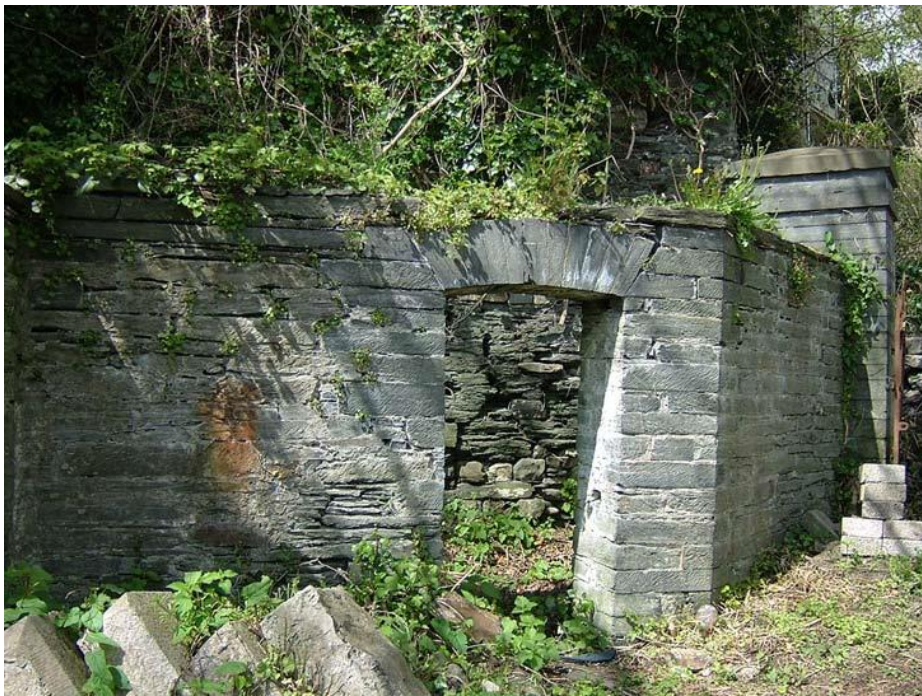
Located just outside of the entrance to the Stables and between here and the entrance piers to the Carriageway lies a small stone building. It has a simple arched

doorway and is built of coursed stone against the medieval castle wall just below the North-east Bastion.

Photo 10c Small stone building lying between the Stables and the entrance to the Carriageway

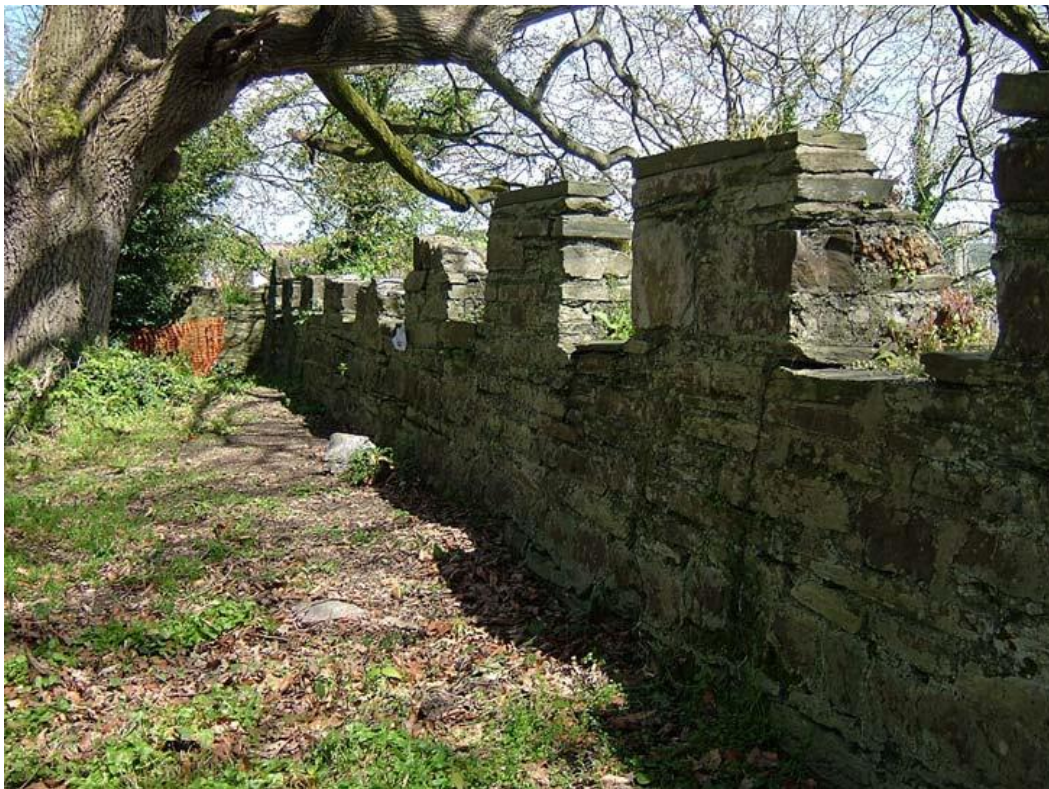
Photo 11 Northeast Wall and Bastion, also showing the Turkey Oak

The steep scarp-slope that runs up to the Northeast bastion from the north (forming the hair-pin bend on the Carriageway) may also represent the line of the medieval town wall, with the bastion itself potentially the remains of another tower.

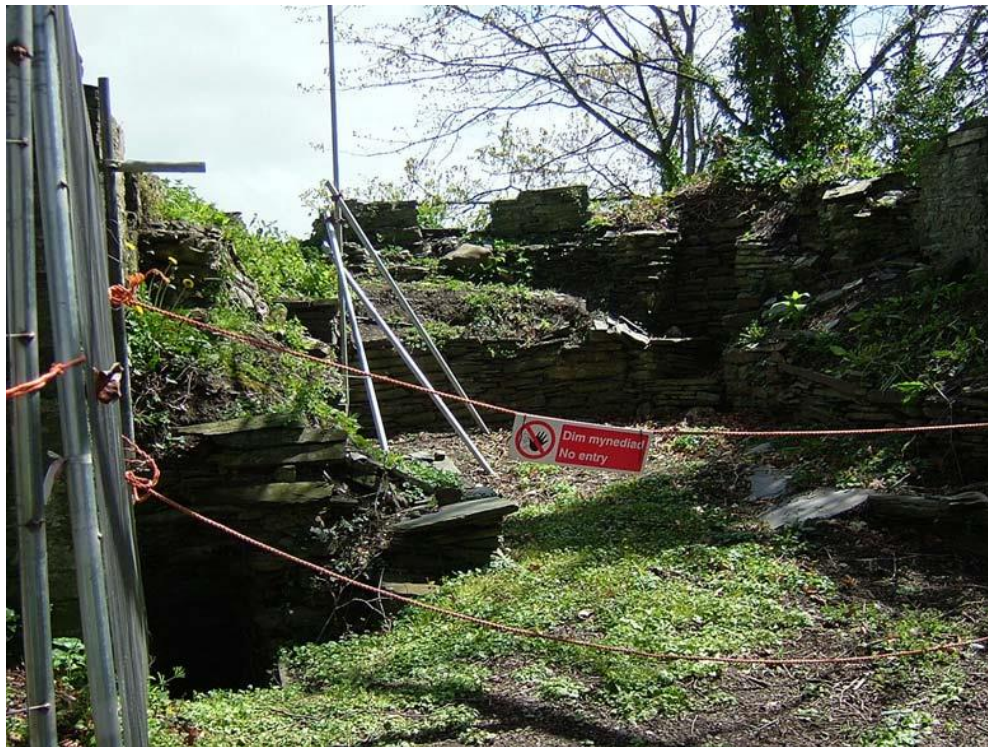
Photo 13. General view of the East Tower

The East Tower is of similar height to the South East Tower (Area 15) and therefore stands c.9.5m above the current pavement level. The current battlements have been embanked with earth and slate seats, probably during the 19th century landscaping of the grounds, when the area was probably used as a viewing platform. From within the Hanging Gardens and on the southwest flank of the tower can be seen an arrow slit and window, whilst at current ground level on the northeast flank are visible the two windows of each garderobe.

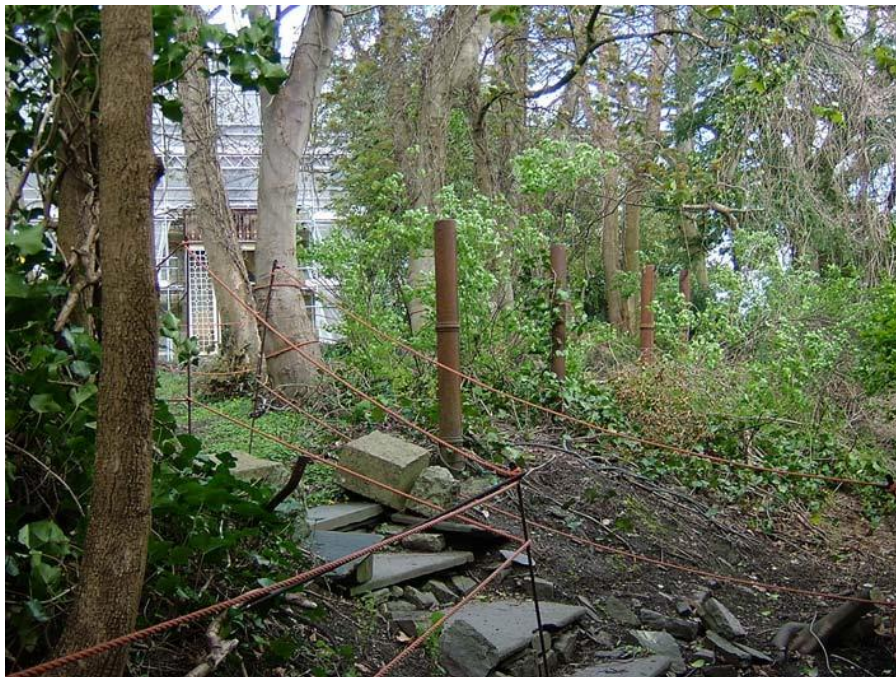
It is likely that the course of the medieval curtain wall linking the East Tower with the South East Tower ran along the top of the slope. The 1984 excavations uncovered a wide shelf cut into bedrock at the top of the slope, presumably for a firm foundation for the medieval curtain wall. The 'Green sloped down' as referred to by Carlisle is assumed to be the bowling green constructed within the castle yard in c.1713, when the first real landscaping of the castle site began. It may even have been at this point that further destruction of the curtain wall took place. Some levelling of the castle would almost certainly have taken place at this point, with further sculpting under Bowen's ownership interfering with any traces of likely structures associated with the medieval castle in the process.

Photo 14. Detail of posts and steps at the top of the Hanging Garden

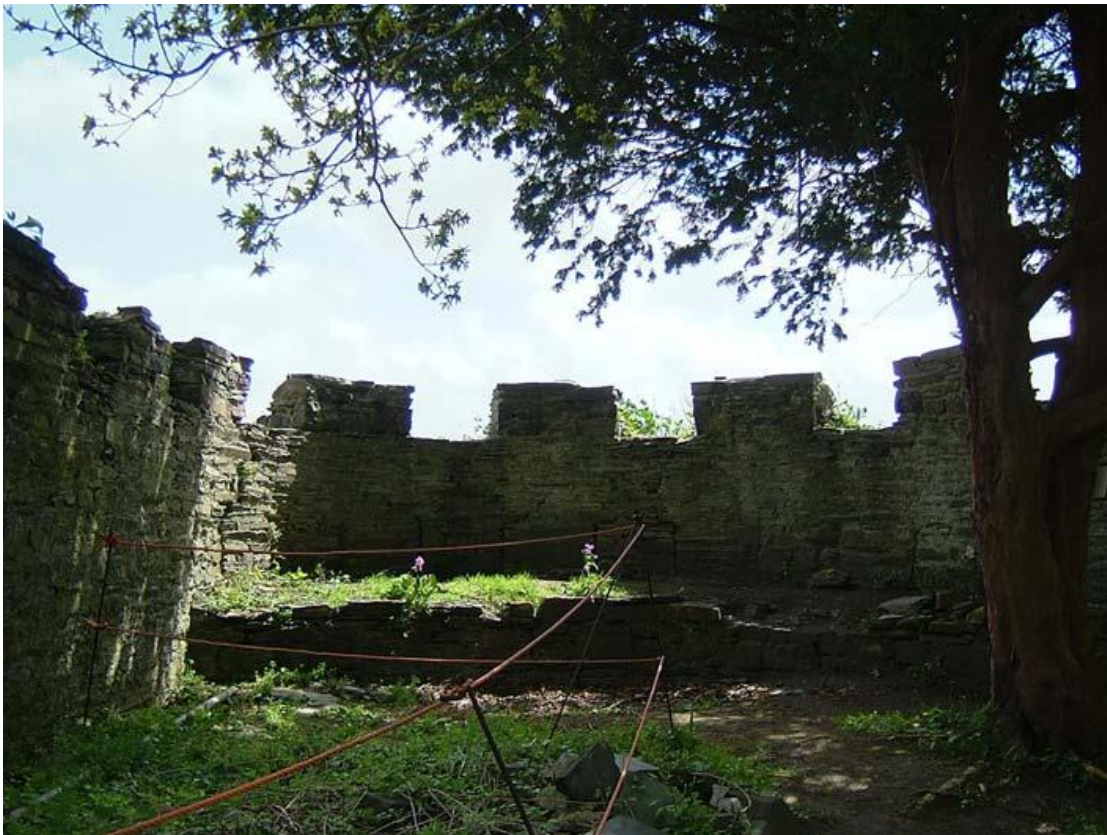
The area of the Wall Walk (Area 17) embanks the Curtain Wall and the Southeast tower, but it is clear that the southwest corner of the tower originally extended further back into the grounds, with the line of the medieval curtain wall now likely to lie beneath the wall walk embankment. 20th century crenellations are visible overlying earlier crenellations, which may themselves be a post-medieval rebuild of the original medieval fabric. There is currently a seating area in front of the tower walls and the tower forms part of the Wall Walk from which excellent views of the river could be achieved.

Photo 15. View of tower

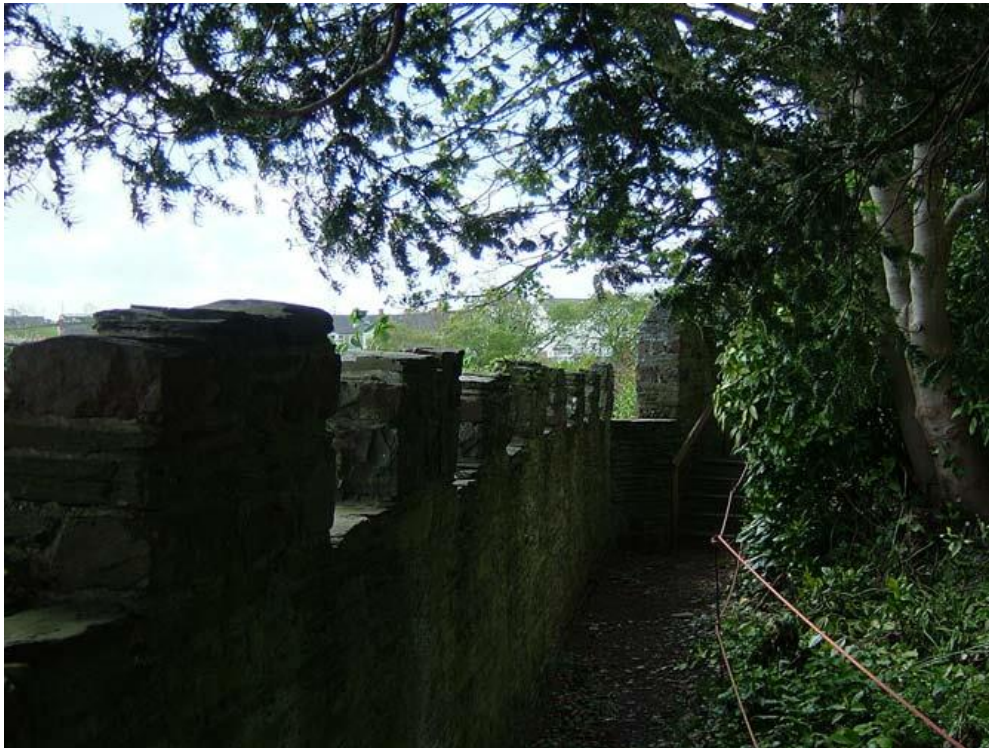
Photo 16. View of the south Curtain Wall

A section of wall at the northern end of this character area collapsed in 1984, revealing the wall and material behind it to be of post-medieval date. This information together with data from the Ove Arup survey demonstrates that the retaining wall was constructed at the foot of a low cliff or slope, and that the space between the wall and the cliff was filled with rubble and other material from the demolished castle.

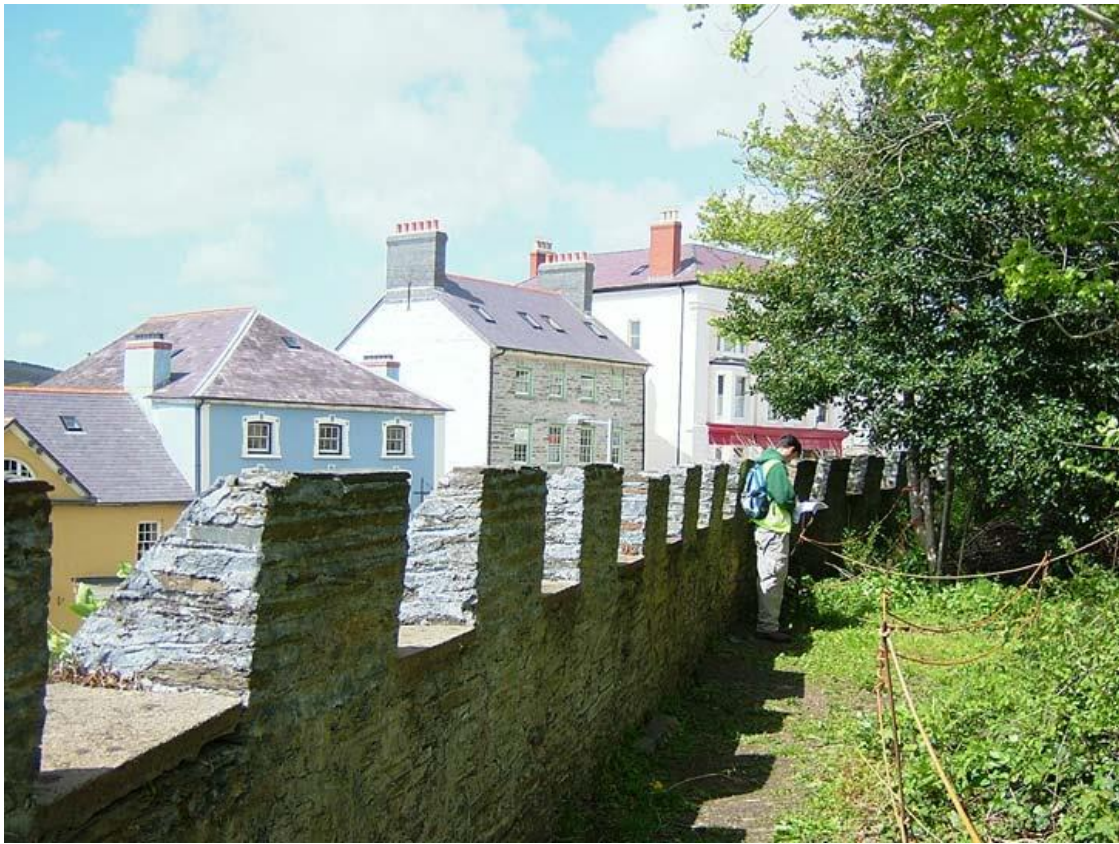
Photo 17. Detail of post-medieval crenellated wall and the Wall Walk

It is highly probable that the area of the Wall Walk overlies the original medieval curtain wall surrounding the 13th century castle, with the current Retaining Wall having been shown to be of post-medieval date. As noted above, there may also be traces of what was once the South West Bastion, located at an angle in the castle wall, where the town walls met those of the castle.

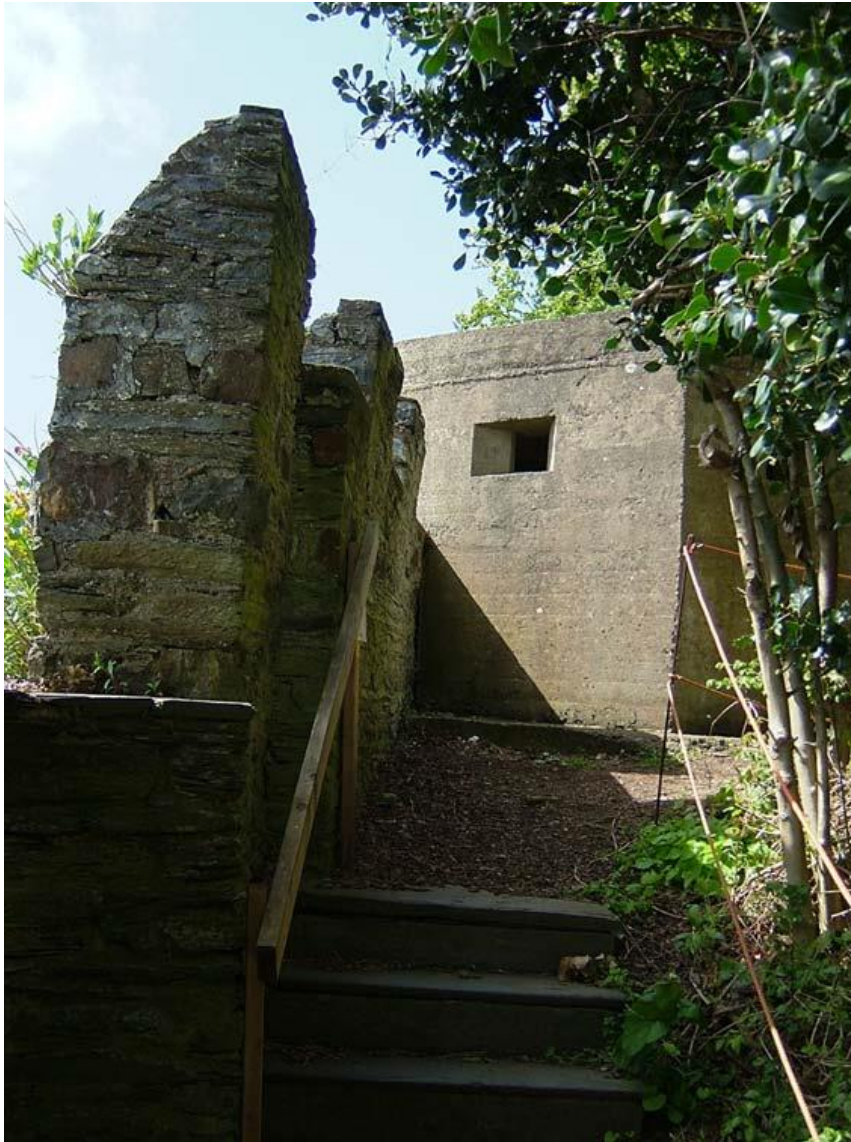
In 1940 the War Office requisitioned the east wing of Castle Green House and also constructed a concrete hexagonal pill box at a strategic point along the curtain wall on the south, at a point overlooking the five-arched bridge crossing the Teifi. A well-preserved flight of slate steps leads up to the pill box, which is built within the route of the Wall Walk.

Photo 18. Detail of steps leading up to the pill box

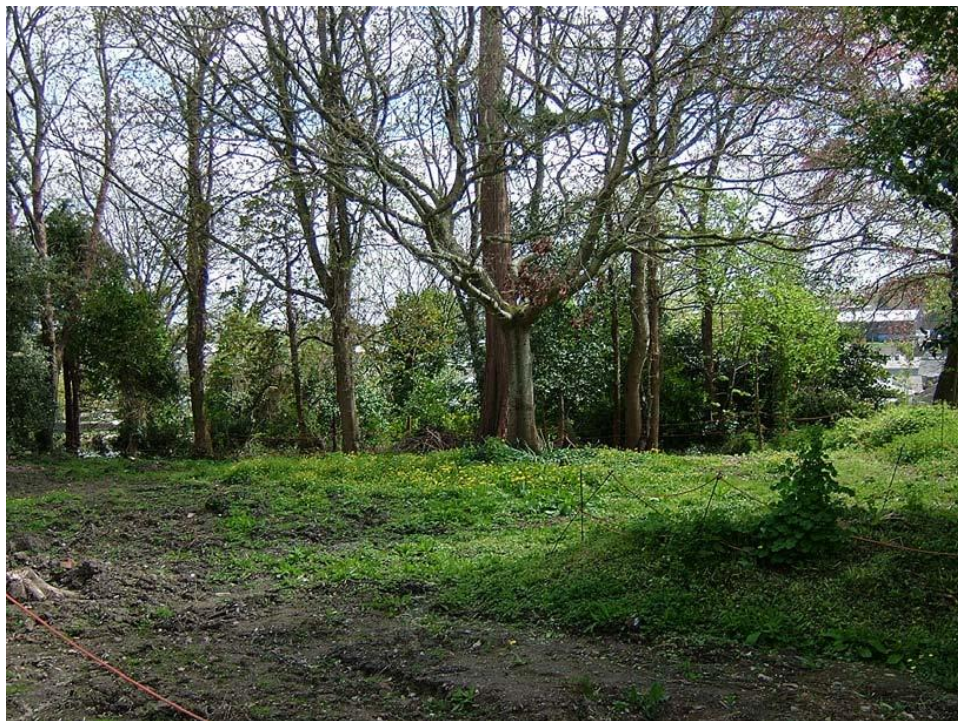
The front garden occupies and thus overlies the entire area of the former medieval castle ward. As such the area might contain significant archaeological deposits associated with the medieval castle, and provide evidence for the location of structures associated with the castle, such as a great Hall. However, excavations in 1984 demonstrated the little in the way of medieval archaeological deposits survive in this area. In most trenches thin topsoil either overlay natural geological deposits or post-medieval levelling which then overlay geological deposits. However, some archaeological deposits were located between 0.6 and 1.4m below the current ground surface. Despite the largely negative results from the excavations, this area is still considered likely to have a high archaeological potential.

Photo 19. Current view of the Main Garden at the front of Castle Green House

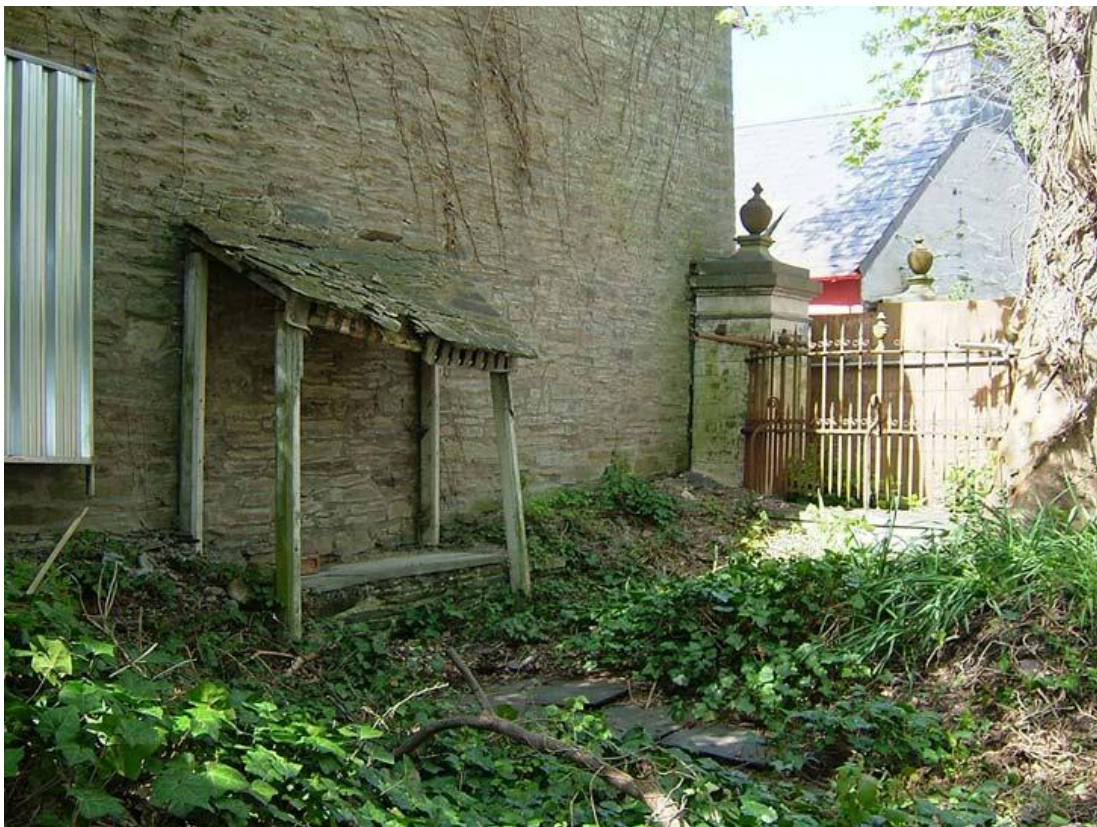
Both this and the Hothouse (Area 23) were built by Arthur Jones in c.1830. The fernery was located immediately to the south of the main entrance to the estate (Area 21) and would have been under glass. The fernery remained *in situ* for a century until 1931, when the head gardener, Victor Reed, demolished it and replaced it with a small, sheltered seat and flagstone patio visible today.

The fernery lies adjacent to Ty Castell, and possibly overlies the line of the medieval castle curtain wall, which is thought to run from the South West Bastion to the gatehouse, which is possibly located beneath the current gateway and Green Villas (Areas 21 and 22).

Photo 20. View of the site of the former fernery

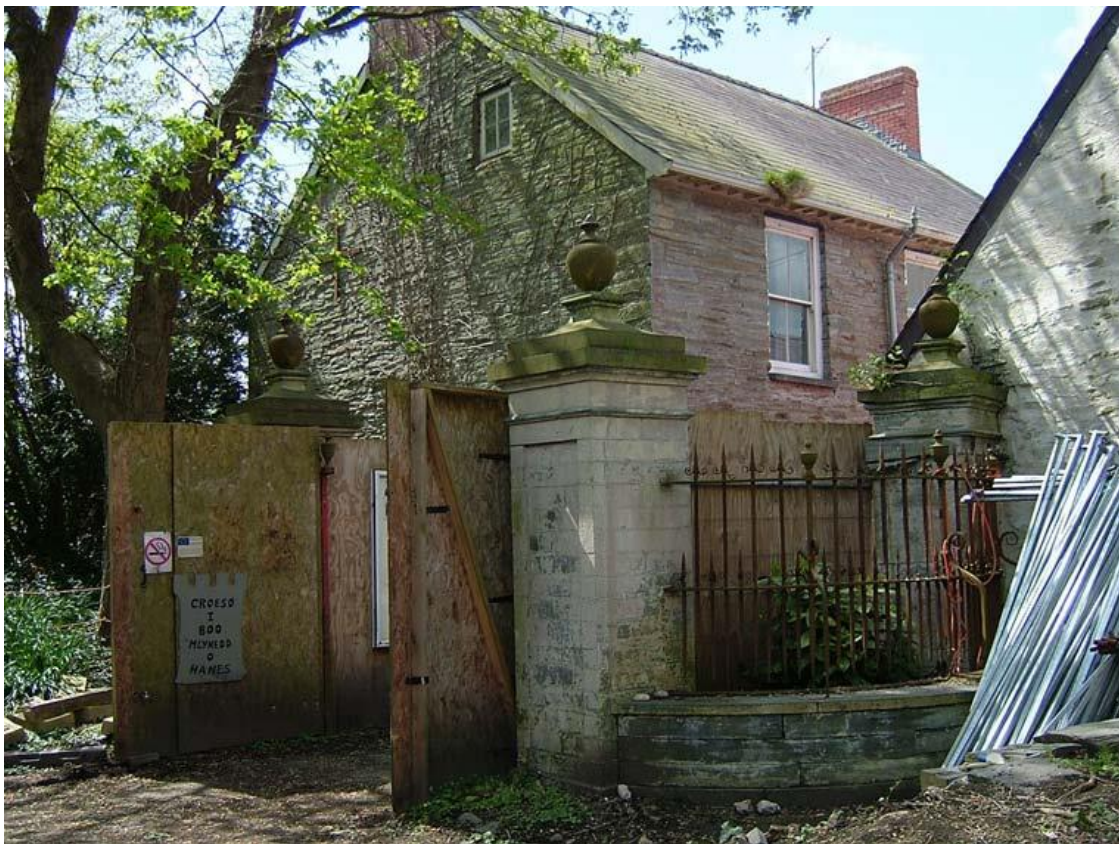
The gateway consists of two sets of dressed square blue lias pillars, c.2.5m high, set back from each other and joined by low, outward-curving stone walls and spear-headed iron railings. This was clearly intended to be the main, grand entrance to the property, as evidenced by the placing of cast iron urn finials adorning the piers: by comparison, the entrance to the Carriageway off Carriers' Lane is quite plain.

It is likely that the current Main Gate into the Castle Green estate overlies part of the original medieval gateway into the castle site.

Photo 21. View of the Main Gate and showing its detailed construction
