CARDIGAN CASTLE: AN ARCHAEOLOGICAL AND HISTORICAL SURVEY, 2009

K Murphy

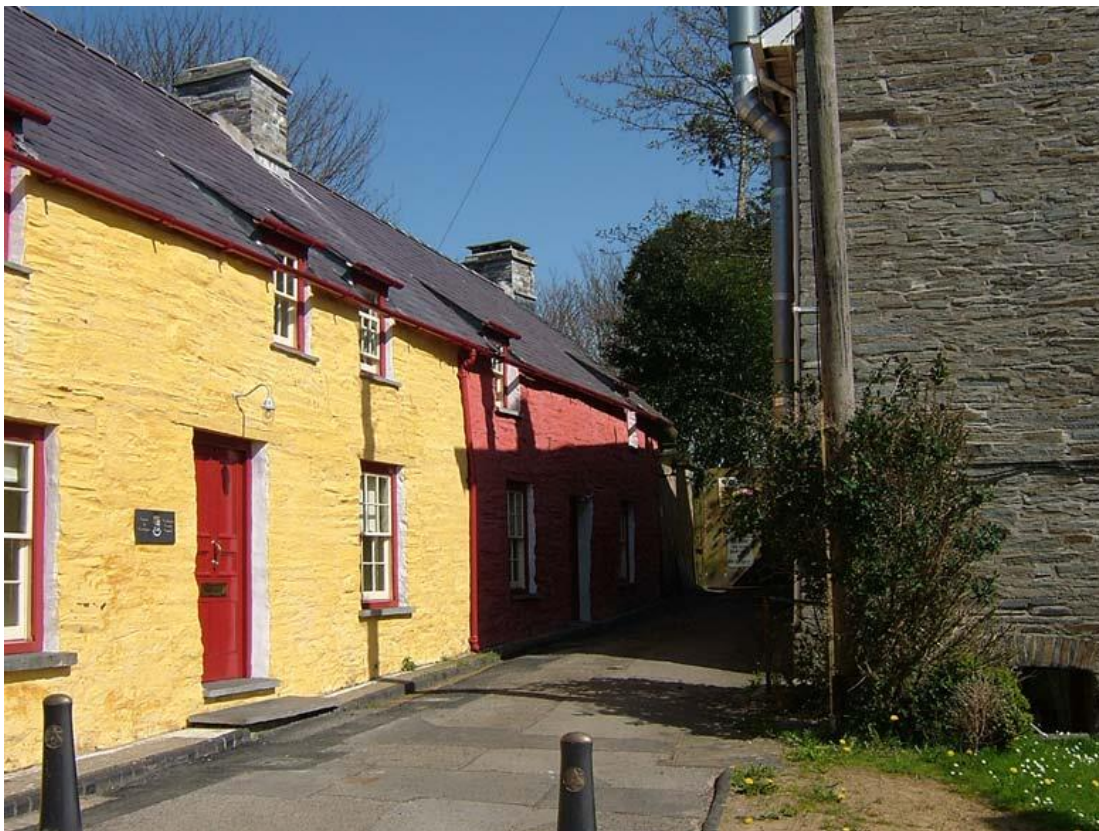
The cottages, Green Street, the Main Gate and Ty Castell are all likely to have been built over the main gateway into the medieval castle and its curtain wall. No traces of the medieval curtain wall, nor any other structural features of the castle on its western side, are currently visible above ground.

Photo 22. Nos. 1 and 2 Green Villas

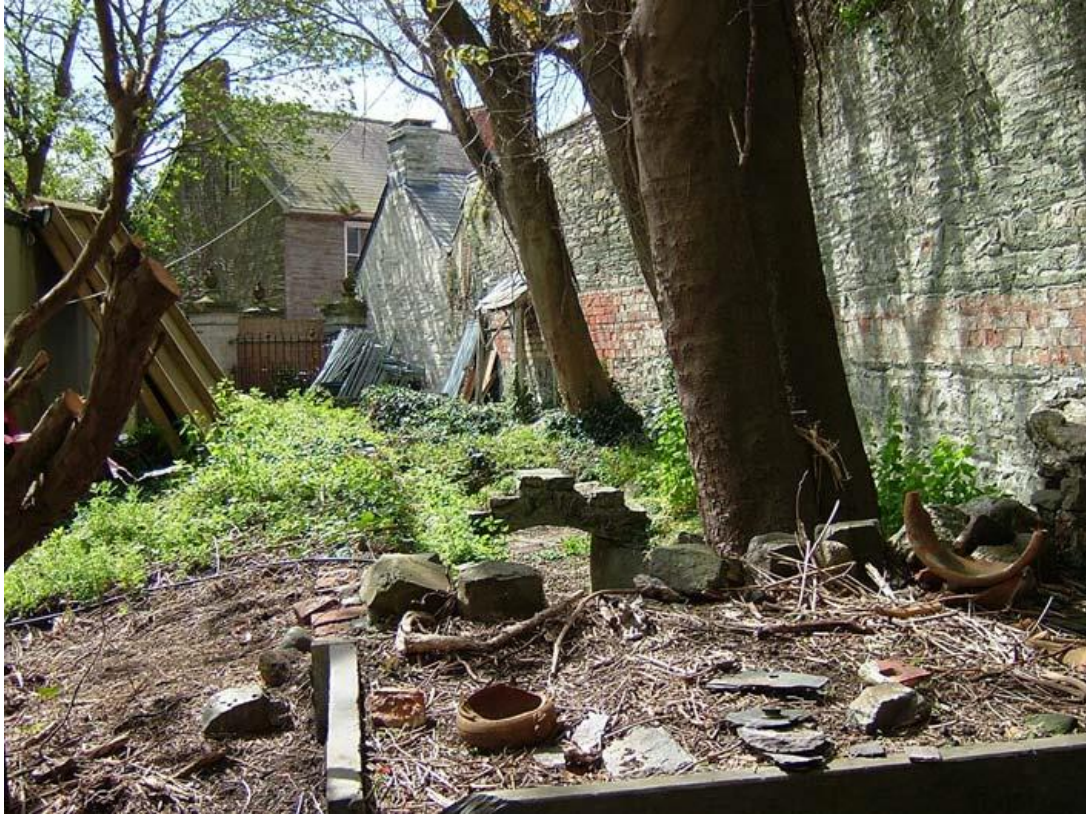
Photo 23b View along the length of the hothouse/lily pond, with red brick flues visible along the back wall, the arched bridge over the lily pond and the 1930s seat, with the slate water tank (now infilled) in the foreground.

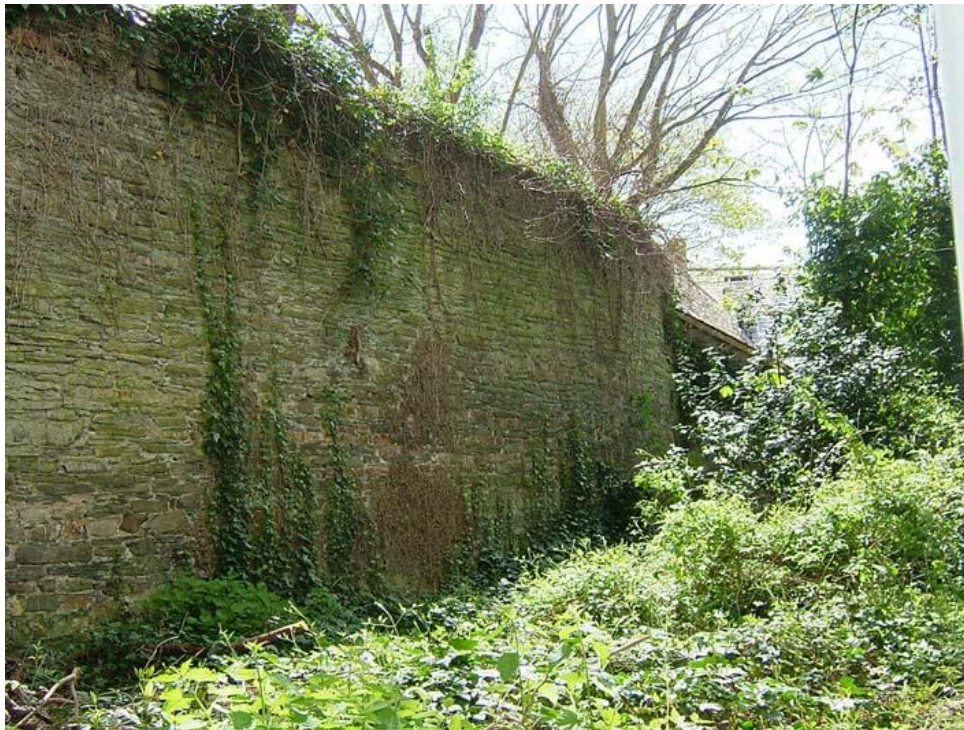
This area, located to the west of the main house, was brought into the grounds of the Castle Green estate at some point during the late 19th/early 20th century, when it was used as a croquet lawn. The southeast wall of the enclosure is of Victorian date, and separates this area from the site of the former hothouse, which lay on the other side. In the south-west corner of the 4m high wall, at the point where the wall angles to bound the rear of the Green Villas properties, there is a slate plaque built into it which says 'THIS WALL BUILT WERN NEWYDD ESTATE 1830'. During the 1930s a glasshouse was built in this area, and it remained lawned, but is currently heavily overgrown.

Photo 24. Victorian curtain wall separating the Croquet lawn from the hothouse

It is likely that the southeast wall of this area overlies the original course of the medieval curtain wall linking the possible gatehouse on the west side of the castle with its North Tower. Beneath the former croquet lawn is it highly probable that there are further surviving buried remains of the 7m wide defensive ditch and counterscarp bank which extended around the perimeter of the northern half of the 13th century castle. As such this area has significant archaeological potential to reveal more about this side of the castle, about which little is known.

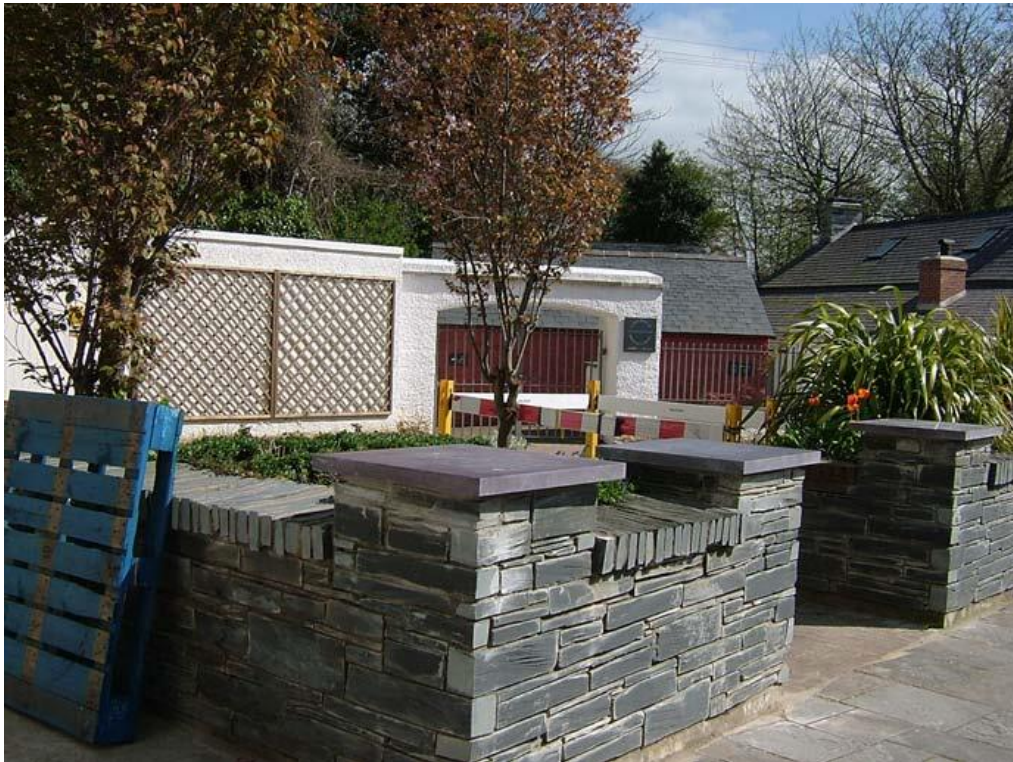
Wood's 1834 map and both the 1st and 2nd edition OS 25" maps illustrate that this area around the perimeter of the castle on its south and west sides was originally densely populated with a likely mixture of dwellings and commercial properties. Today all that survives is Ty Castell cottage, located opposite Green Villas, with the remainder of the area given way to pavement, grassy banks at the foot of the castle walls, and an area of seating overlooking the rear of Green Villas where Bridge Street meets the High Street (Area 26).

Photo 25a Area of Bridge Street Frontage, formerly buildings, demolished in the 1920s and now a pedestrianised seating area overlooking the rear of Green Villas

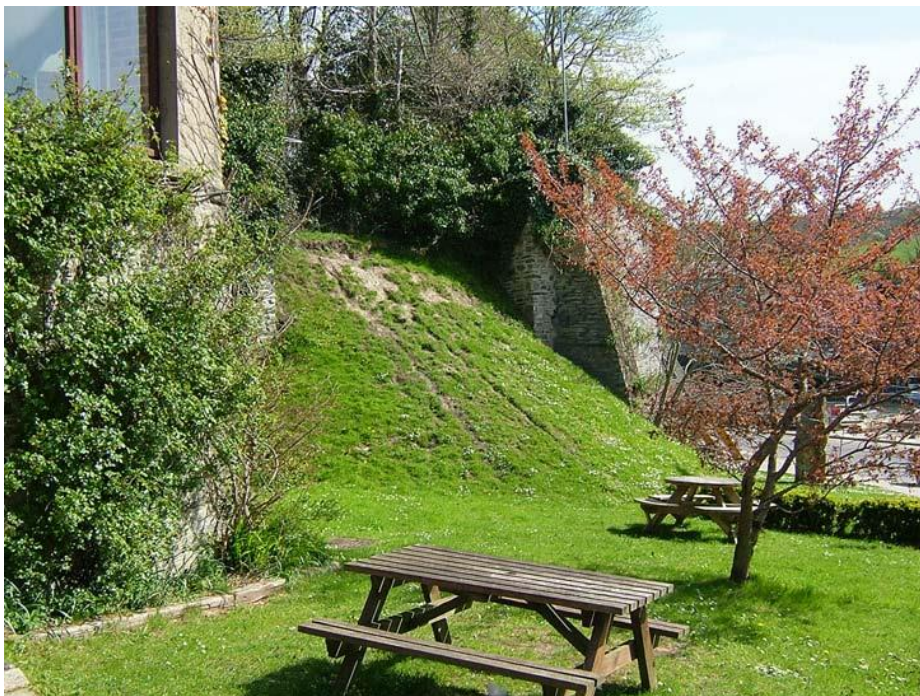
On the west-southwest side of the castle fronting Bridge Street an area of the curtain wall collapsed in 1984 behind Ty Castell, and this has been left as a grassed-over tumble of earth.

Photo 25e Area of collapse located behind Ty Castell

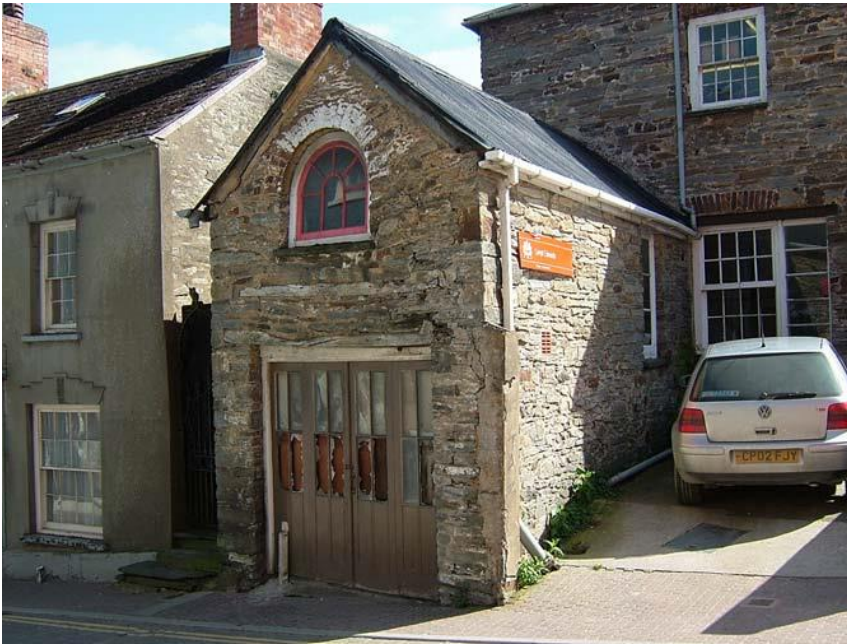
The Old Stables, built in the early 19th century for Castle Green House, is now in use as offices and is a Grade II listed building. The building consists of a two-storey main block set back from the street, with a low single-storey wing and attic coming forward to the street line. Inside the former stables there are timber posts supporting a 3-bay arcade, formerly fronting stalls and rear wall hollows for hayracks. The buildings here back onto the Garages (Area 6), which re-used the former Coach-house most likely associated with the Old Stables.

Photo 28a The northeast wing of The Old Stables

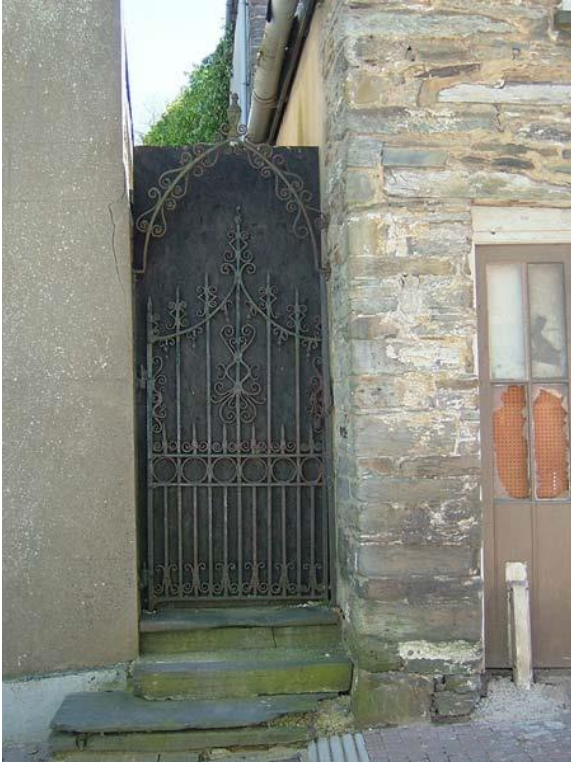
It is likely that The Old Stables were built by John Bowen, with the larger Stable block range fronting Carriers' Lane (Area 10) built c.1828 for Arthur Jones when he expanded Castle Green House. Adjacent to The Old Stables, and separating it from No. 43 St Mary's Street (part of Area 29) is a narrow passageway leading up to the Garages/former Coach House and the northern end of the Carriageway (Area 7) at the rear of Castle Green House. This passageway is accessed via an ornate gate, which fronts St. Mary's Street.

Photo 28b The Grade II listed ornate wrought iron gate separating The Old Stables from No. 43 St Mary's Street

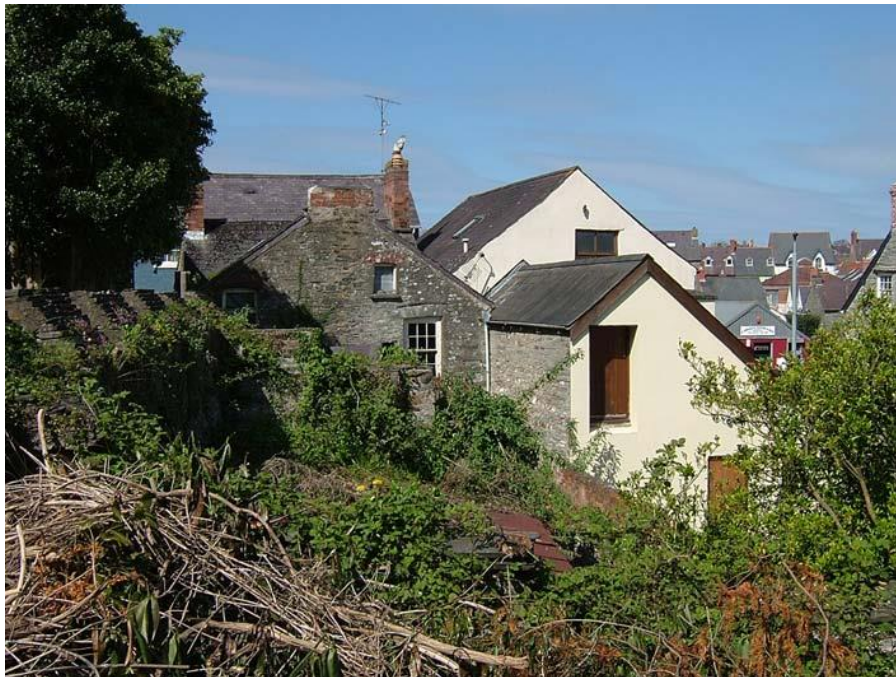
These properties back onto the area of the Additional Gardens (Area 8), which was first brought into the Castle Green estate in the 1920s following the widening of Carriers' Lane. Prior to this there was an additional property next to No. 42 St Mary's Street, which was the original house on the corner of the two roads, but this, and all the other cottages on the west side of Carriers' Lane (visible on both Wood's 1834 map and the 1st and 2nd Edition OS 25" maps) were demolished when the road was widened.

Photo 29 Rear of the properties

These properties probably lie just to the east of the projected line of the medieval town wall, which ran northwards from the North East Bastion of the 13th century castle. Although it is possible that the town wall ran across this area, as either of two retaining walls at different levels could be the line of the medieval wall, and indeed could incorporate medieval masonry in their construction.
