**BRUNANT HIGHWAY SUPPORT SCHEME,
PUMPSAINT, CARMARTHENSHIRE
ARCHAEOLOGICAL
WATCHING BRIEF
(NGR SN 6682 4084)**

RHIF YR ADRODDIAD / REPORT NO. 2015/23
RHIF Y DIGWYLLIAD / EVENT RECORD NO. 108470

BRUNANT HIGHWAY SUPPORT SCHEME, PUMPSAINT, CARMARTHENSHIRE ARCHAEOLOGICAL WATCHING BRIEF

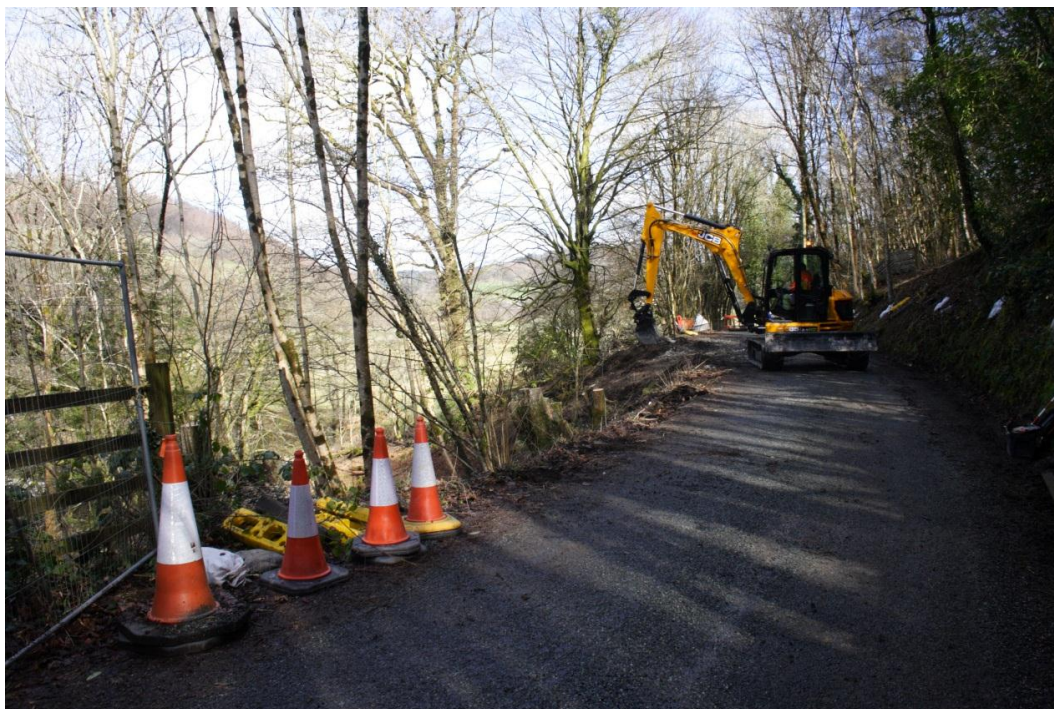
Photo 1: View northeast along road line showing area entire area of groundworks

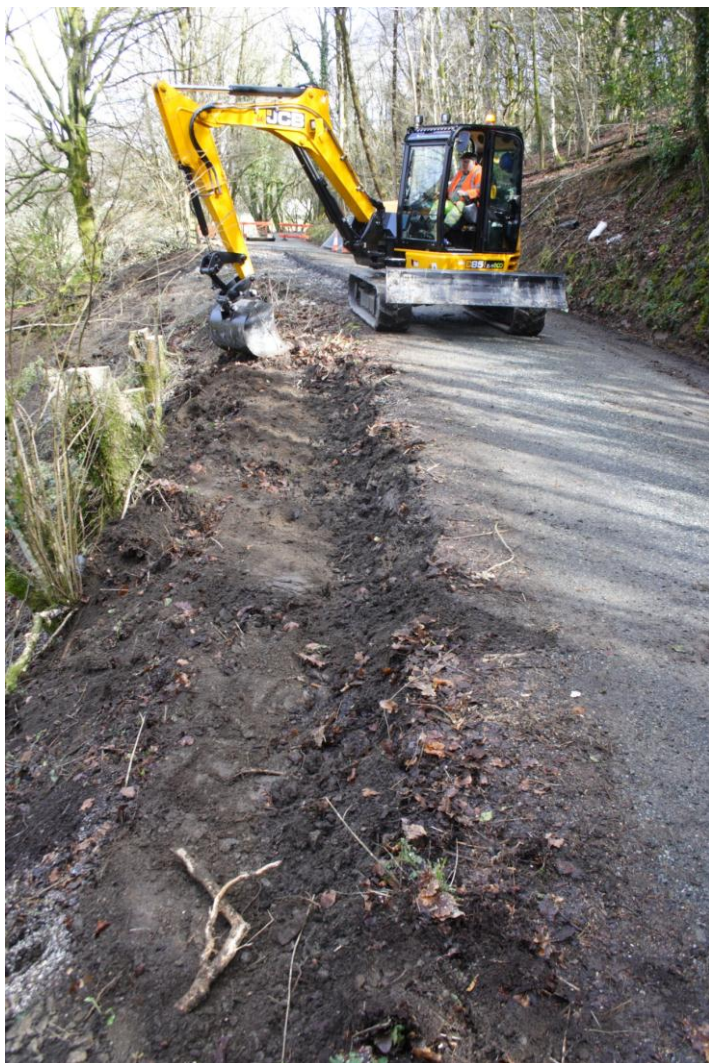
- 5.2 The second visit on 10th March 2015 observed groundworks along the length of the 15m stretch of the road repair area and an area to the southwest where shallow groundworks were being carried out (Photo 1). These additional groundworks included the partial removal of a slight (modern) bund along the western edge of the road and the cutting back and cleaning up of silts and other material accumulated on the road edge (Photo 2).

Photo 2: Cleaning the road edge to the southwest of the road repair area

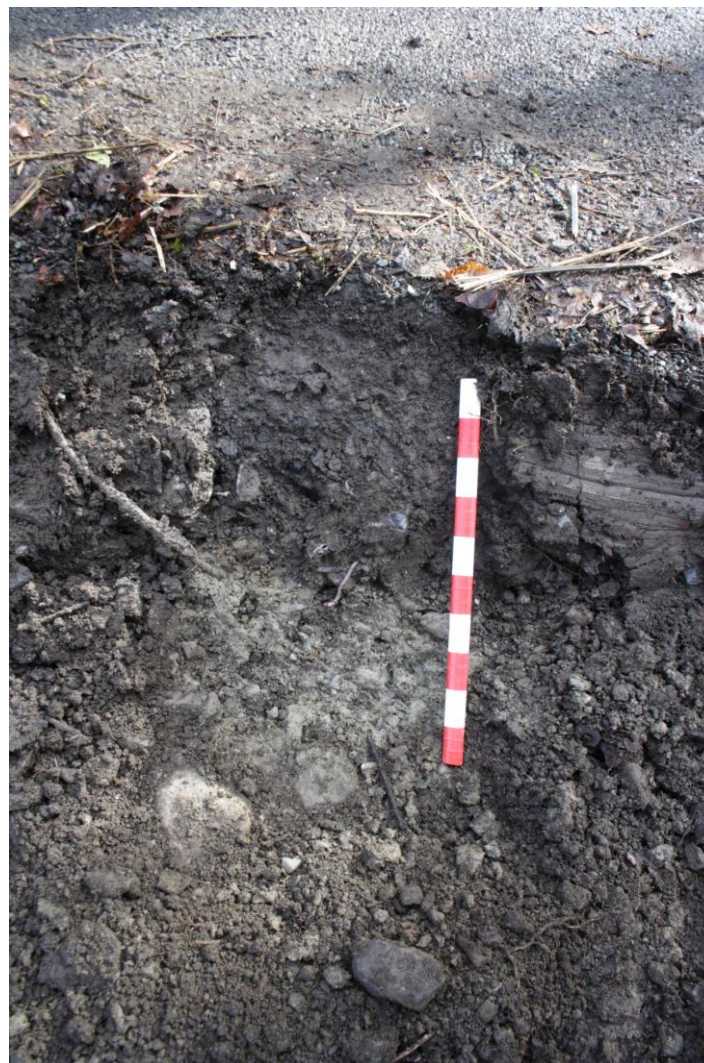
- 5.3 Through discussion with the site contractors the archaeologist was given the opportunity to investigate the road make-up in this area to the south of the main 15m stretch support scheme. A small section was excavated through the stripped area to the road edge (Photo 3). The section indicated a depth of tarmac road surface of around 0.10m sitting on top of a dark stone and mixed tarmac layer of 0.30m depth. Below this was a light grey stone and sand level of a minimum depth of 0.20m, which was also levelling material for the road, containing larger stones than seen within the layer above. This layer was also present along the base of the stripped area.

Photo 3: Small section cleaned up against existing road edge showing make-up layers

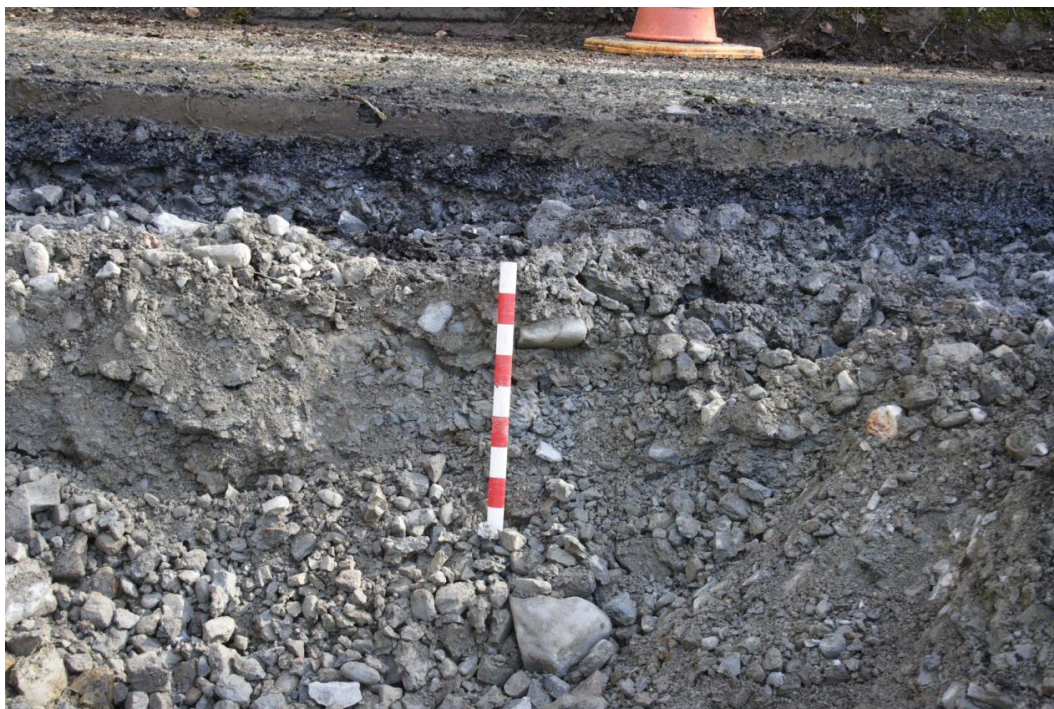
- 5.6 Three areas of the 15m stretch were subject to deeper excavation under archaeological supervision to provide sections excavated through the road make-up and into the hillslope to determine if archaeological remains were present. The first test slot was excavated at the southwestern end of the scheme, identifying a similar sequence of road make-up deposits as was recorded to the southwest, although the lower layers were slightly shallower (tarmac – 0.10m; tarmac and dark stone – 0.10m – 0.20m; light grey larger stone and sand – 0.10m – 0.20m) (Photo 4).

- 5.7 In this area it was possible to dig beneath the lower light grey stone and sand layer which demonstrated it lay on natural sandstone bedrock of a light grey colour very similar to the lower layer of road make-up.

Photo 4: Representative northwest facing section through road make-up deposits within the 15m length of the Brunant Highway Support Scheme area (0.5m scale bar placed in front of bedrock)

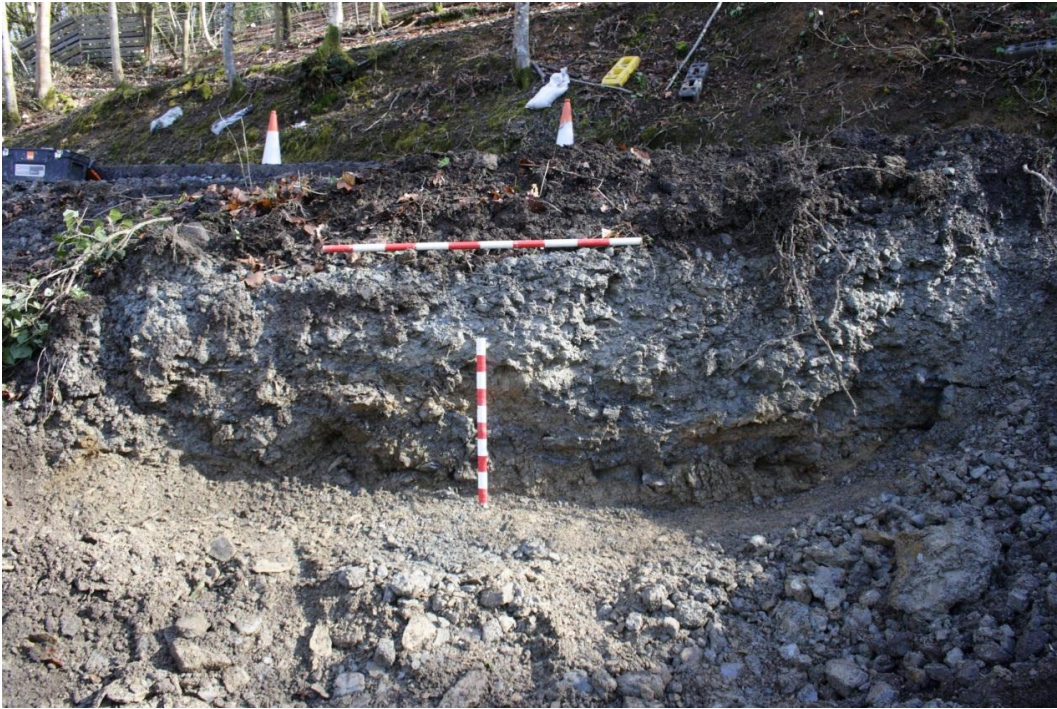
- 5.8 A deeper test slot was excavated in the central part of the scheme running at an angle to the edge of the road line through to the steep hillslope leading down to the Afon Cothi. The slot indicated a range of different bedrock levels below the road make-up layers, ranging from light grey sandstone, with a more yellow sandstone layer beneath overlying thin bands of both yellow and grey stones beneath (Photos 5 & 6). The bedrock was observed to the edge of the hillslope.

Photo 5: West facing section through natural bedrock below road make-up layers (material above the 1m horizontal scale bar is re-deposited)

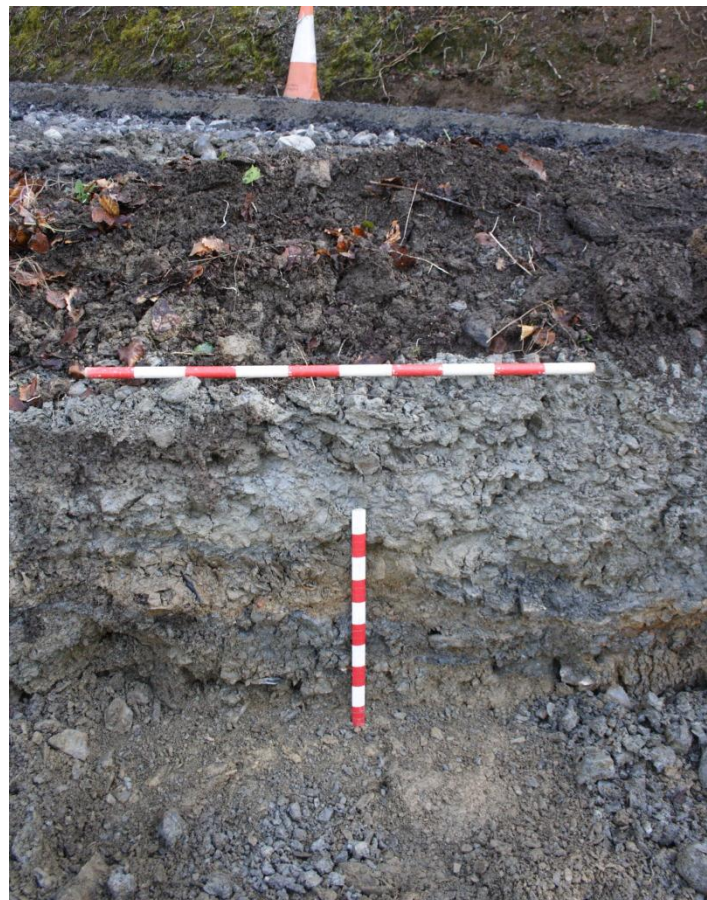
Photo 6: Detail of west facing section through natural bedrock below road make-up layers (material above the 1m horizontal scale bar is re-deposited)

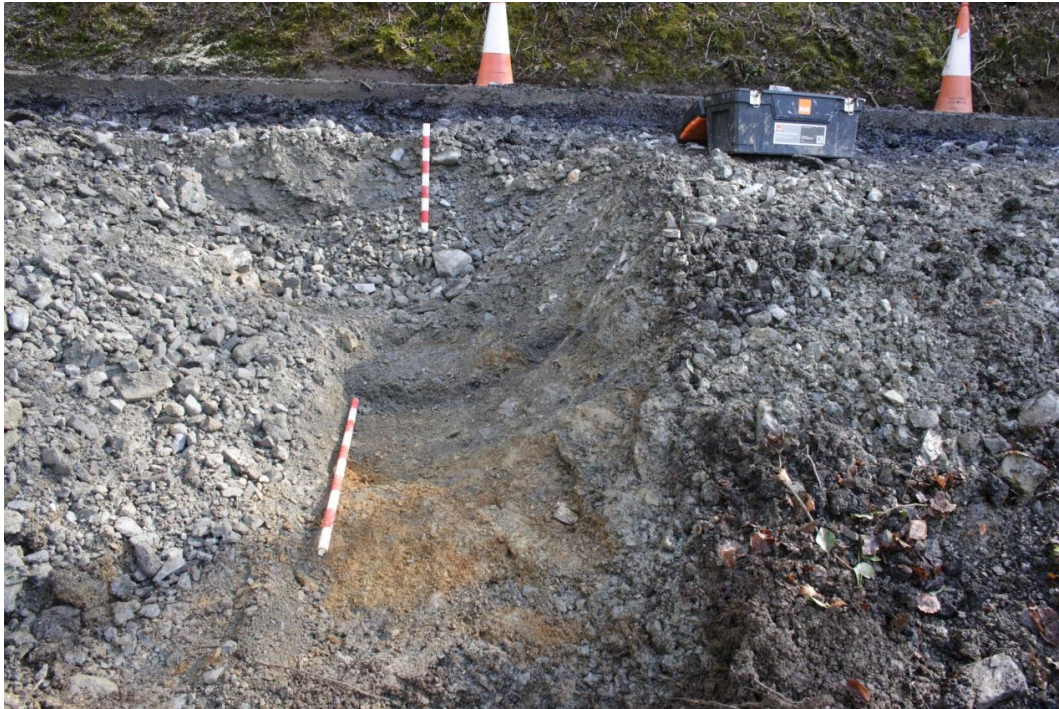
- 5.9 A second test-slot was excavated at the northeastern end of the scheme, running from the cut edge of the road through to and slightly down the hillslope (Photo 7). This area was excavated deeper into the bedrock and revealed more variation in its colour, including light grey, orange/yellow and dark grey banding (Photos 7 & 8).
- 5.10 At the northwestern end of the test slot a small amount of excavation was carried out removing part of the thin topsoil of the hillslope. This could be seen to range in depth of between 0.10 to 0.15m depth lying directly on the bedrock which had a steep slope of around 70° running down to the river below (Photo 8).

Photo 7: Test slot at northeastern end of scheme showing cut edge of tarmac, road make-up and bedrock beneath viewing southeast (1m and 0.5m scales)

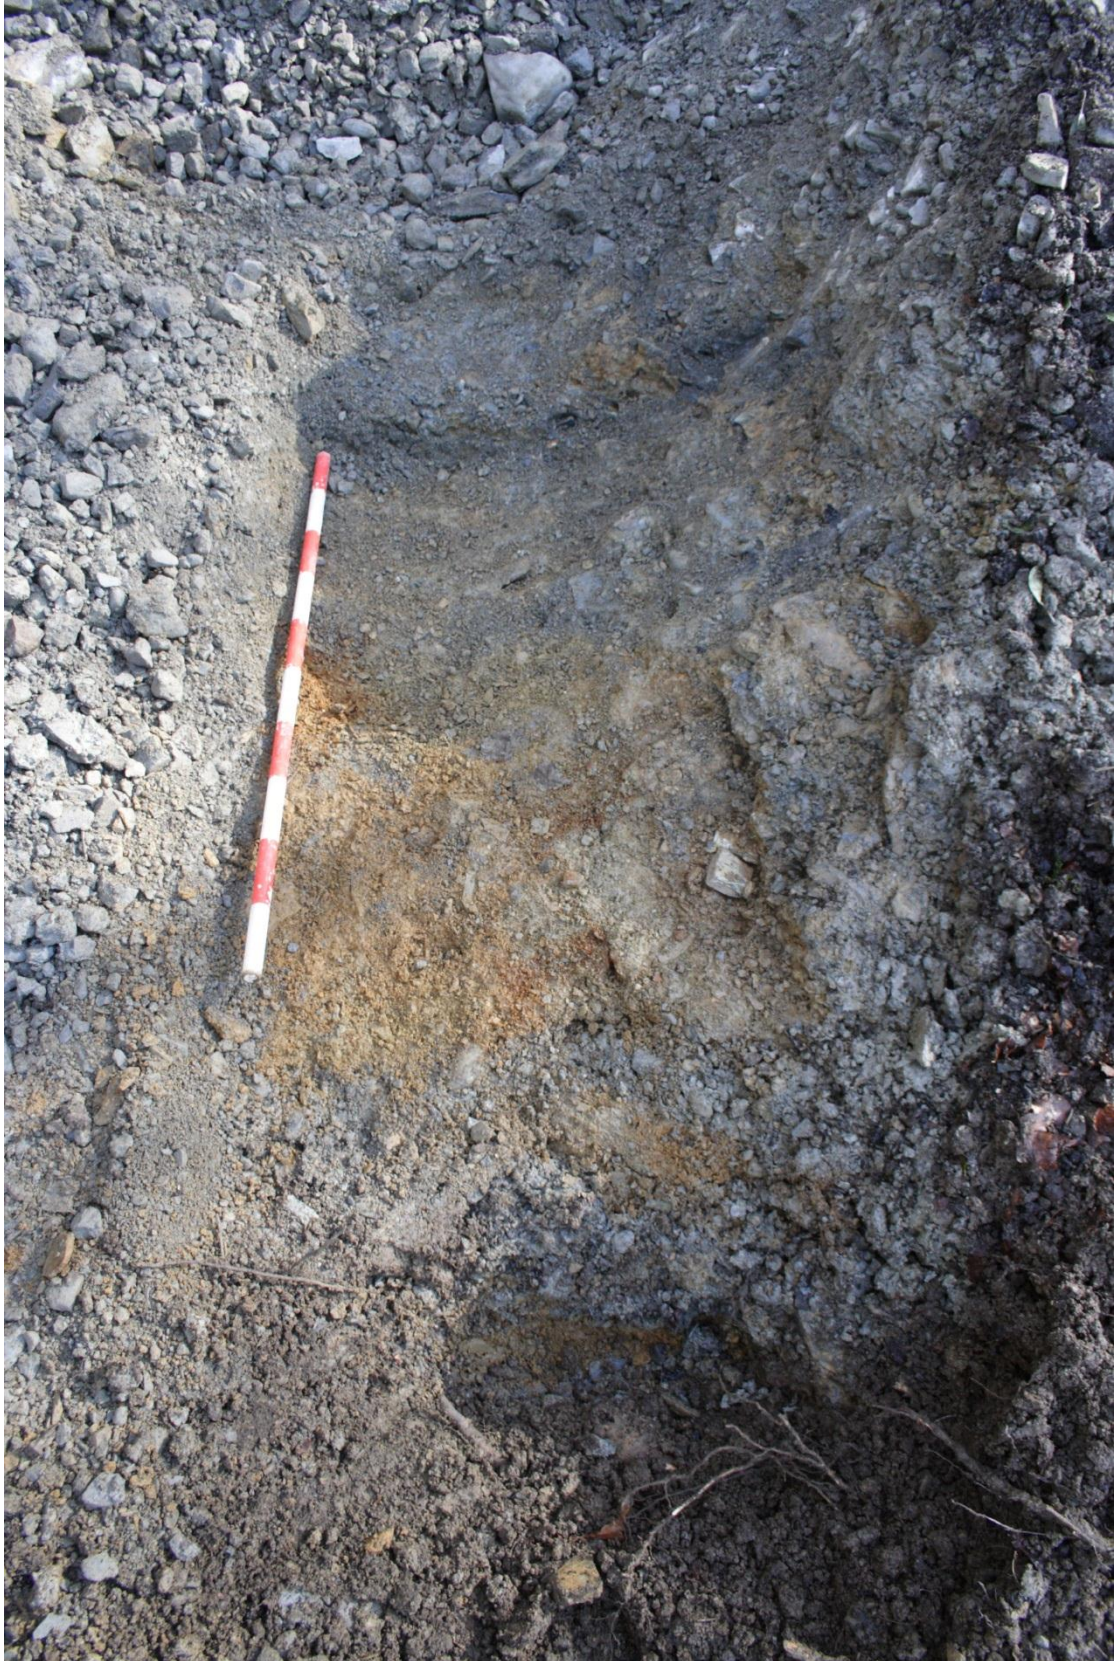
Photo 8: Detail of base of test slot trench showing variations in colours of the natural bedrock and topsoil on top of steep bedrock slope at bottom of photograph viewing northeast (1m scale)

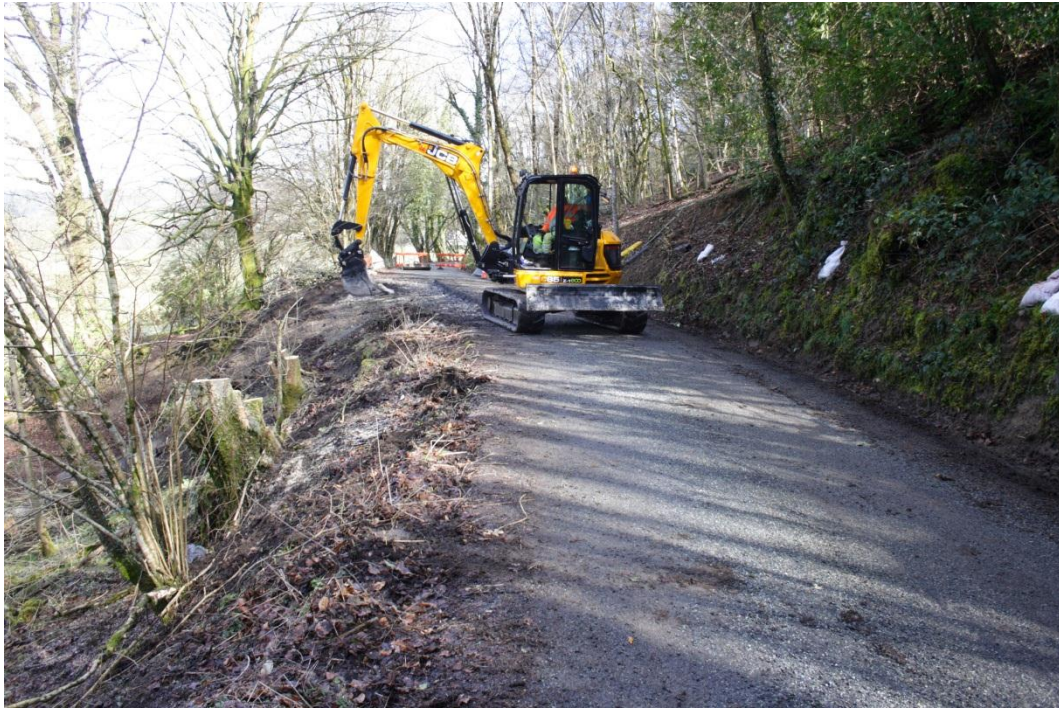
- 6.7 There was no indication that any archaeological deposits survived within the area of the Brunant Highway Support Scheme. If any archaeological deposits had been present they would have been removed with the construction of the existing road which had evidently been significantly terraced into the former hillslope (Photo 9). No evidence survived of any earlier road surfaces.

Photo 9: View northwest along the Brunant Highway repair area showing the significant terrace into the slope of the existing road line
